A Study of Loe Bar

A study into the history of the bar and the development of a technique for future monitoring as well as an insight into the geomorphology.

Submitted by Annabel Pardoe to the University of Exeter as a dissertation towards the degree of Master of Science by advanced study in Surveying with Land and Environmental Management, 7th September, 2015.

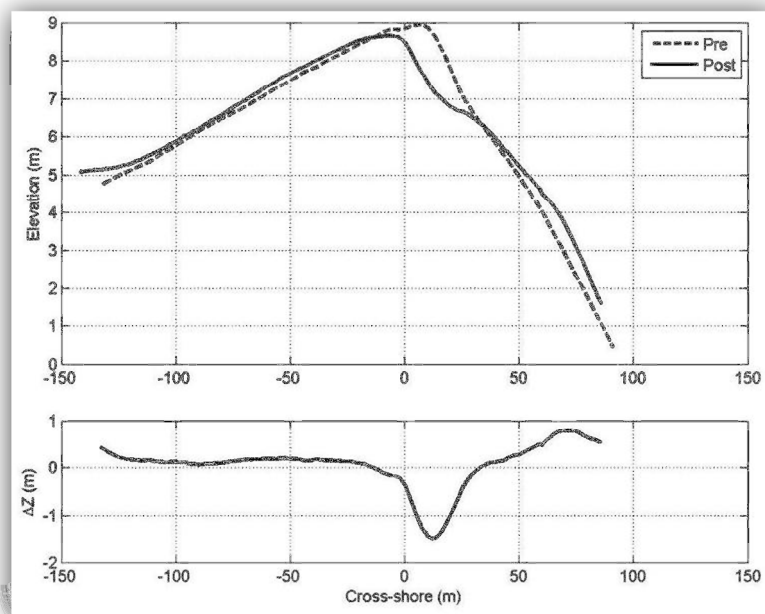
Figure 11: Diagram displaying results found from a pre- and post-storm survey at Loe Bar completed in February 2014 (note: vertical exaggeration) (Masselink, 2015). This can be compared to the diagrams in the left side of figure 9 above and the process demonstrated in figure 10.

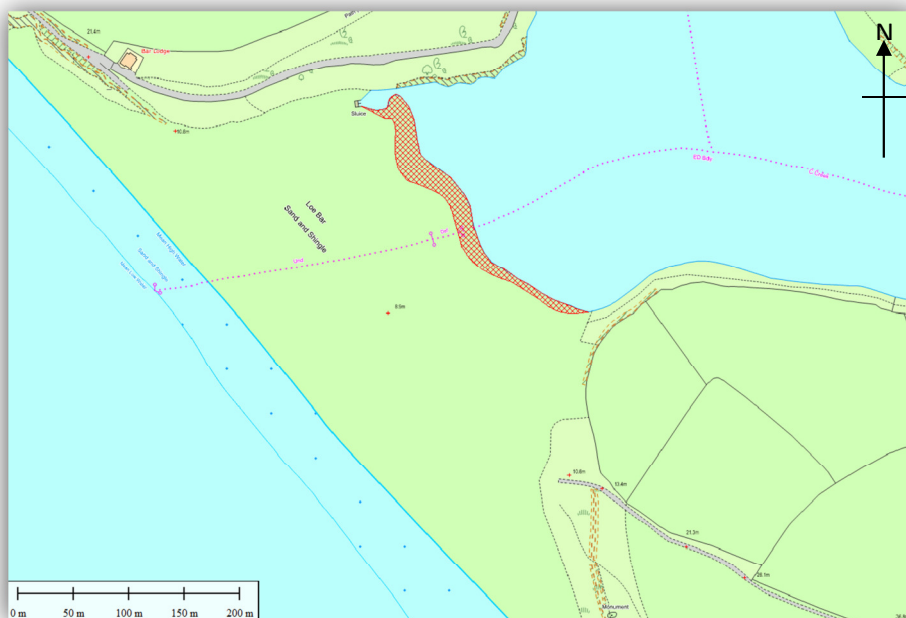
Figure 12: The amount of landward movement of the boundary between Loe Bar and Loe Pool going by OS maps produced in December 2013 and May 2014 (Base map: Edina Digimap).

Using topographic OS maps from recent years it is possible to see the effects of the storm which caused the landward movement of the lake border. The location of the landward side of the bar remained constant in maps published from June 2007 to December 2013. It is between December 2013 and May 2014 that the shift can be seen, with the landward side of the bar moving up to almost 25m in some areas, gaining around 4,052m² in area on the landward side (figures 12 and 13).

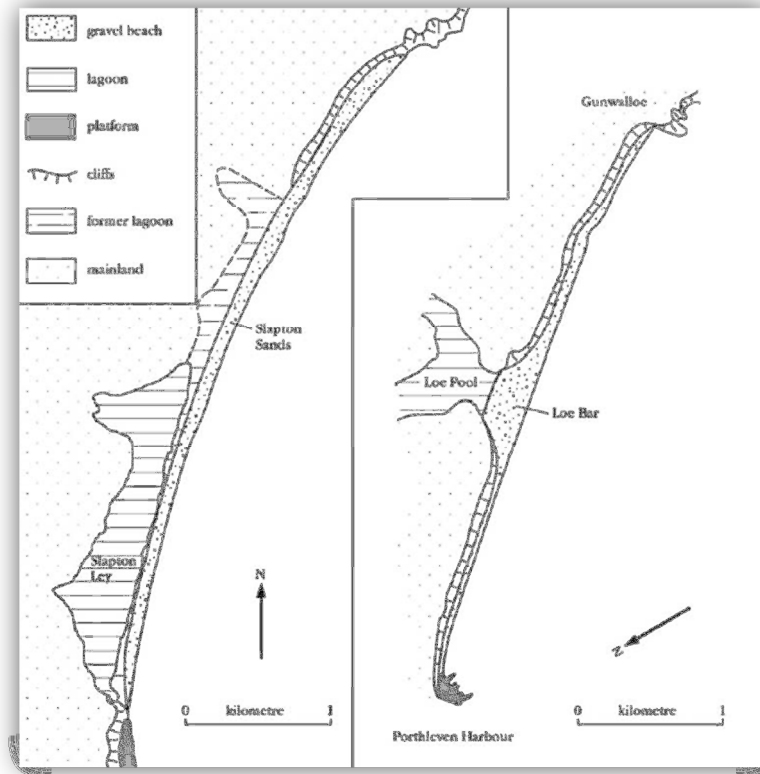
Figure 14: A comparison of geomorphological form between Slapton Sands, enclosing a large lagoon, and Loe Bar, blocking a narrow estuary (Source: May and Hansom, 2003).

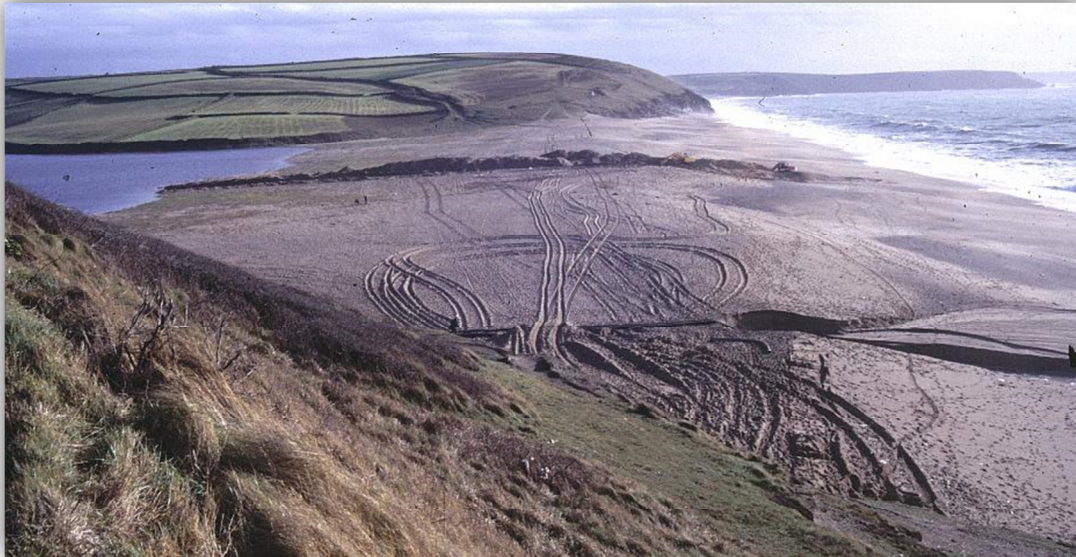
Figure 16: Photograph of the 'cut' being made to release water from Loe Pool to the sea in November 1984, looking southeast (Davies, 2012).

When the bar is cut a narrow channel is made with shovels or, in more recent times, a small digger. The volume and speed at which water leaves the lake causes the cut to be greatly widened. In 1865 an account of the breach described it as having become 'wider than a stone could be thrown across with a strong arm' (Davies and Matthews, 2002). The breach carried out in 1984 by South West Water is recorded to have evolved from being a small one metre wide opening in the evening to that which was sixty metres wide and 10 metres deep by the early hours of the next morning (Davies and Matthews, 2002). Rendel (1837) notes that the bathymetry of the sea at the location of the bar became greatly altered when compared to the rest of the coast due to the amount of

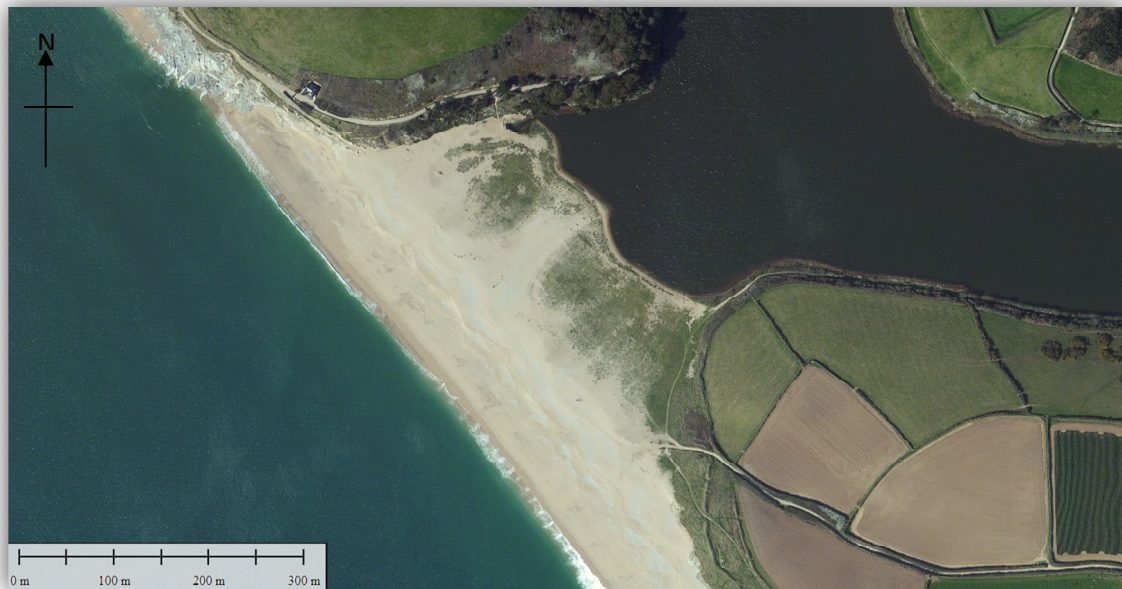
Figure 17: Satellite Image of Loe Bar. The lack of vegetation is visible in a linear NE-SW direction, caused by the cutting of the bar to let water out to the sea in November 1984 (Source: World Imagery, Global Mapper).

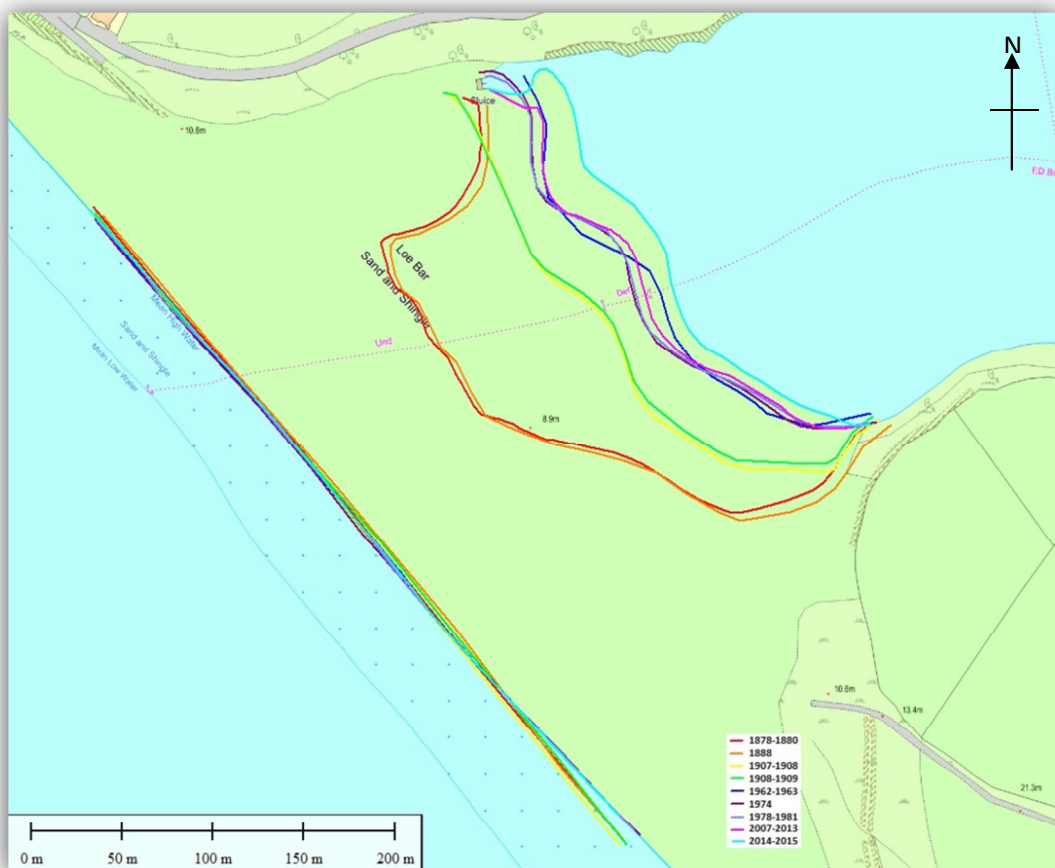
Figure 18: Changes in morphology of Loe Bar at various intervals between 1878 and present day (Source: Edina Digimap Historical & Mastermap data).

Historical OS maps dating from 1878 to present day show clear widening of the bar over time since 1878 (figure 18). The seaward side has remained relatively constant, yet the landward side has notably moved inland by a considerable amount. Despite the bar being cut in 1984, a clear recovery has been made, with the present day lake line being further inland than it was seen to be in historical maps published in 1978-1981, before the cut was made. This implies that the cut did not greatly affect the growth of the bar and that in order to have an effect on its width, a significant frequency of cuts would be required. With no more, or at least very seldom, cutting taking place, the bar has been able to return to its natural rate of growth through onshore deposition (Loe Pool Forum, 2015). Whilst OS maps are subject to a degree of error, a confident representation of how the bar used to be in the past is determinable from the information available.

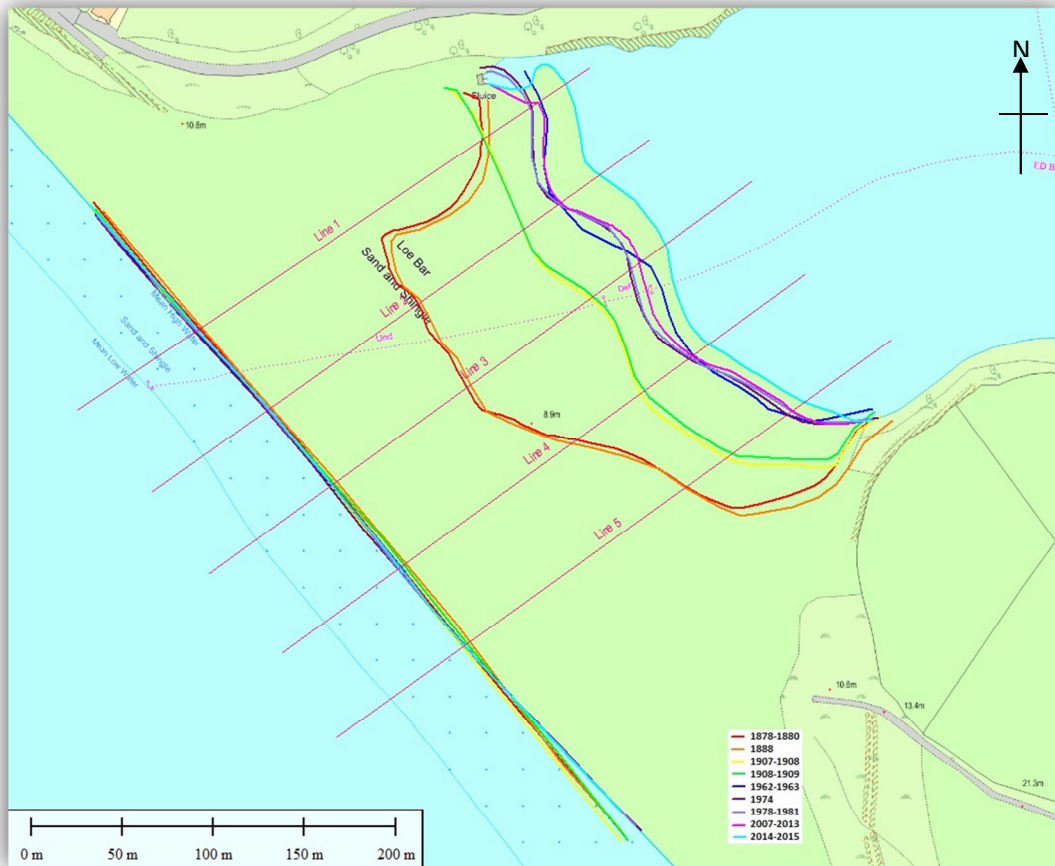
Figure 19: Changes in morphology of Loe Bar. Lines 1 to 5 represent chronological profiles shown in figure 20 a to e.

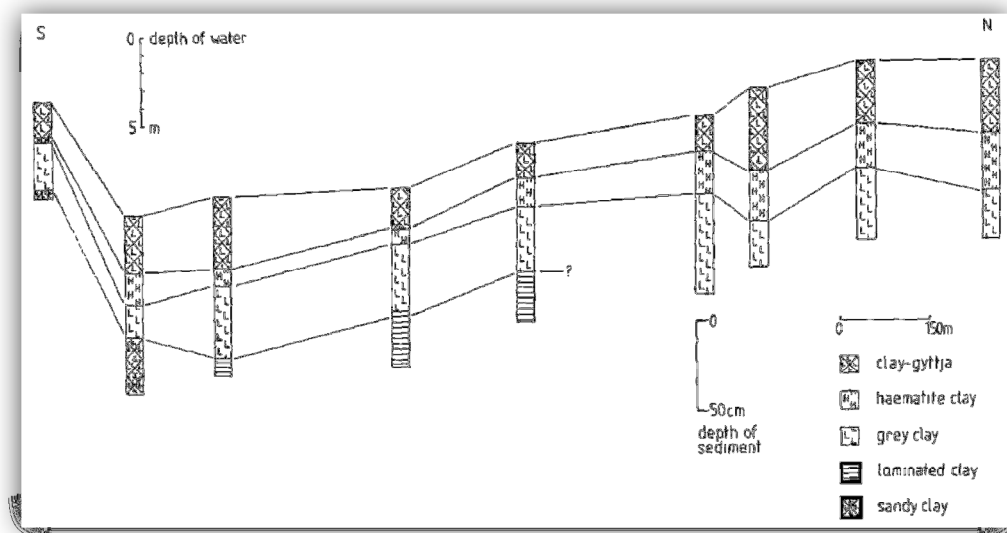
Figure 25: Generalised North-South section of the top few metres of sediments in Loe Pool (O'Sullivan et al, 1982).

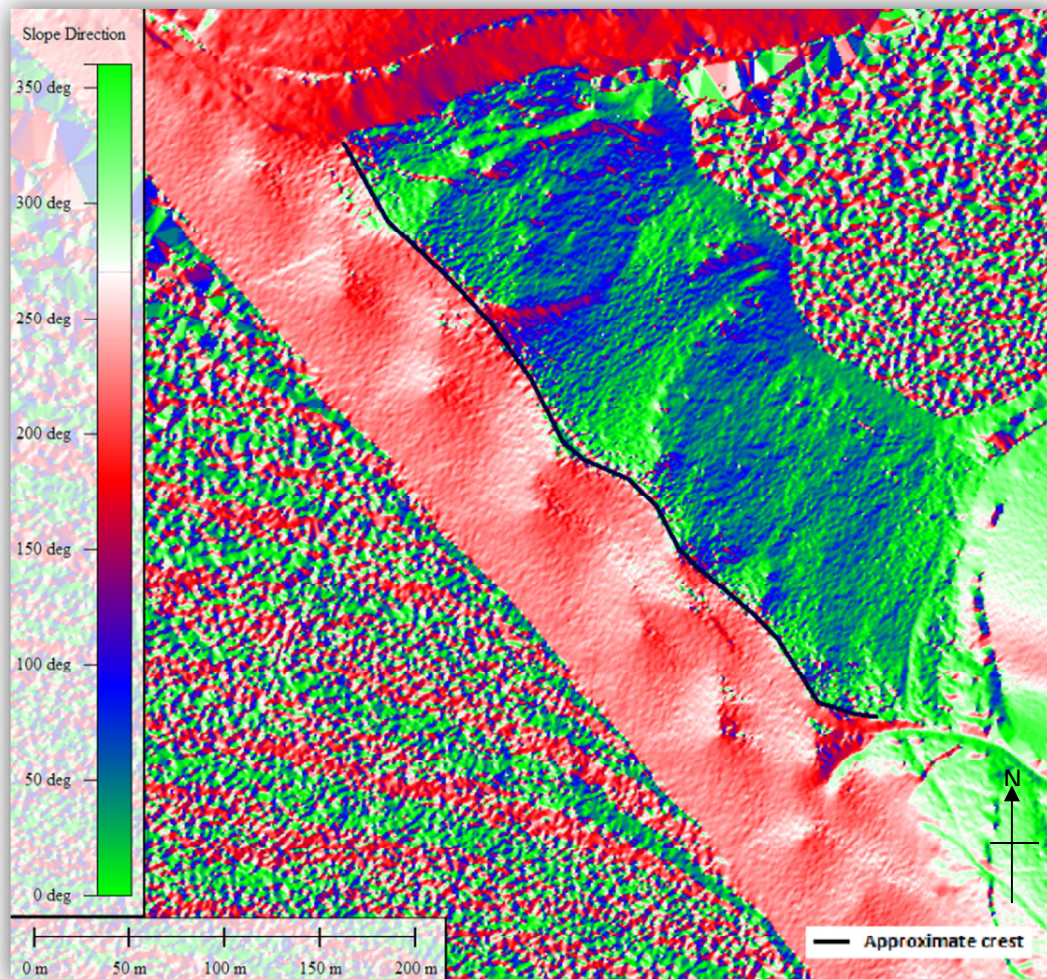
Figure 27: Slope direction of the bar enabling the distinction of the approximate location of the crest of the bar as marked (Source: Ferraccioli et al, 2014).

GIS can also be used to look at the direction of the slope detected by the LiDAR data. In this case, figure 27 shows a distinct change in slope direction running NW-SE. This can be used to approximate the position of the crest along the bar, as is displayed.

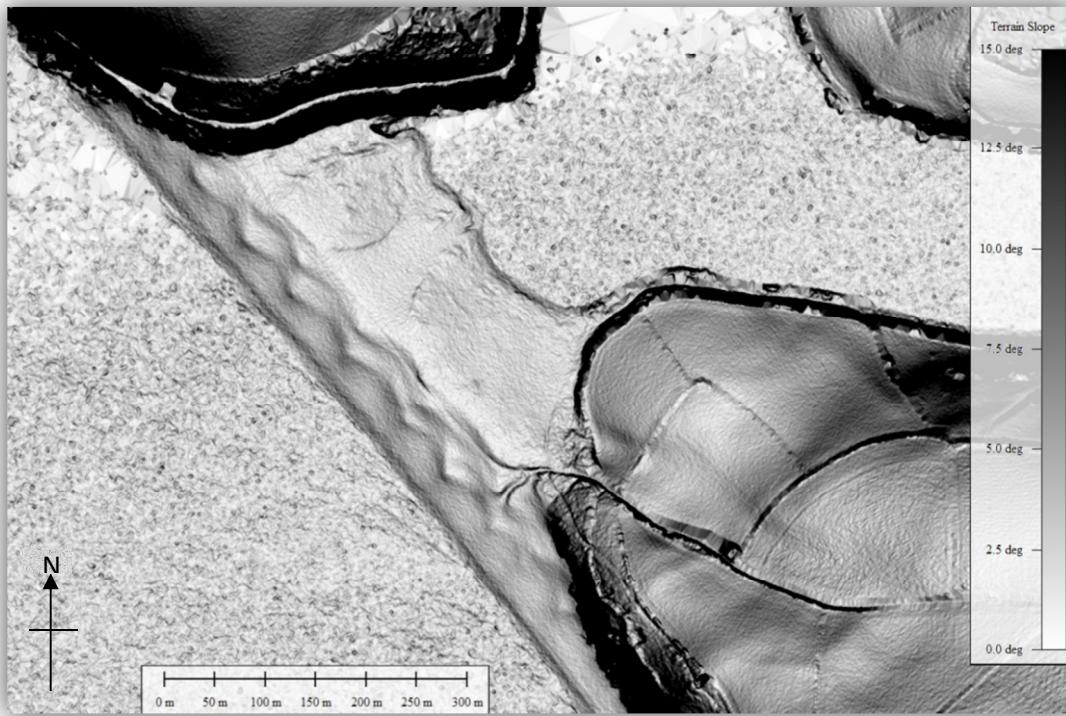
Figure 28: View of Loe Bar in Global Mapper's 'slope shader view', showing slope characteristics and morphological features (Source: Ferraccioli et al, 2014).

Another possibility with the use of GIS, is to display the LiDAR data using the gradient of slope. Figure 28 shows areas of steep gradients as dark and vice versa. Displaying the data like this can show a vast amount of detail regarding the morphology of the bar. The area of the cut carried out in 1984 is easy to see, and with the aid of 3D visualisation the bar can be seen in its context with the surrounding cliffs as well as showing clear differences between the landward and seaward sides of the bar (figures 29 and 30).

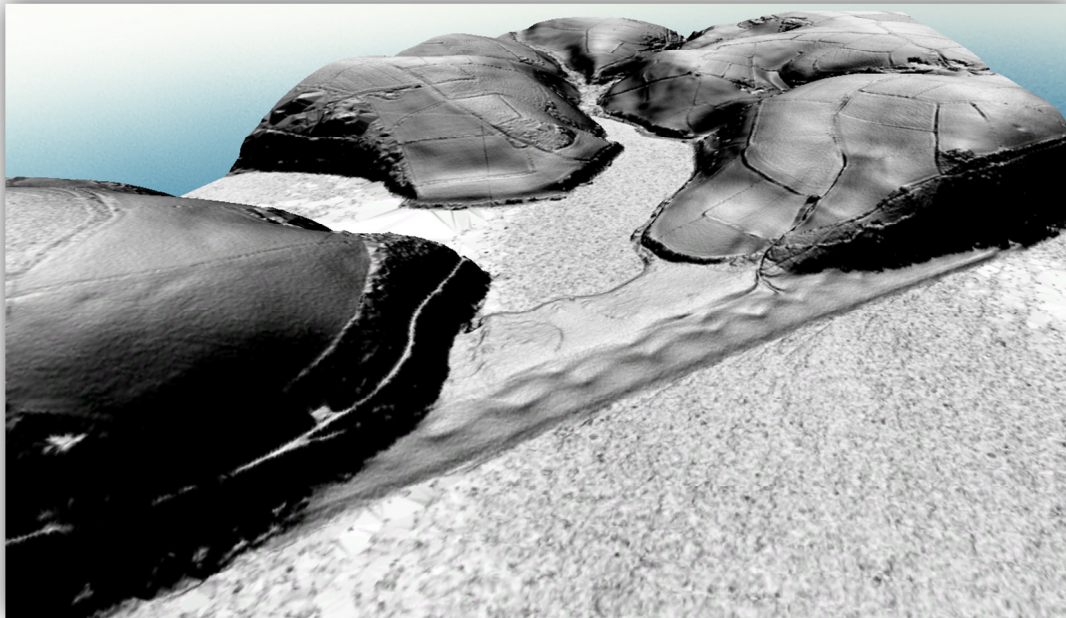
Figure 29: 3Dview of Loe Bar and surrounding area using LiDAR data from TELLUS, looking approximately east (vertical exaggeration: 1.2500, Source: Ferraccioli et al, 2014).

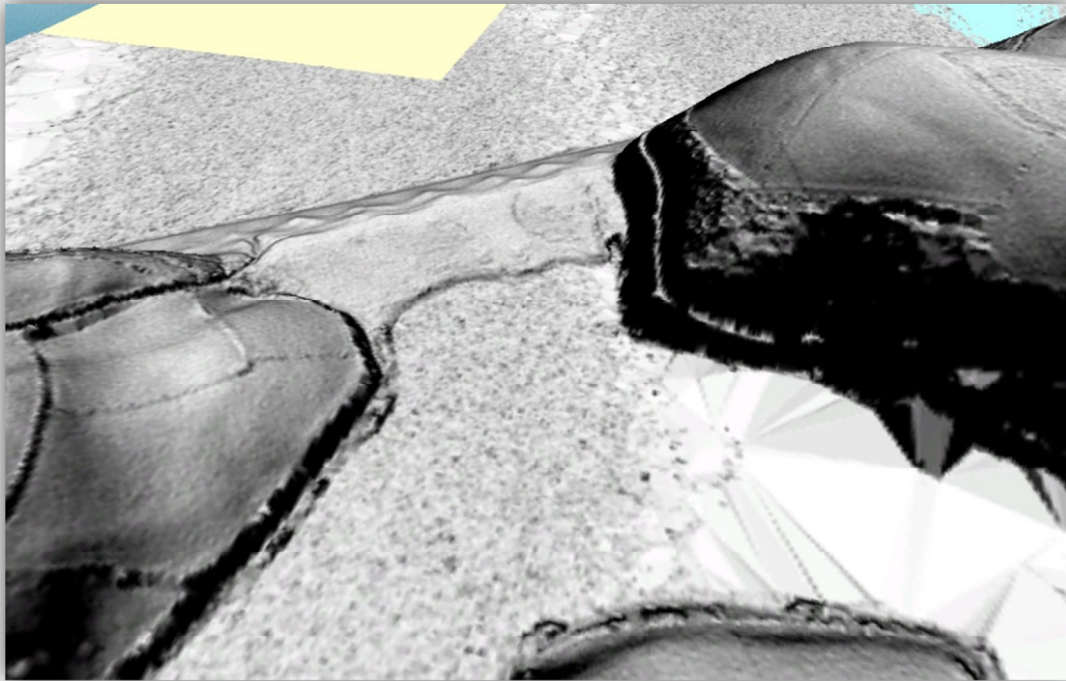
Figure 30: 3D view of the TELLUS LiDAR data showing the lake-ward edge of the bar, looking west (vertical exaggeration: 1.2500, source: Ferraccioli et al, 2014).

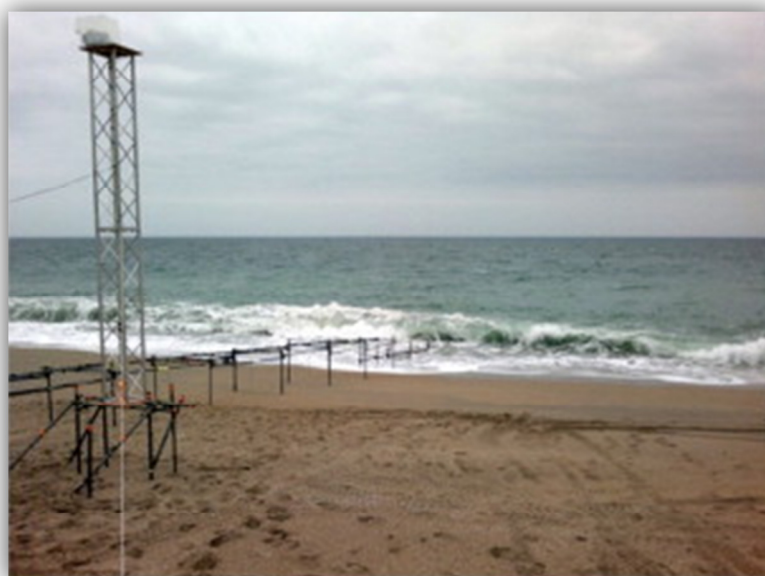
Figure 32: Part of the equipment used in the 2012 beach morphology observations made at Loe Bar by Poate et al (2013).

A comparable study to this was carried out by Poate et al (2013) where a similar mount was constructed on the seaward side of the bar and hosting a single beam LiDAR with the addition of an acoustic bed level sensor (BLS) measuring 70m, extending from the Mean High Water Springs (MHWS) to the crest of the bar (figure 32). This structure, supported by 3m vertical scaffold poles driven 2m into the bar, held 45 acoustic bed level sensors positioned between 1.5m and 2m apart and 1-1.5m above the bed. An all-terrain vehicle (ATV) was also used to measure 3D topography across the bar recording points every 1m using RTK GPS. In addition, a limited number of points were also collected on foot. Accuracies gained by the ATV were $\pm 0.080\text{m}$, compared to $\pm 0.030\text{m}$ when done on foot at 3m intervals. This was due to the sinking of ATV tread into the beach, compared to a flat-bottomed staff used by the surveys which were completed on foot (Poate et al, 2013).

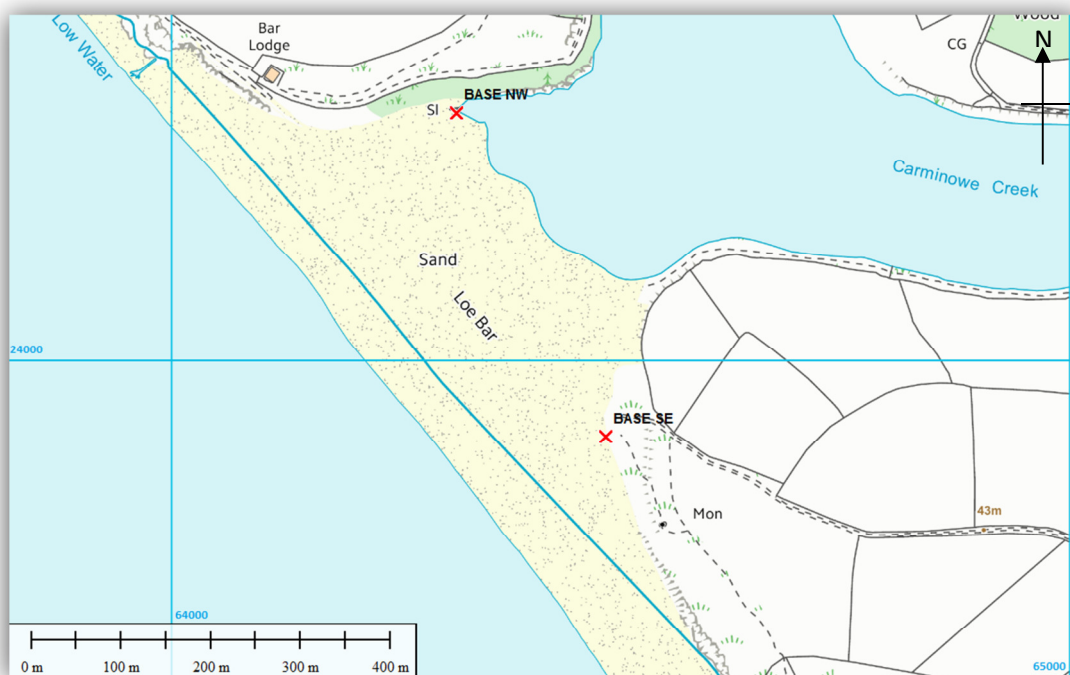
Figure 33: Locations of the GPS base stations established for use in surveying the bar.

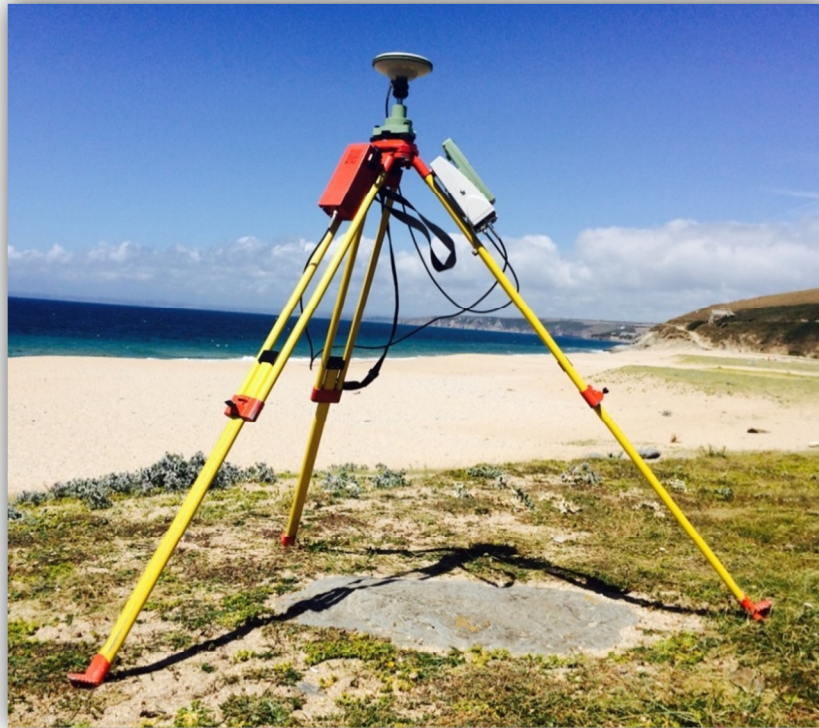
Figure 34: GPS Base station set up over an 'X' marked in the rock at Base SE.

In order to set an accurate baseline to work from throughout the survey, two GPS points were derived at opposite ends of the bar (figure 33). To establish these points, Leica 1200 GPS base stations were set up over two marked points (figures 34 and 35) and left to run for three hours each in order to fully capture the satellite information available (table 4).

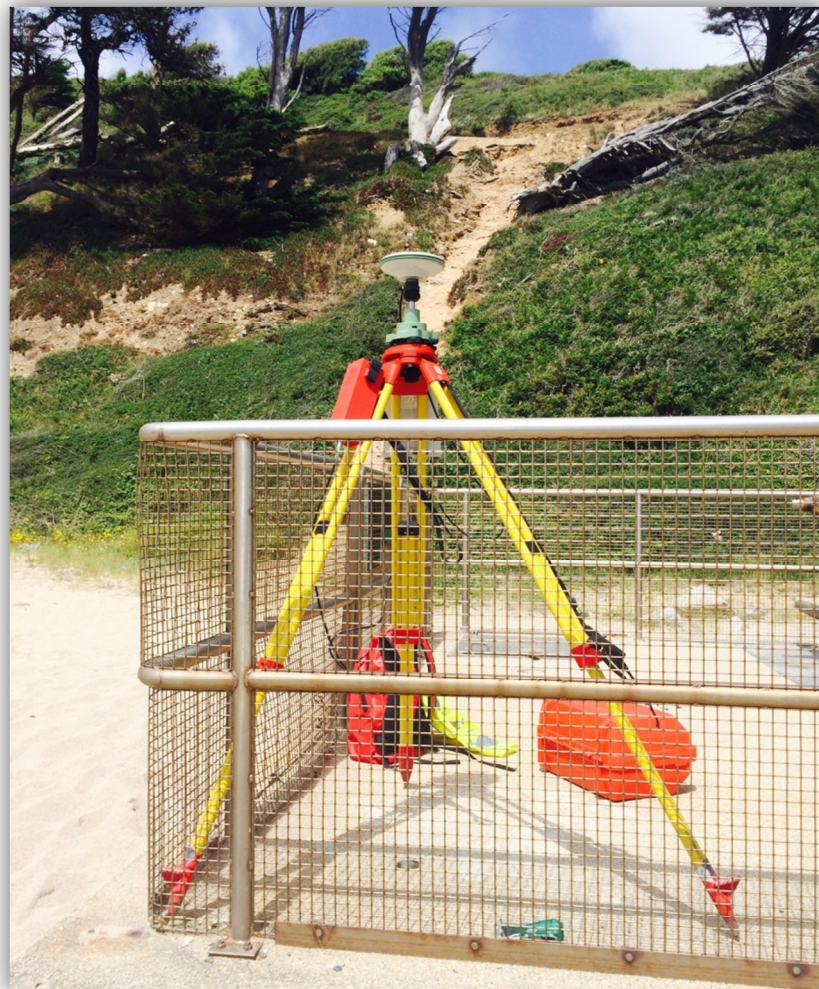
Figure 35: A GPS base station set up over an existing survey point at base NW.

Base NW was set up over an existing survey station previously placed by the Environment Agency which involved centring and levelling over the existing point (figure 36). Base SE was determined by finding a patch of ground which could be returned to and would not be manipulated by human traffic or the elements. This was chosen as a patch of rock bedded very firmly into the grass (figures 37 and 38). An 'X' was marked into the rock with both a hacksaw and a marker pen and the instrument set up over it.

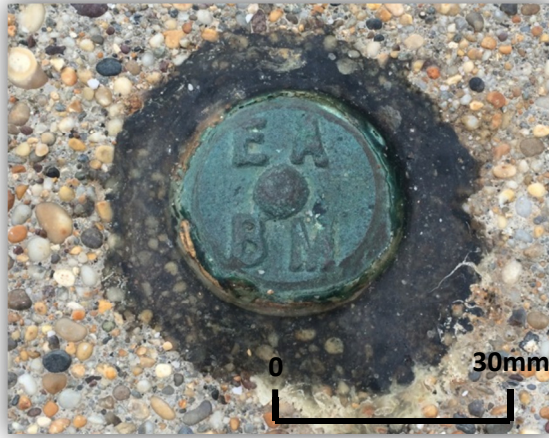
Figure 36: The existing survey point placed by the Environment Agency and used as a point for 'Base NW'.

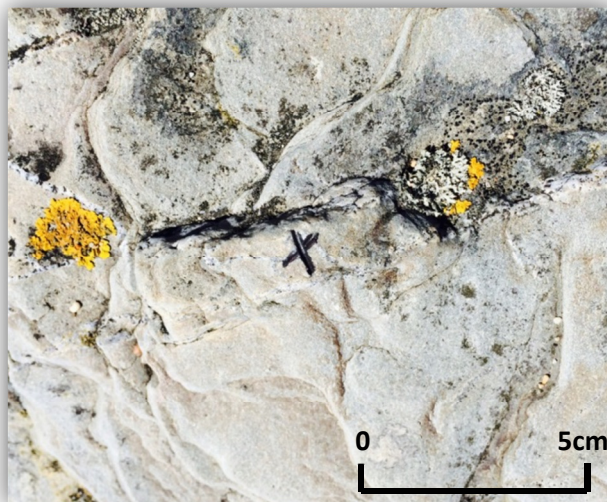
Figure 38: The 'X' marked on the rock in figure 37 above, created with a hacksaw and marker pen.

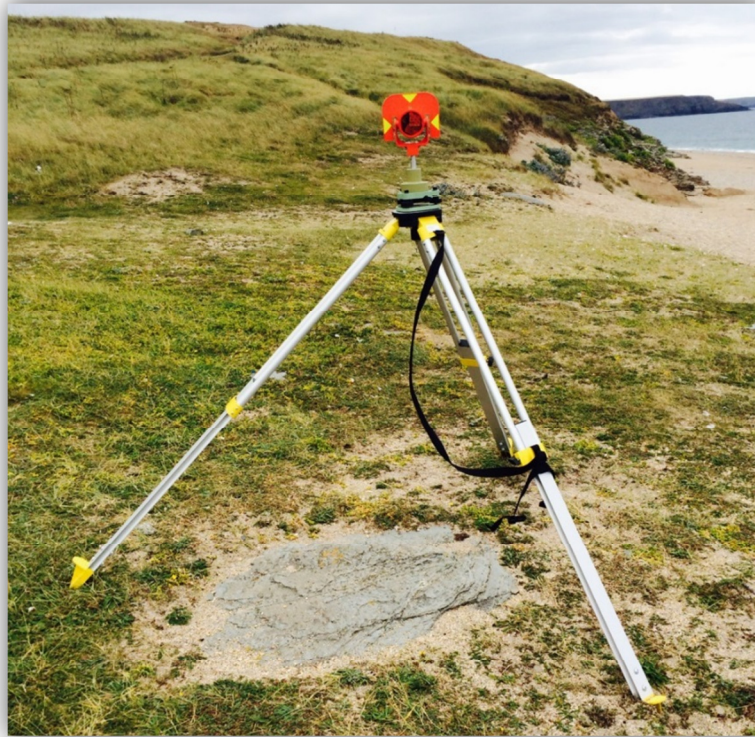
Figure 39: Leica prism set up on a tripod over base SE, used in resection.

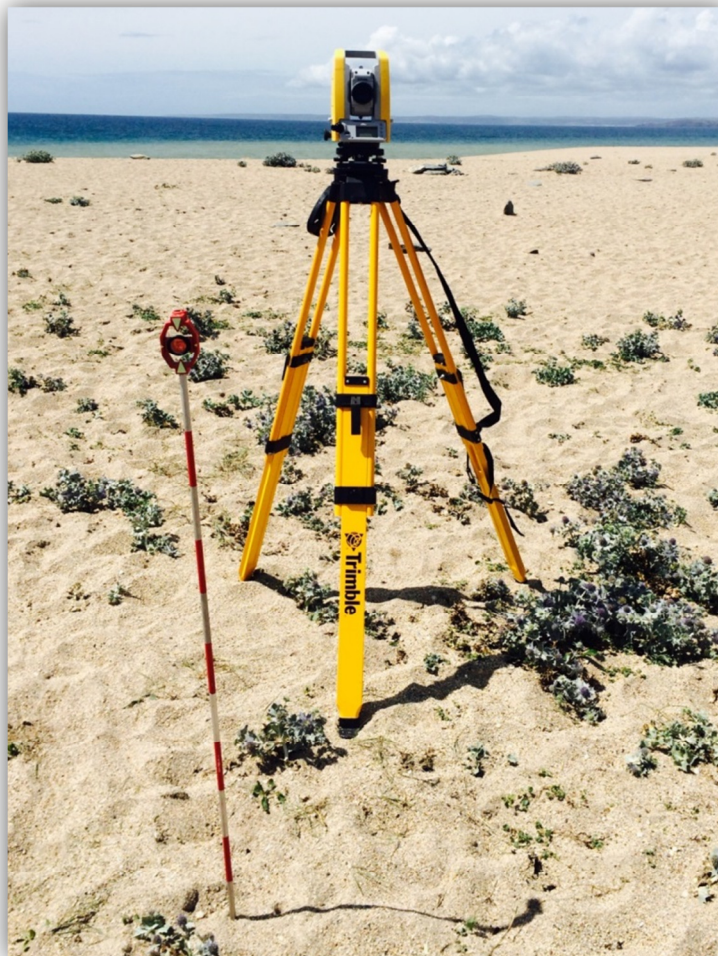
Figure 40: The Trimble M3 total station used in the topographical survey carried out.

The Trimble M3 has an accuracy of 2" and 2mm+2ppm. For the majority of the survey a mini prism was used, at a constant staff height of 1.300m and a prism constant of 18mm. These constants were programmed into the machine before commencing the survey. When collecting points at the water's edge, the mini prism and staff (table 6) were occasionally found to be of an insufficient height to extend over the ridge line. When this problem arose, a longer staff was used with the ability to extend up to a height of 2.150m, hosting a circular Leica prism. The prism constant and staff height were changed whenever necessary, and kept at lengths as short as possible, in order to reduce error from staff wobble. Both staffs which were used had a pointed end, and were expected to cause accuracy problems from sinking into the sand. To combat this, a flat-bottomed plastic bottle was put over the end of the staffs to stop the sinking from occurring and eliminate potential errors.

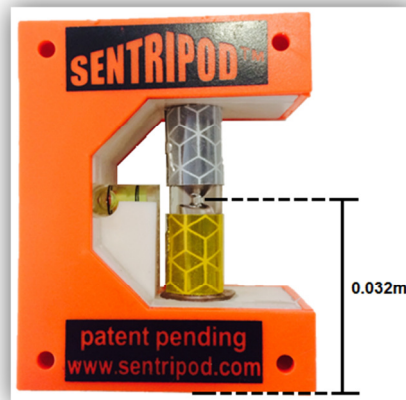
Figure 41: Photograph of a Sentripod. Height of target is marked (not to scale).

The sentripod (figure 41) is a piece of surveying equipment which can be used as a prism, as it makes use of retro reflective technology, set on a cylindrical target. Observations are made by sighting to the centre point of the cylinder using a prism constant of 4.4mm.

The sentripod's small size makes it easy to transport and is also visible from almost any angle, making it more versatile than a circular prism. The 5/8th imperial thread on the top and bottom make it mountable onto a tripod or pole or fixed to a surface of any angle. If mounted on an oblique surface, a magnetic strip can be applied to the back and the prism can be adjusted within its plastic casing to maintain a vertical position. Accuracies stated by the manufacturer of the sentripod are 1mm to a distance of 60m and 3mm for distances up to 150m, making them competitive to regular prisms at short distances.

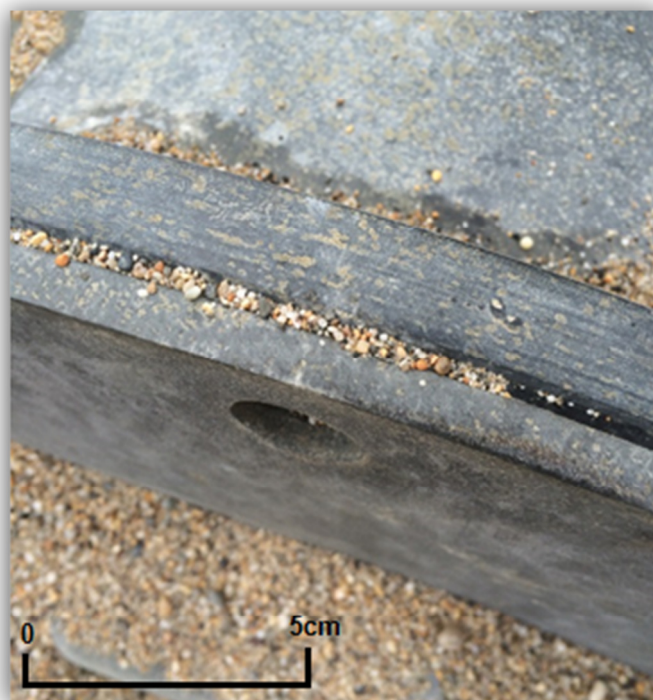
Figure 43: Photograph of the mark made in the pipe which will be the new base station point.

Although the number of fixed locations for placing base stations is limited, another potential location for a base station was identified at the northern end of the bar. This was on a metal pipe sticking out of the sand. A mark was made in the edge of the pipe with a hacksaw and marker pen (figure 43) and a GPS station was set up and run for three hours (figure 44), similar to the technique used for Base SE and Base NW.

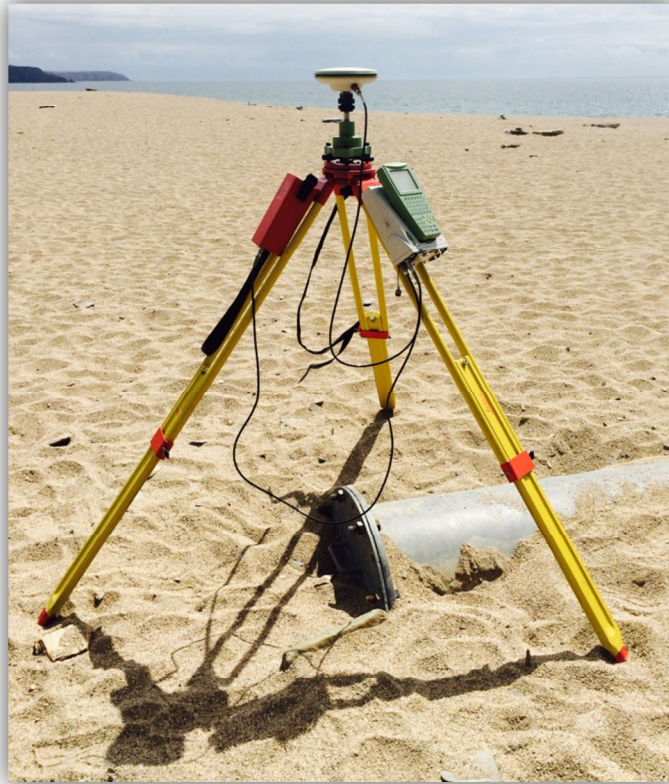
Figure 44: Photograph of the GPS station set up over a point marked on the pipe to create another base station for future resection use.

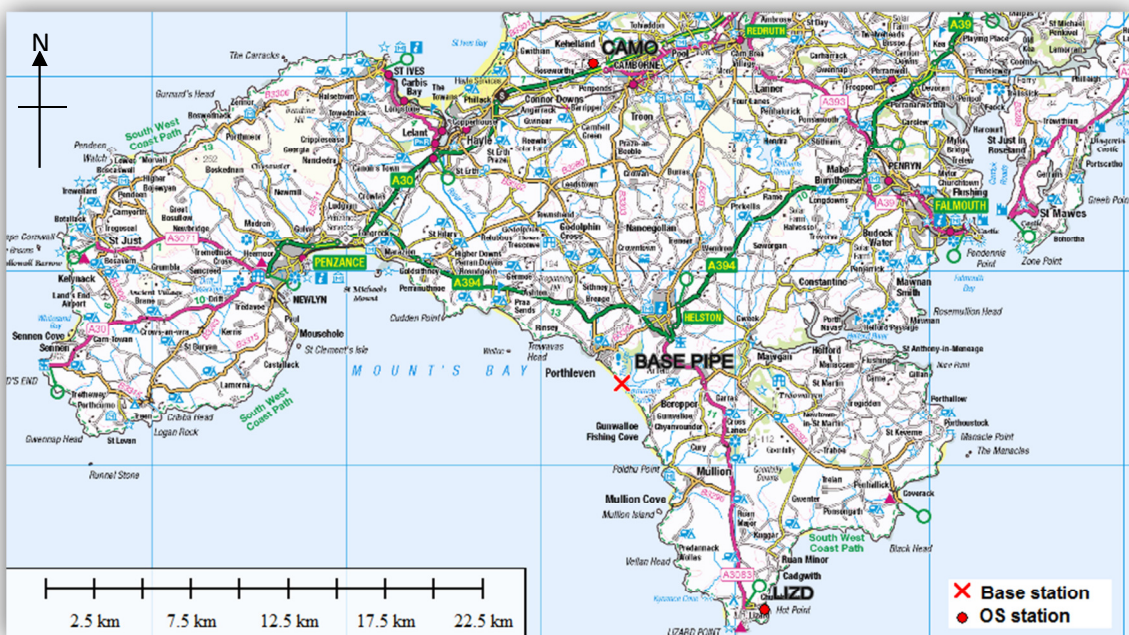
Figure 45: Location of 'Base Pipe' in relation to OS stations at Camborne (CAMO) 16.787km away and The Lizard (LIZD) 13.796km away (base map: Digimap).

When obtaining RINEX information for the coordinates of this station, it was found that the GNSS base station located at The Lizard (LIZD) had been out of action for several days. This meant that the RINEX corrections for this point were obtained from the next closest station at Camborne (CAMO). This should not significantly affect the results as the station is less than 3km further from the bar than that of the Lizard (figure 45). The location of the new base point can be seen in figure 46 and the coordinates before and after RINEX corrections in table 7.

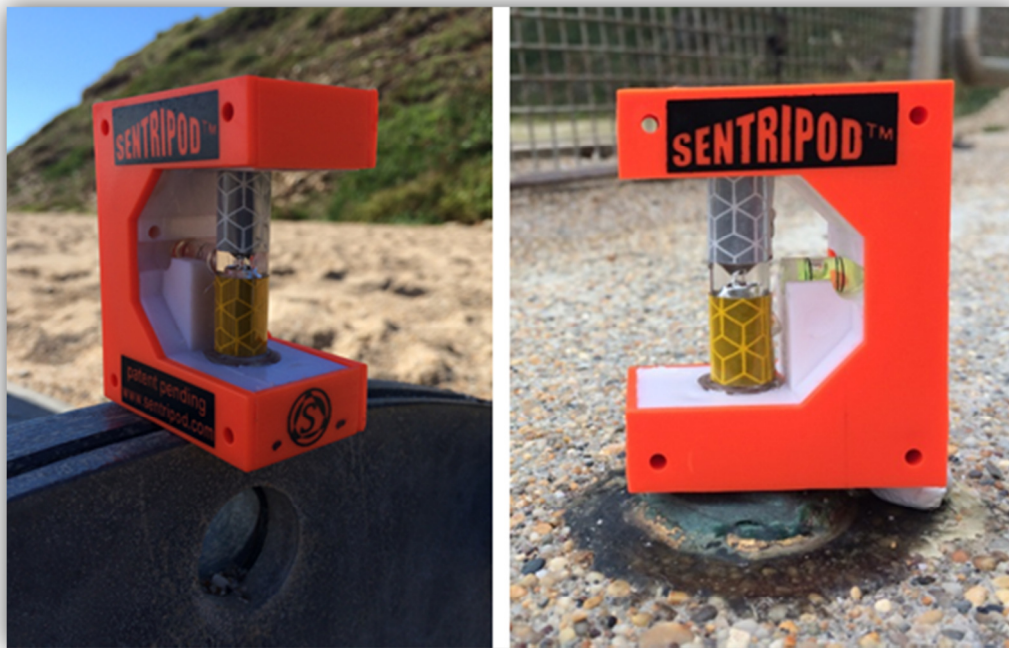
Figure 51: Sentripods in place at Base Pipe (left) and Base NW (right).

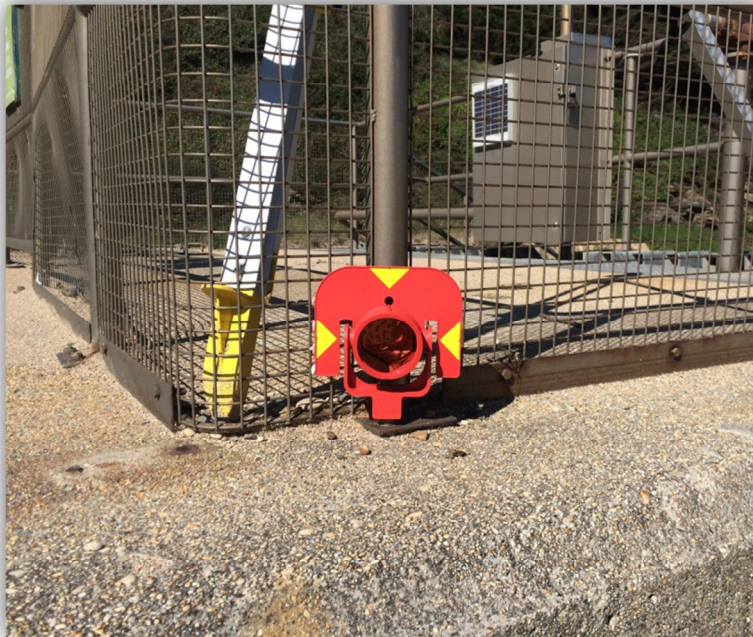
Figure 53: Circular prism placed on the bolt for determining coordinates. Note the collar to the right of the prism which obstructs the view to the sentripod from certain places on the bar.

To obtain coordinates for this point, a tripod was set up at the bases NW and Pipe, with a Leica prism on each. Another Leica prism was placed on the bolt and secured using tac to ensure its position was level (figure 53). Leica prisms were used rather than sentripods due to the higher accuracy which can be achieved, as previously seen. The Trimble M3 total station was set up at five different locations (figure 54) using resection and from each, a total of 10 readings were made to the prism on the bolt, turning the instrument away, both horizontally and vertically, between each reading. A statistical analysis was then carried out to reject any outliers in the results from each setup. These averages were then weighted according to their resection error and an overall coordinate was produced which could be attributed to the bolt (table 10). The height of the bolt was determined by using a level, recording the differences in height between Base NW and the bolt. Appendix D contains the tables of how the coordinates were derived.

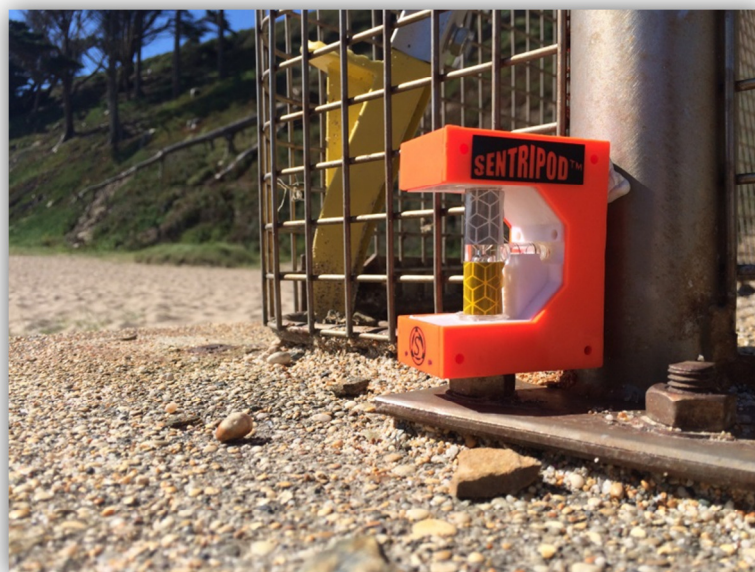
Figure 55: Sentrypod placed on bolt a held level and in place using tac. This can be used in resection if view of Base NW is obstructed. Note the sentripod fits over the 5mm tall bolt, providing the need to adjust the target height to 0.027 rather than 0.032.

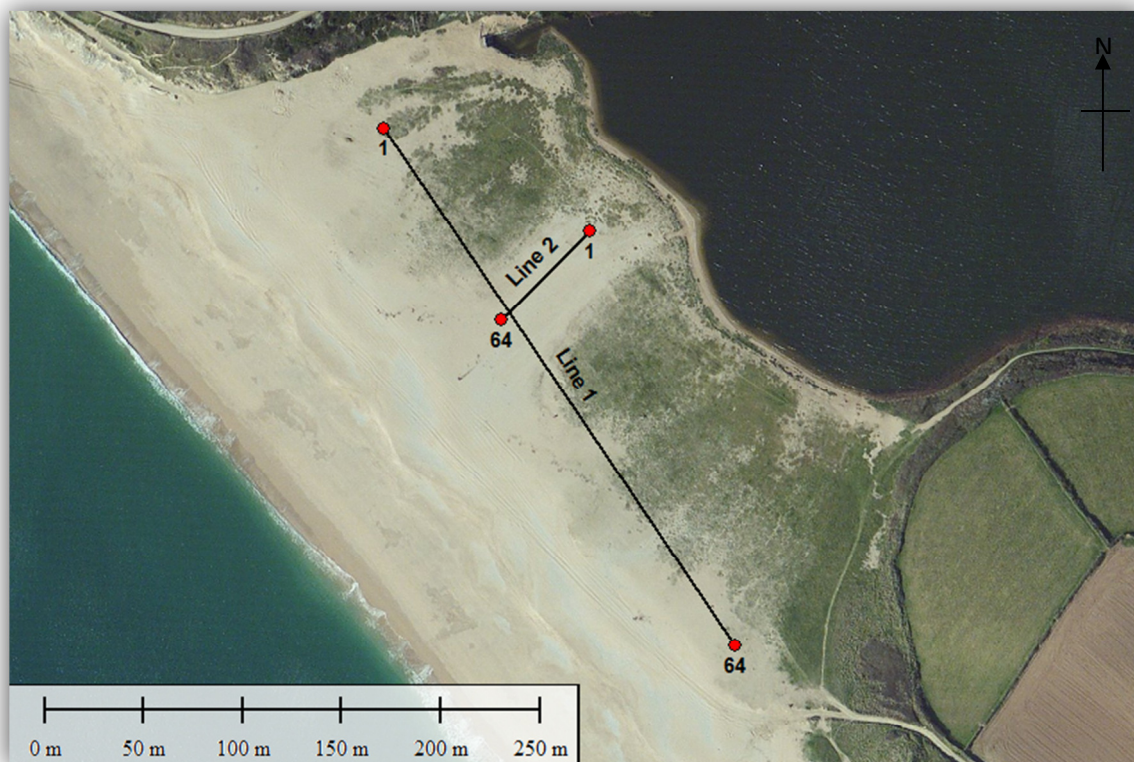
Figure 59: Location of resistivity lines 1 and 2 displayed on satellite imagery, with electrode numbers labelled (satellite image source: Global Mapper).

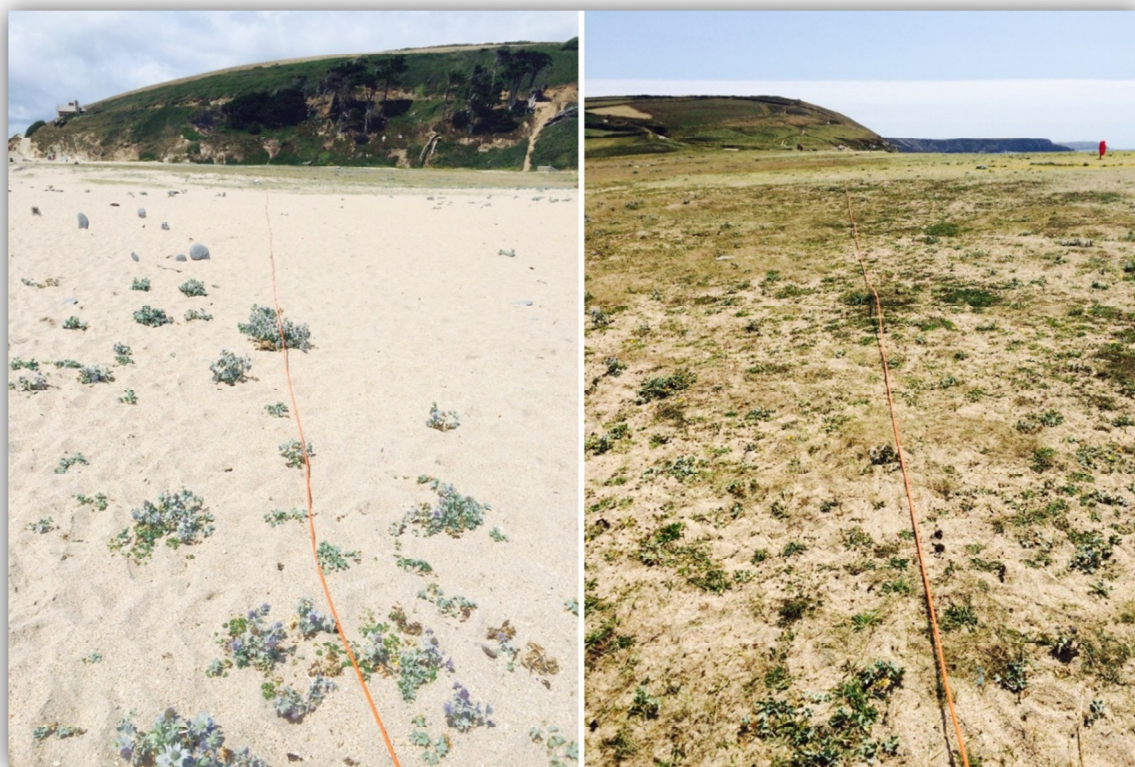
Figure 60: Photographs of the placement of the resistivity line 1 rolled across the bar looking NW (left) and SE (right).

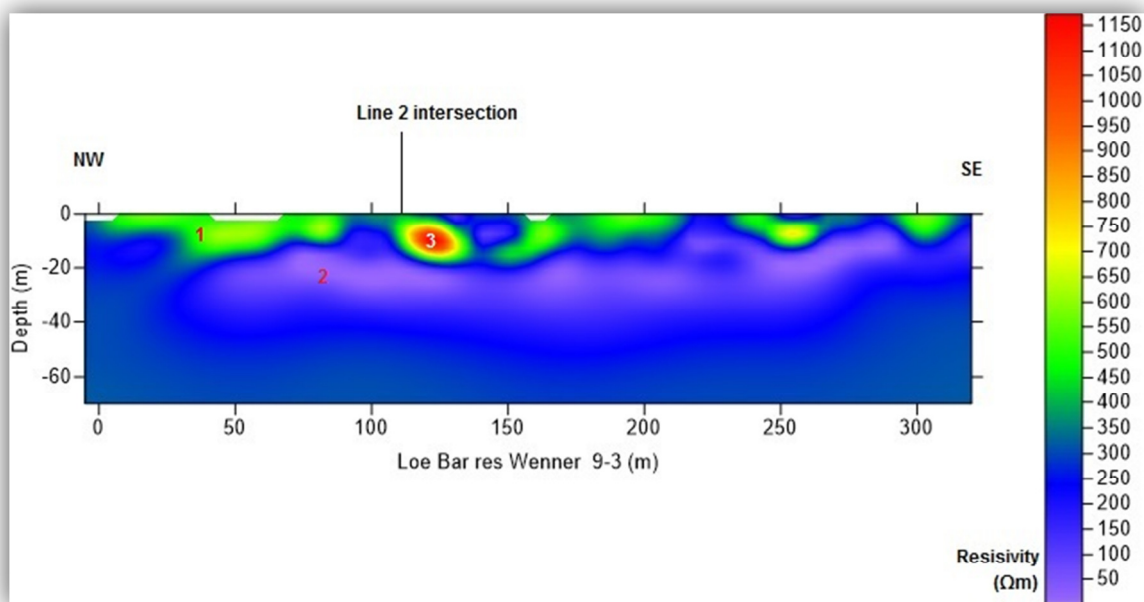
Figure 62: Resistivity pseudo-section of line 1 using a Wenner array (processed by Mr N.A. Wood). Smoothing coefficients: Horizontal = 9, Vertical = 3.
