A Study of Loe Bar

A study into the history of the bar and the development of a technique for future monitoring as well as an insight into the geomorphology.

Submitted by Annabel Pardoe to the University of Exeter as a dissertation towards the degree of Master of Science by advanced study in Surveying with Land and Environmental Management, 7th September, 2015.

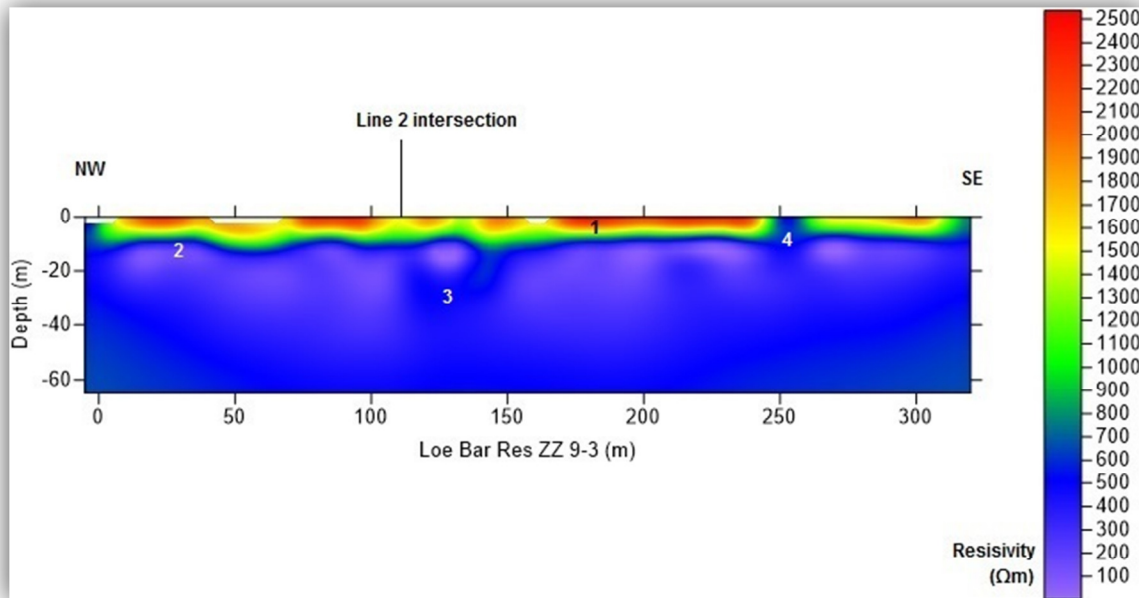
Point 4 shows a feature with a resistivity value of around 500 Ωm , consistent from the surface to around 20m depth. In studying the surface both in the field and using satellite imagery, this feature has no obvious cause and may require further investigation in order to determine the reason for its presence. Possible explanations for the presence of this feature may see a link to the bar's prolific history of shipwrecks and war defences or may even be remnants of an old 'scar' created by cutting the bar many years ago.

Figure 63: Resistivity pseudo-section of line 1 using a ZZ array (processed by Mr N.A. Wood). Smoothing coefficients: Horizontal = 9, Vertical = 3.

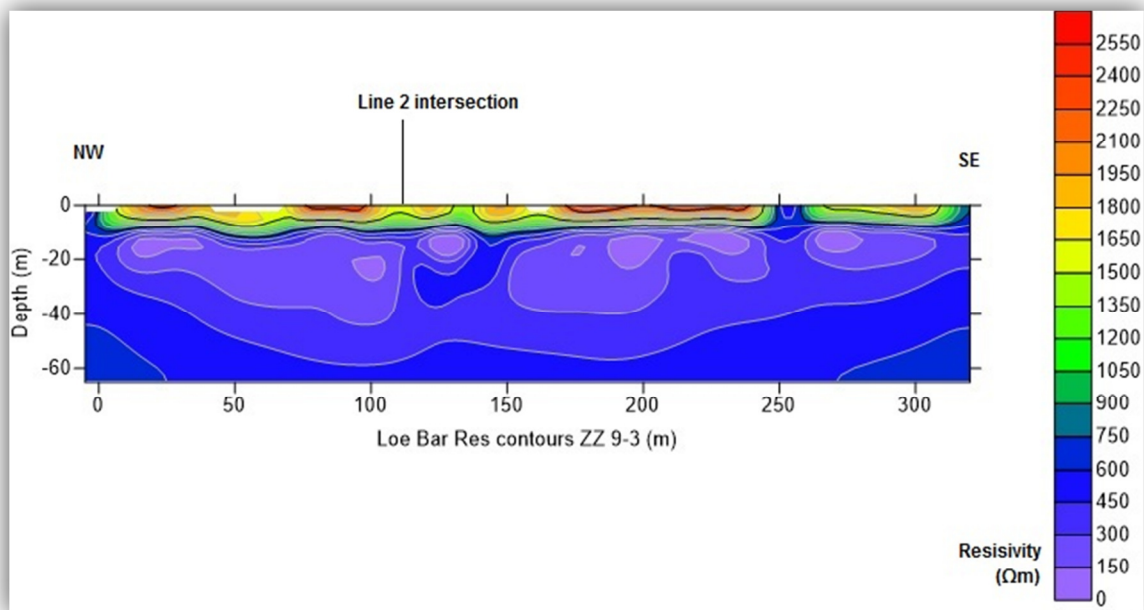
Figure 64: Resistivity pseudo-section of line 1 using a ZZ array. Contours are applied to clarify values in the image (processed by Mr N.A. Wood). Smoothing coefficients: Horizontal = 9, Vertical = 3.

When the bar was last cut in 1984 a clear trend was seen in its regrowth and repair, with the closure of the cut occurring initially at the sea-ward side of the bar and gradually closing inwards, as is represented photographically in appendix A. The cut is documented as only reaching a depth of 10m, however freshwater would have been present in the channel for a number of years afterwards, with the photographs showing only partial fill up to June 1989, and total fill by the following December. In this time, fresh water may have seeped into the porous sand. The possibility may also exist for a freshwater channel to be present, taking water from the lake to the sea. Although it was stated in 1967 that no water passes through the bar, this information was gathered before the bar was last cut and may be outdated in terms of assessing the potential passages deeper within the bar. In order to further investigate this theory, some more resistivity lines would be required in order to distinguish the shape and extent of this feature, or boreholes drilled to obtain physical samples at known depths.

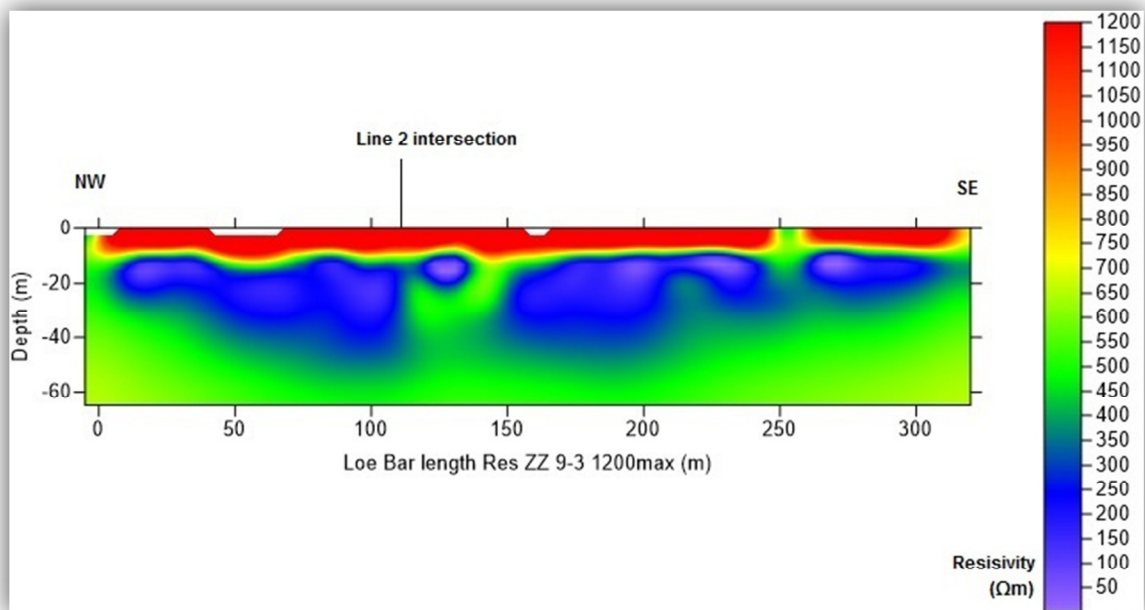
Figure 65: Resistivity pseudo-section of line 1 using a ZZ array. Scale is altered to show a maximum value of 1200 Ωm (processed by N.A. Wood). Smoothing coefficients: Horizontal = 9, Vertical = 3. Scale units Ωm .

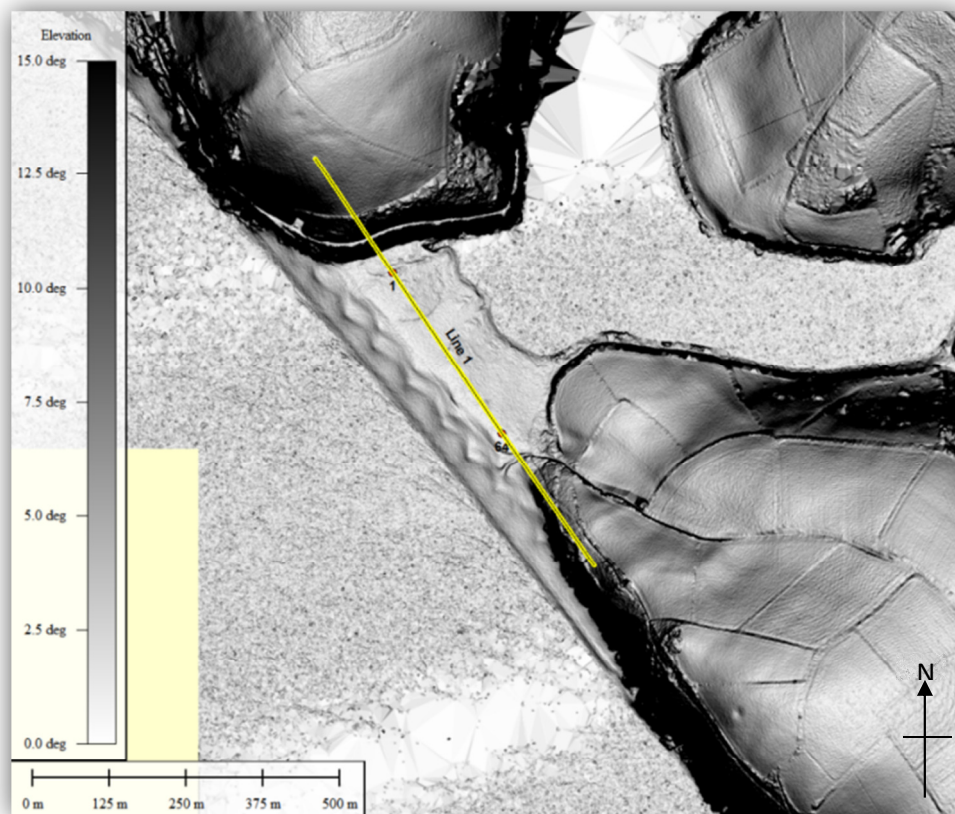
Figure 66: Position of cross section generated for comparing the morphology of the channel feature with that of the surrounding valley in figure 67.

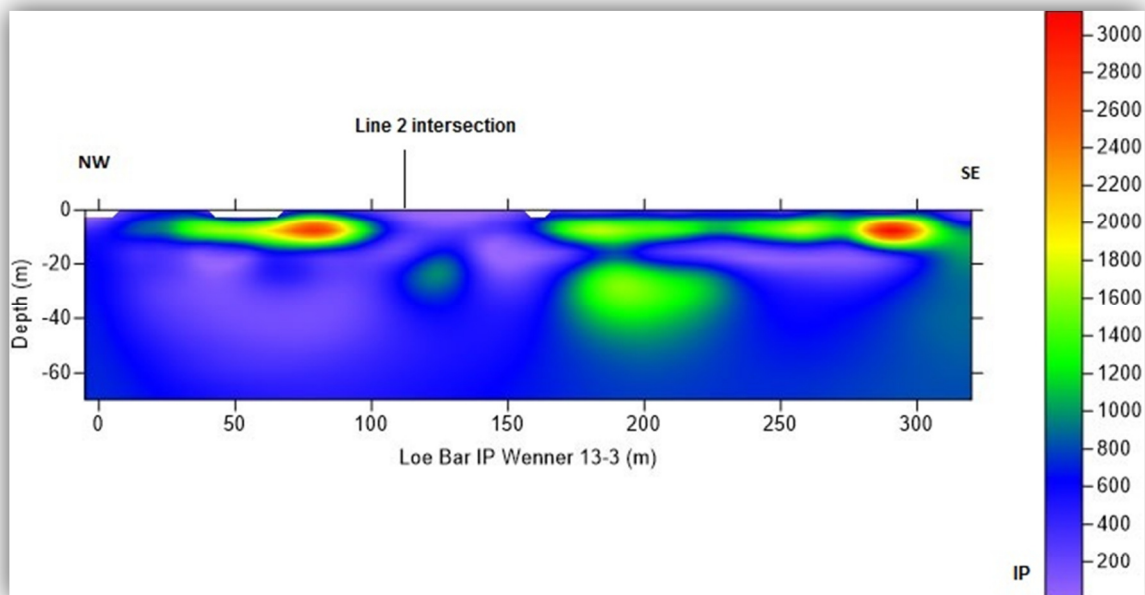
Figure 69: Induced polarisation pseudo-section of line 1 using a Wenner array (processed by N.A. Wood). Smoothing coefficients: Horizontal = 13, Vertical = 3.

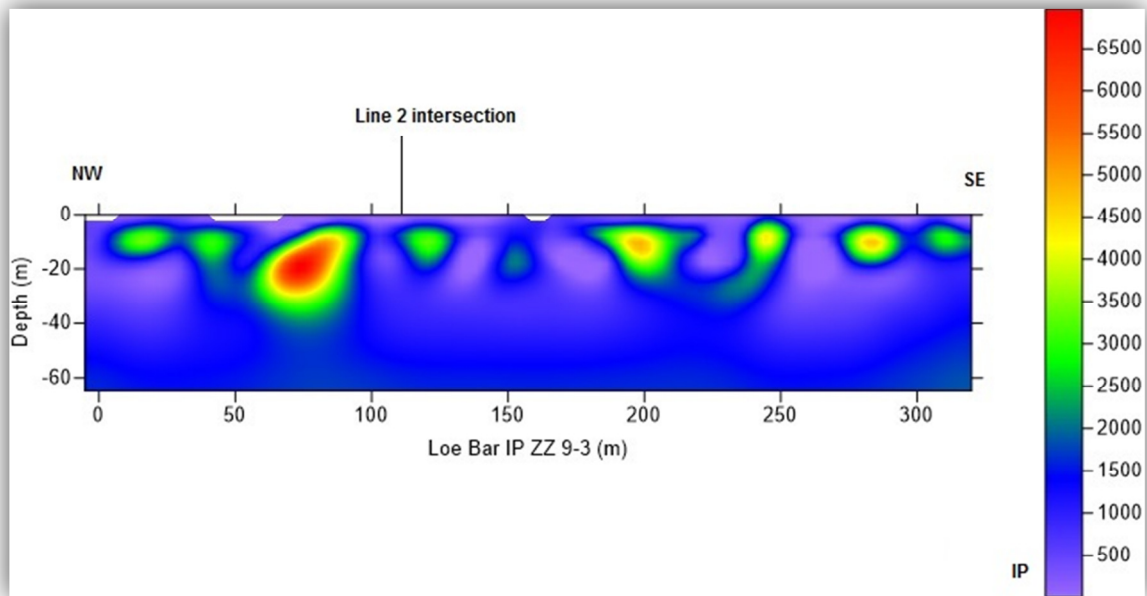
Figure 70: Induced polarisation pseudo-section of line 1 using a ZZ array (processed by N.A. Wood). Smoothing coefficients: Horizontal = 9, Vertical = 3. Scale units Ωm .

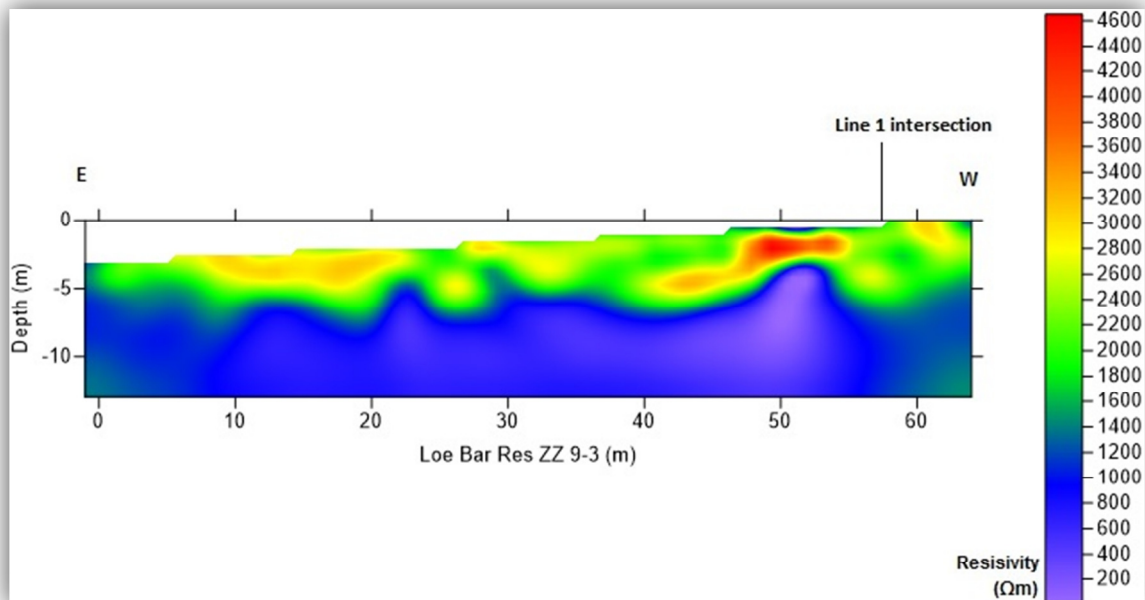
Figure 72: Resistivity pseudo-section of line 2 using a ZZ array (processed by N.A. Wood). Smoothing coefficients: Horizontal = 9, Vertical = 3. Scale units Ωm .

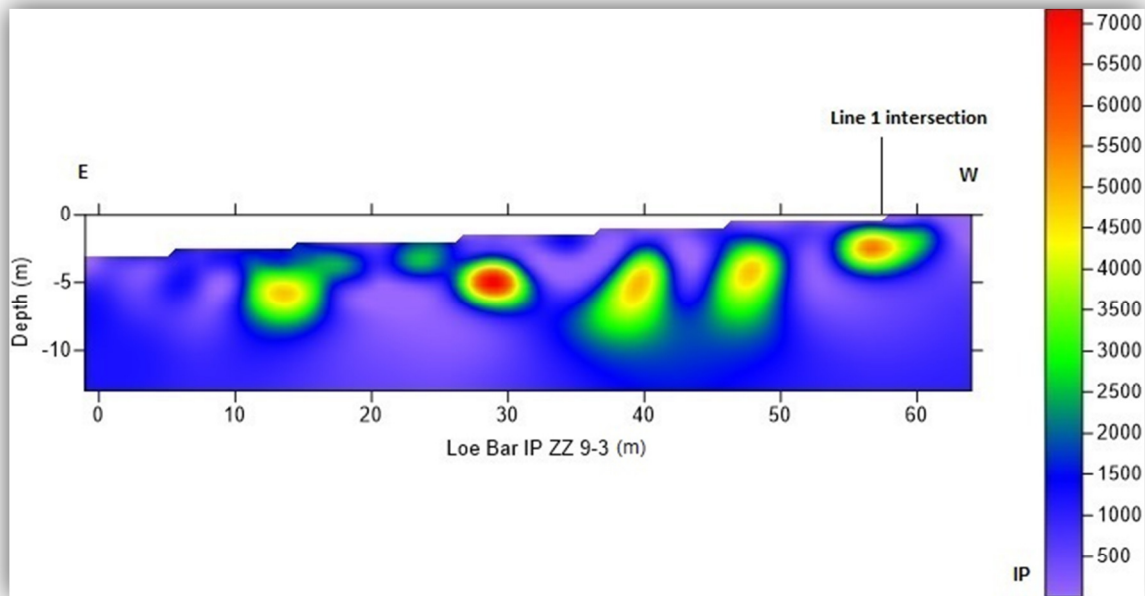
Figure 73: Induced Polarisation pseudo-section of line 2 using a ZZ array (processed by N.A. Wood). Smoothing coefficients: Horizontal = 9, Vertical = 3.

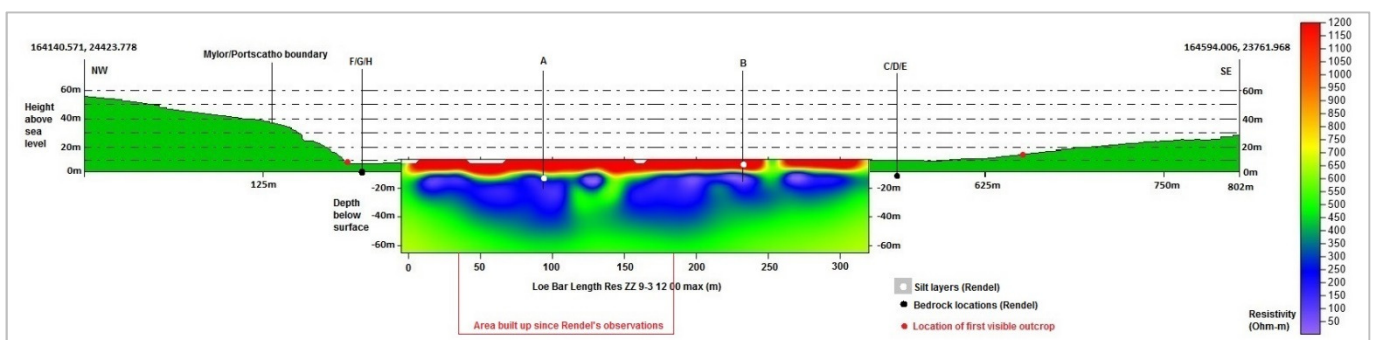
Figure 74: Cross section with pseudo-section superimposed (as in figure 67) with the addition of probable locations of Rendel's bores (subject to assumptions). Points on the bore locations represent features of interest found.

The points at which Rendel found underlying 'killas' or bedrock towards the edges of the bar coincide with the inferred boundary between the outcrops and the resistivity line.
