# Loe Pool SSSI Macrophyte Survey 2012

**Report Date:** February 2013  
**Author:** Dr Jan Dinsdale  
**Survey Dates:** 26/28 June 2012;  
09/19/21 September 2012  
**Dive contractor:** Kennack Diving  
**Ecologist:** Dr Jan Dinsdale

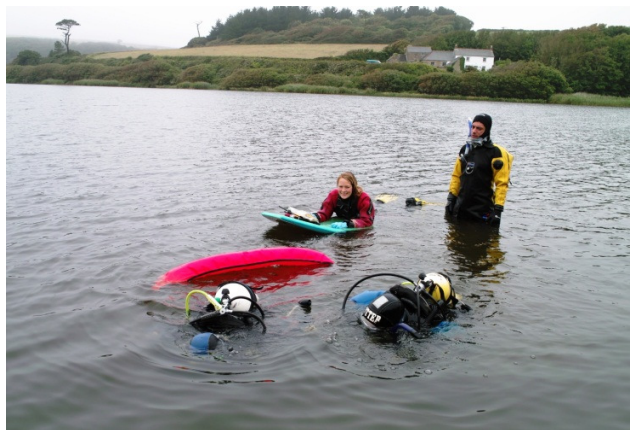
Photo 3: Kennack Divers undertaking survey within Carminowe Creek with GPS on the surface (Jan Dinsdale)

When surveying in deep water away from the shore, diving buddy pairs were followed by the GPS operator; a third team member floating on the surface (Photo 3). The GPS recorded positions at 5 second intervals. Water depth was recorded using a Suunto Dive Computer (*Appendix 3*).

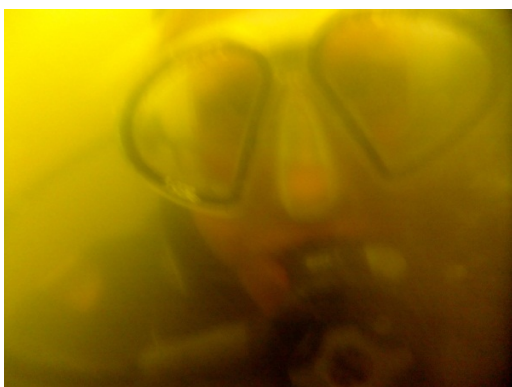
Photo 4: Underwater image showing very poor visibility, less than 0.5m (Des Glover, Kennack Diving)

Visibility was extremely poor on all three survey dates, less than 1.0m (Photo 4). Divers needed to be within 0.5m of the lake floor, in order to carry out a thorough search for macrophytes. Any contact with the unstable benthic sediments that were present across much of the lake rapidly reduced visibility to 0m. The need for accurate and careful movement underwater combined with poor visibility made the scuba-divers progress very slow at times.

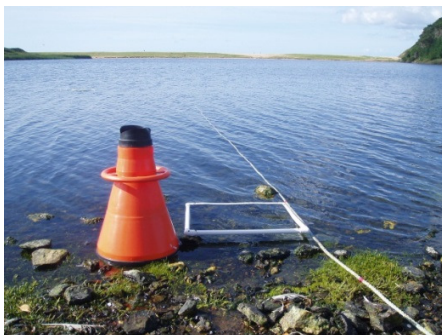
Photo 6: Permanent transect survey equipment: Bathyscope, quadrat and weighted rope (Jan Dinsdale)

Vegetative cover for individual species in each 0.5m x 0.5m quadrat was recorded quantitatively using the DOMIN scale. Periodic checks and comparisons were carried out between the two surveyors (Dr Jan Dinsdale, Ecologist and Rebecca Morton-Clarke, Assistant) conferring on cover estimates to ensure consistency of recording. The depth of water was measured at 0.5m intervals using a metre rule.

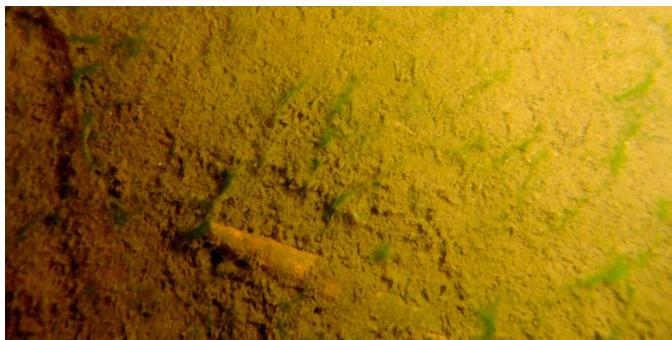
Photos 9 and 10: Stony substrate supporting green algae and mobile benthic sediments (Des Glover, Kennack Diving)

Large areas of the stony lake floor also support an encrusting filamentous green algae, *Cladophora aegagropila*; Photo 9 shows the green algae among the inundation plant community.

The deep water dive survey presented an opportunity to explore and record the Lake's benthic sediments. Across all of the areas surveyed, when more than 20-30m from the shore, the lake floor comprises extremely unstable, fluid sediments. These have the consistency of thick soup or soft mousse! The texture of these fine fluid sediments varies a little across the Lake, but out beyond 3.0m depth the sediment is not sufficiently stable to support a person's weight. These sediments are very mobile; light contact from a diver would 'explode' a cloud of particles, reducing visibility in that locality to zero. Photo 10 indicates how these mobile fluid sediments appear to be hostile to higher plant growth.

Based on the information gathered as part of this scuba-dive survey. It is clear that the physical texture of the benthic sediments continues to be unsuitable for rooted plant growth and therefore the macrophyte translocation trials are not recommended at present.

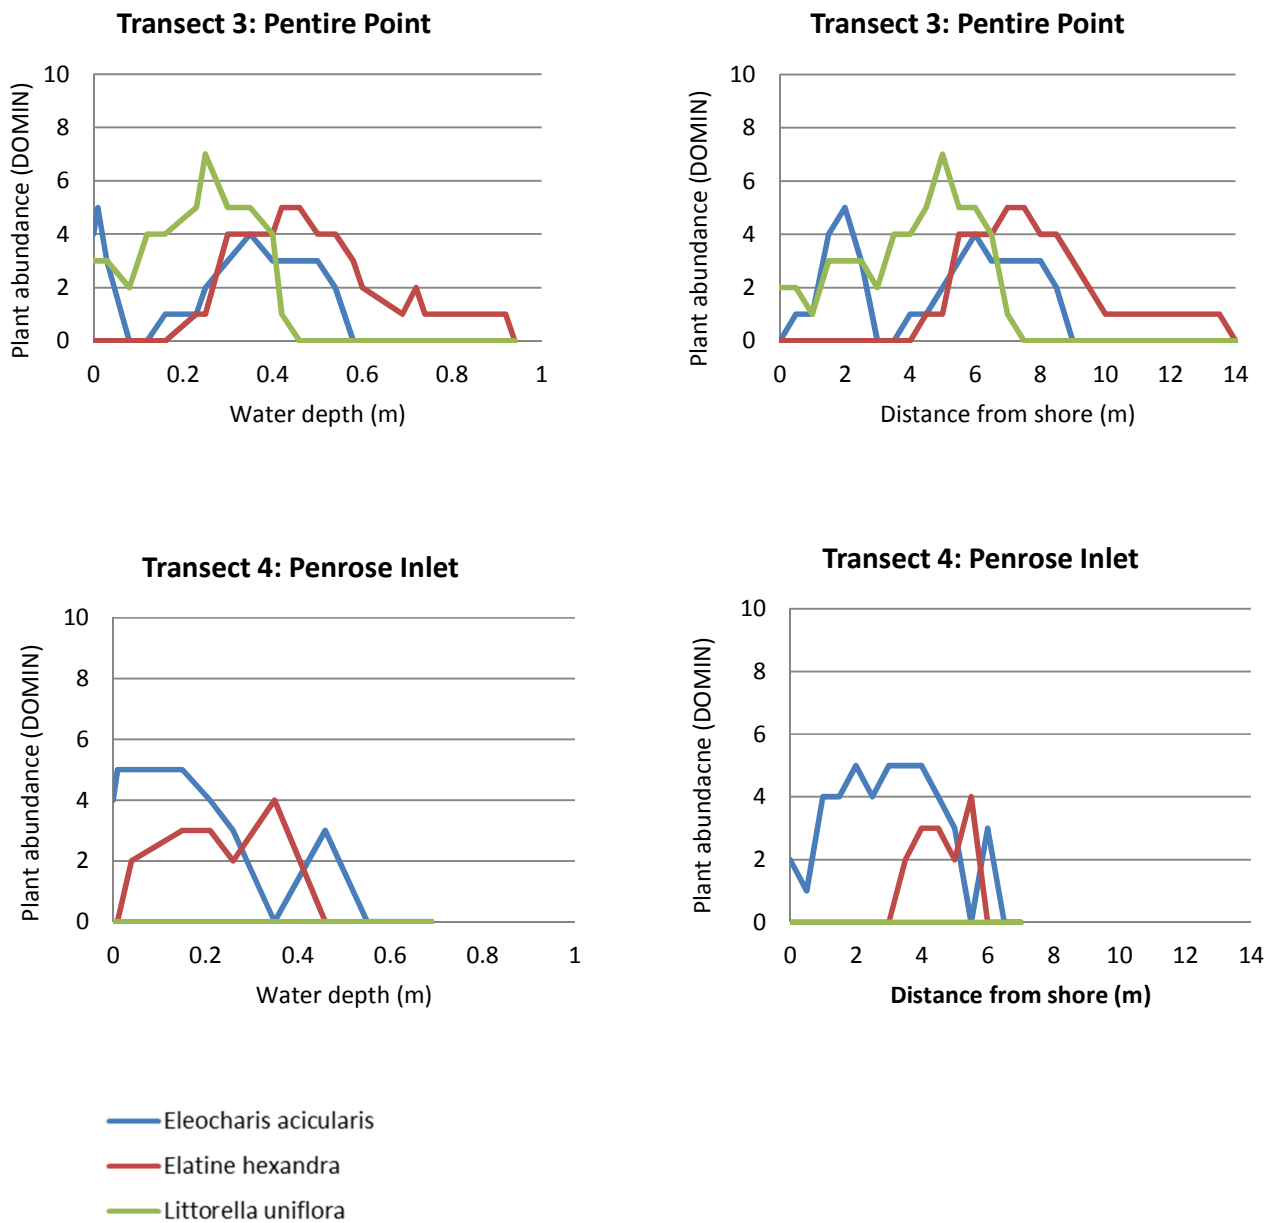
Figure 7: Variation of species abundance within the inundation community with water depth and distance from shore along four transects within Loe Pool SSSI

The survey results of the four permanent transects are shown in Figure 7 below.

The locations of the four permanent transects were chosen following the qualitative dive and bathyscope survey outline above, to best fit the criteria outline in Section 2.3. In practice, however, the southern half of the lake, particularly Carminowe Creek, was well represented in the survey while the inundation communities were absent from the Cober arm. One transect was positioned in the Penrose Inlet to represent the northern lake, despite of the weak inundation community present at this location. At this location only two of the three inundation species were present (*Eleocharis acicularis* and *Elatine hexandra*).

In many areas of the shore a community zonation is present, with *Littorella* more frequent in the shallows to a depth of 0.3m and *Elatine hexandra* found in deeper water, 0.5m-0.6m. *Eleocharis acicularis*, Needle Spike Rush, occurs across the full range of both other species.

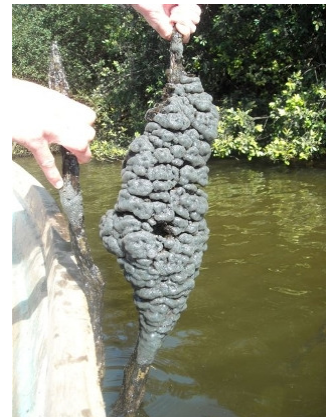
- The freshwater bryozoan *Plumatella fungosa* has been recorded in Loe Pool each year since 2009. Relatively large colonies of this benthic, suspension-feeding invertebrate were also present this year, on submerged tree roots and floating deadwood within the central neck of the lake and Carminowe Creek; smaller colonies were also attached to rocks on the lake floor within Carminowe Creek. *Plumatella fungosa* flourishes in warm, eutrophic waters and is among the most tolerant of all freshwater bryozoans to organic pollution. The colonies are capable of prolific growth when not overgrown by algae (Sládeček, 1980).

*Plumatella fungosa*  
Photo: M. Hardy, NT, 2009
