The National Trust Penrose Estate

Hydrological Study to Inform the Future Management of Loe Valley Carr SSSI

February 2014

PENROSE ESTATE, WEST CORNWALL HYDROLOGICAL STUDY TO INFORM MANAGEMENT OF THE LOE VALLEY POOL AND CARR SSSI

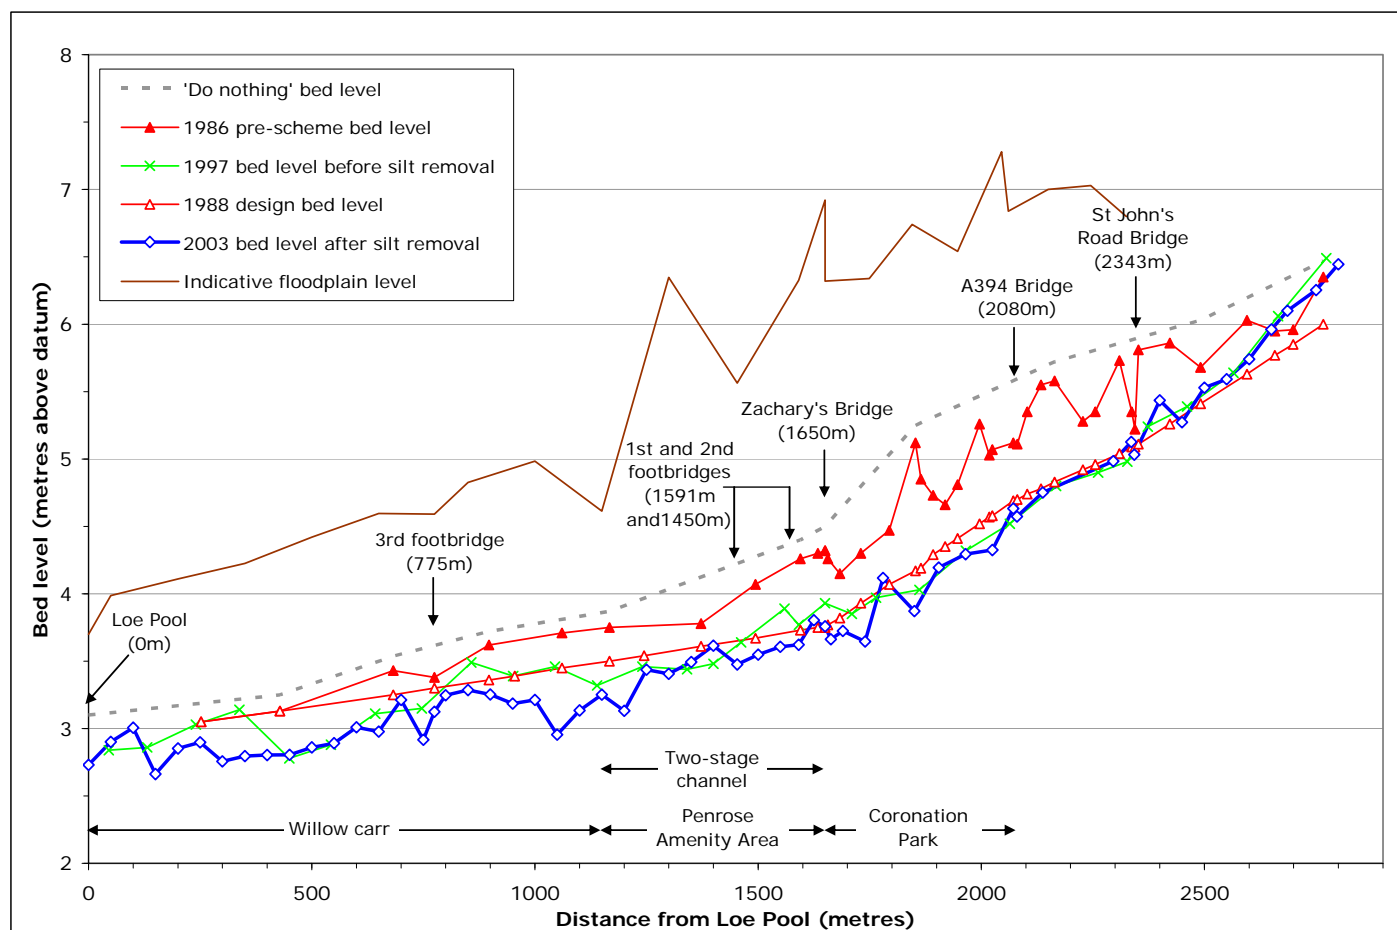
Figure 3.6 Longitudinal Bed Level Surveys of the River Cober, including Predicted Bed Levels under Different Maintenance Regimes (EA 2007)

- 3.28 Based on the bed level surveys presented in the River Cober Maintenance Plan (2007) and illustrated in Figure 3.6 it is fair to assume that midway through the willow carr, the bed level is some 0.25m below that measured at Zachary's Bridge. In the surveys shown, the bed level is precisely 3.0m AOD in 2003 at 600m downstream of Zaccharys Bridge, a position in proximity to the access gate which marks the boundary between maintained and low maintenance NT land.

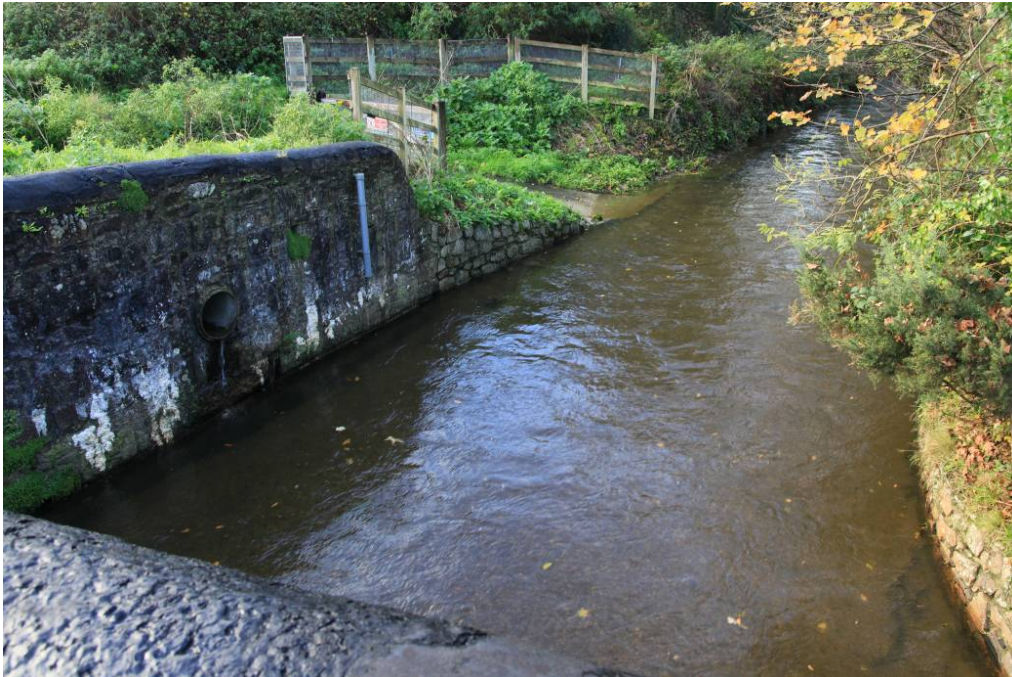
River Cober in Helston (St Johns Close area) - Stage meter right bank looking downstream

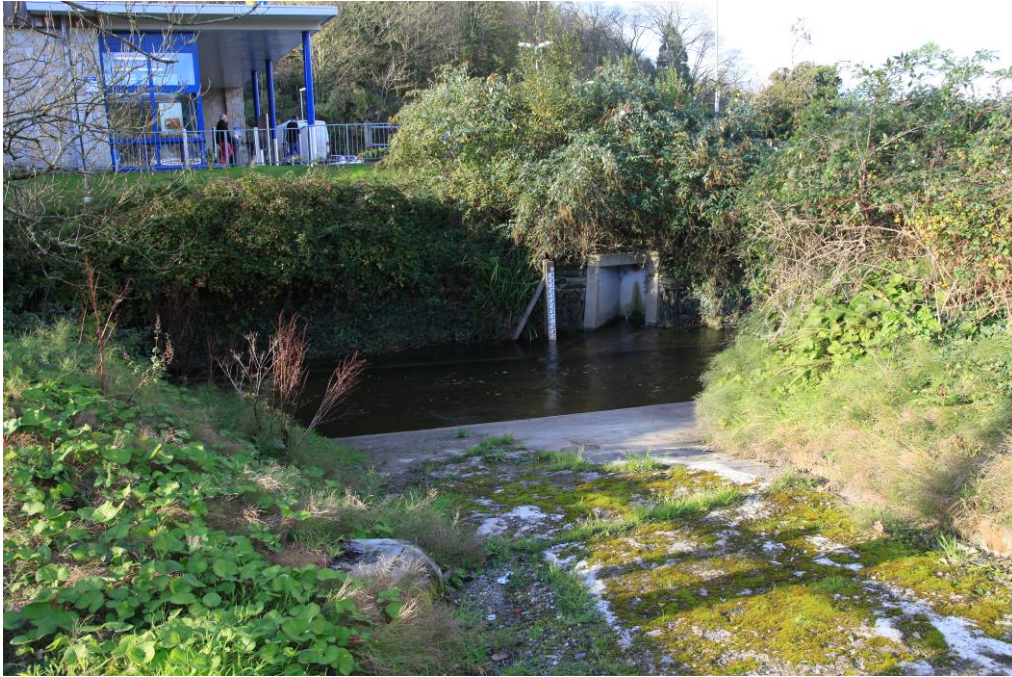
River Cober in Helston (LiDL Store) - Stage meter and urban runoff outfall, left bank looking downstream

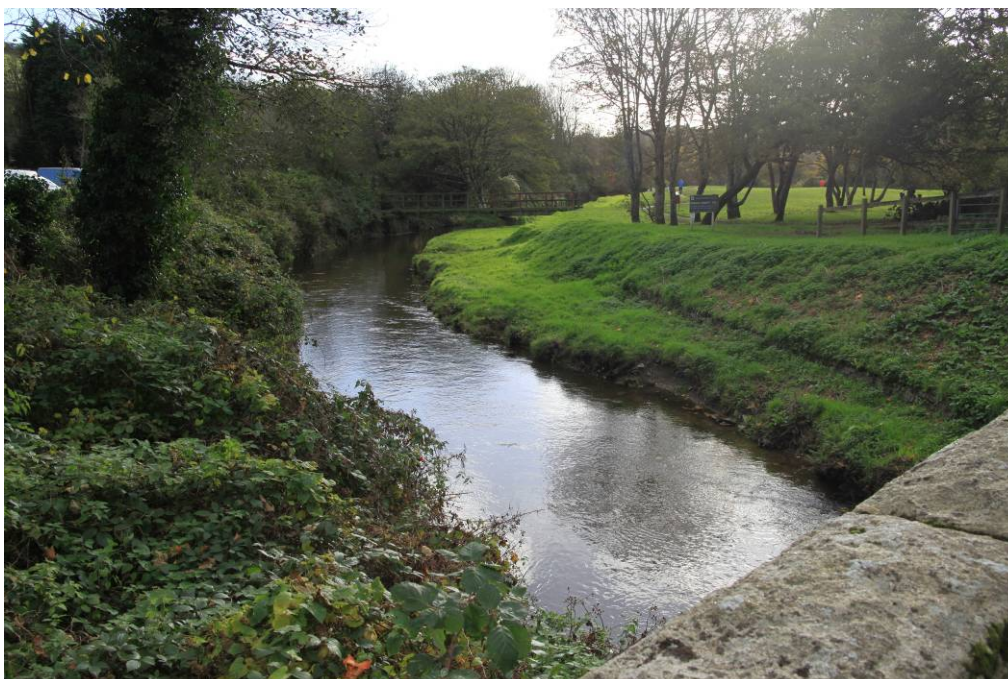
River Cober immediately downstream of Zacharys Bridge – Two-stage flood channel constructed in 1988 as part of Helston flood defence works

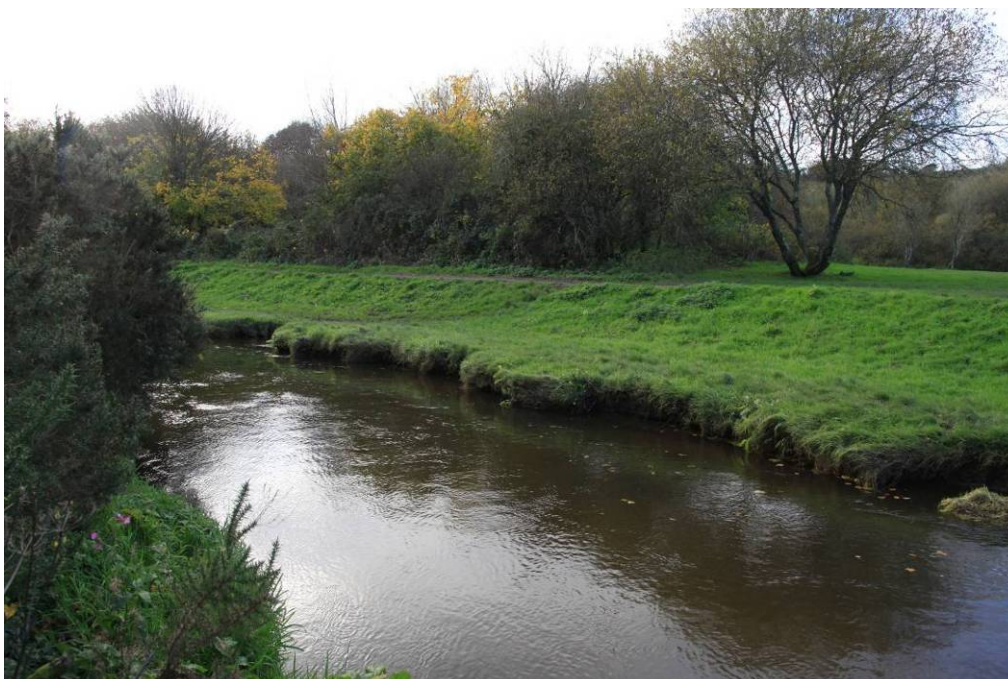
River Cober downstream of Zacharys Bridge - Two stage flood channel constructed in 1988 as part of Helston flood defence works

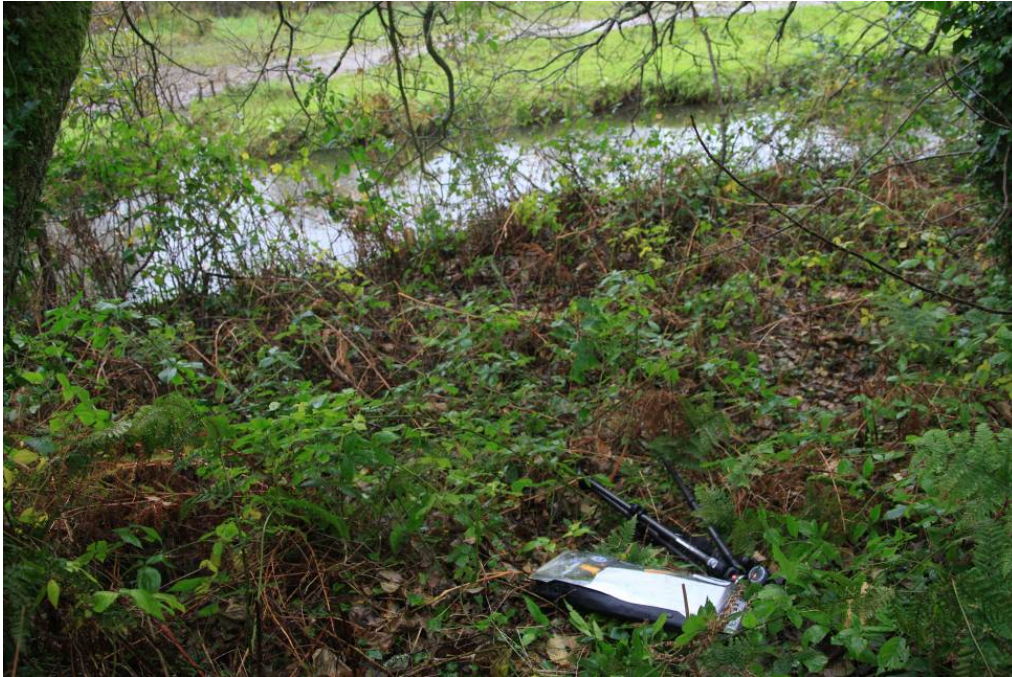
Photo 77 - Very significantly raised bank on left bank of River Cober, looking across to the stretch of two-stage channel (1988 flood defence works). Carr behind bank reasonably wet though little standing water (November). Extremely dense vegetation. Pipe installation not recommended due to unsuitable topography, levels and access issues.

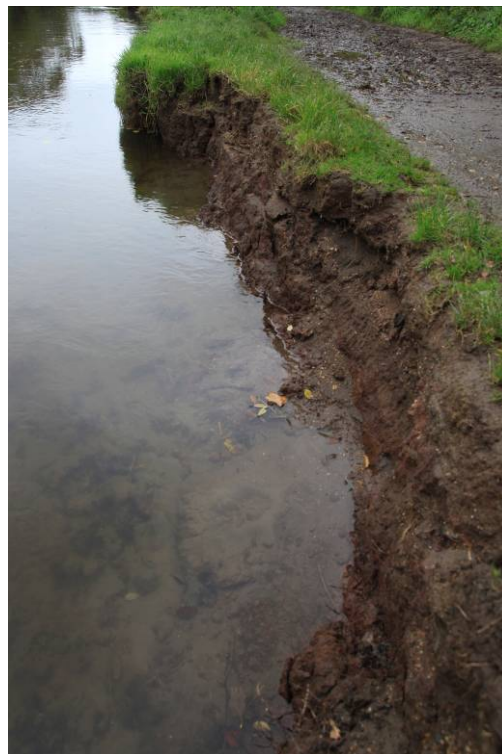
Photo 61 - Collapsed silt bank with mining sediment deposits

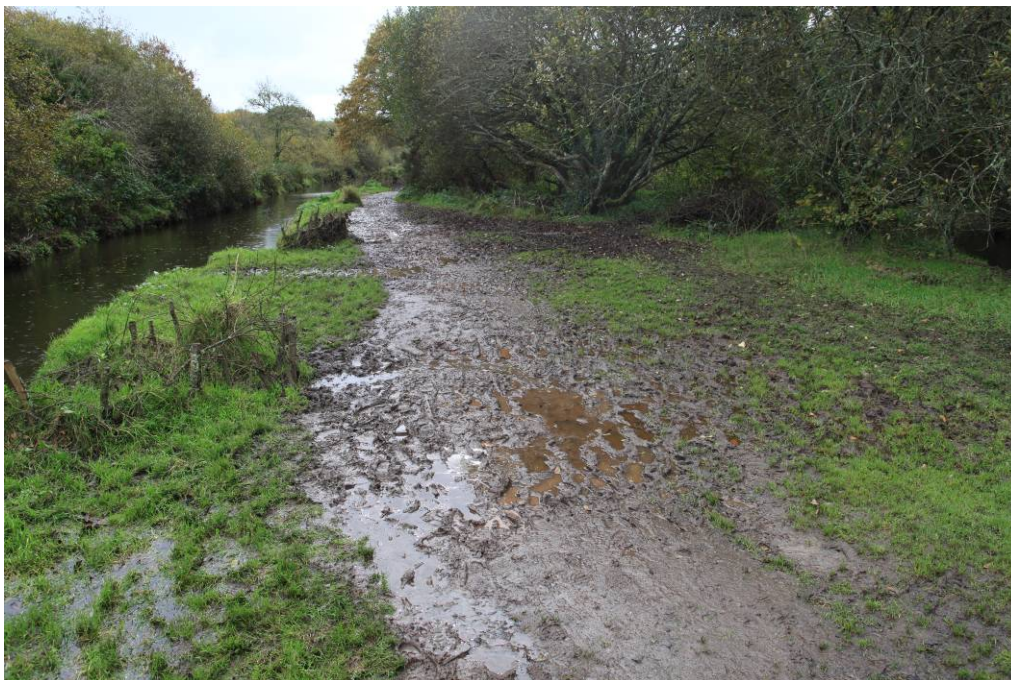
Photo 63 - Water drains out of the carr into the river (site where in-filled, former river channel exits the carr)

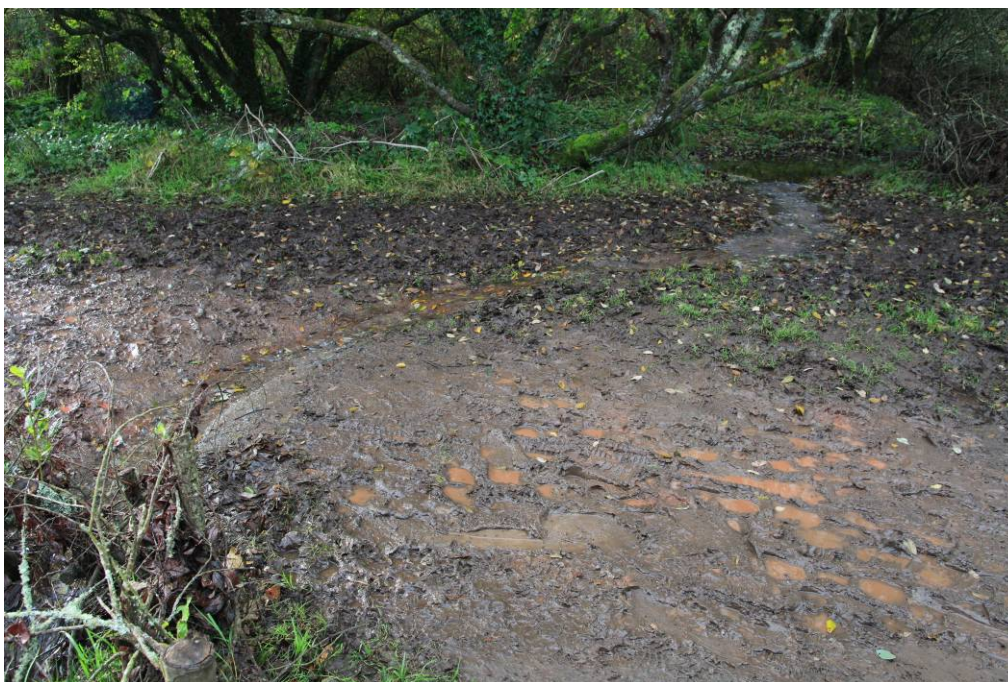
Photo 64 - Water drains out of the carr into the river (where infilled, former channel exits the carr)

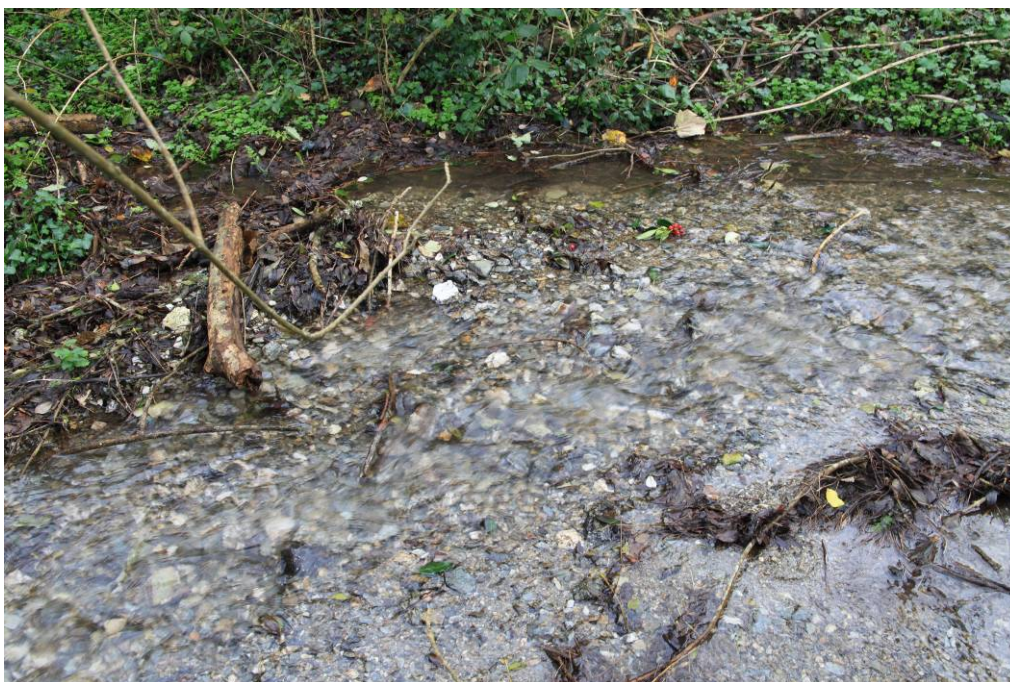
High coarse sediment load at tributary feeding into the carr at the lower end near Loe pool reedbeds (Location A)

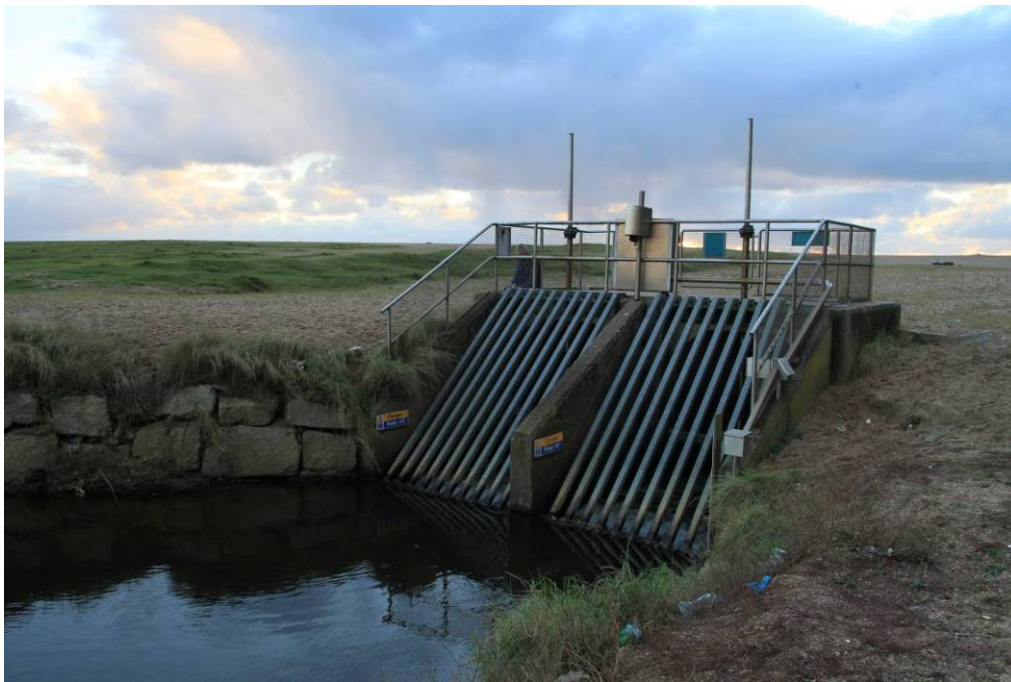
EA Outfall from Loe Pool into sea (Location N)

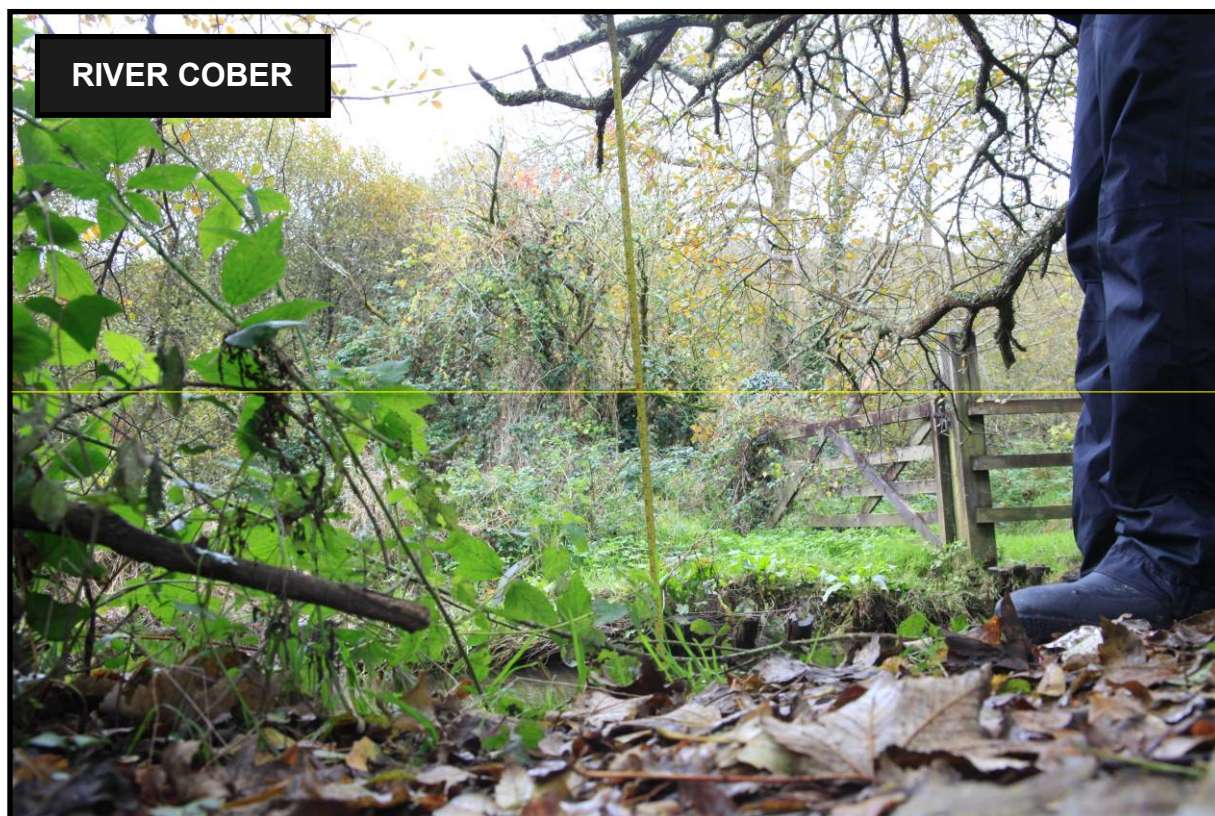
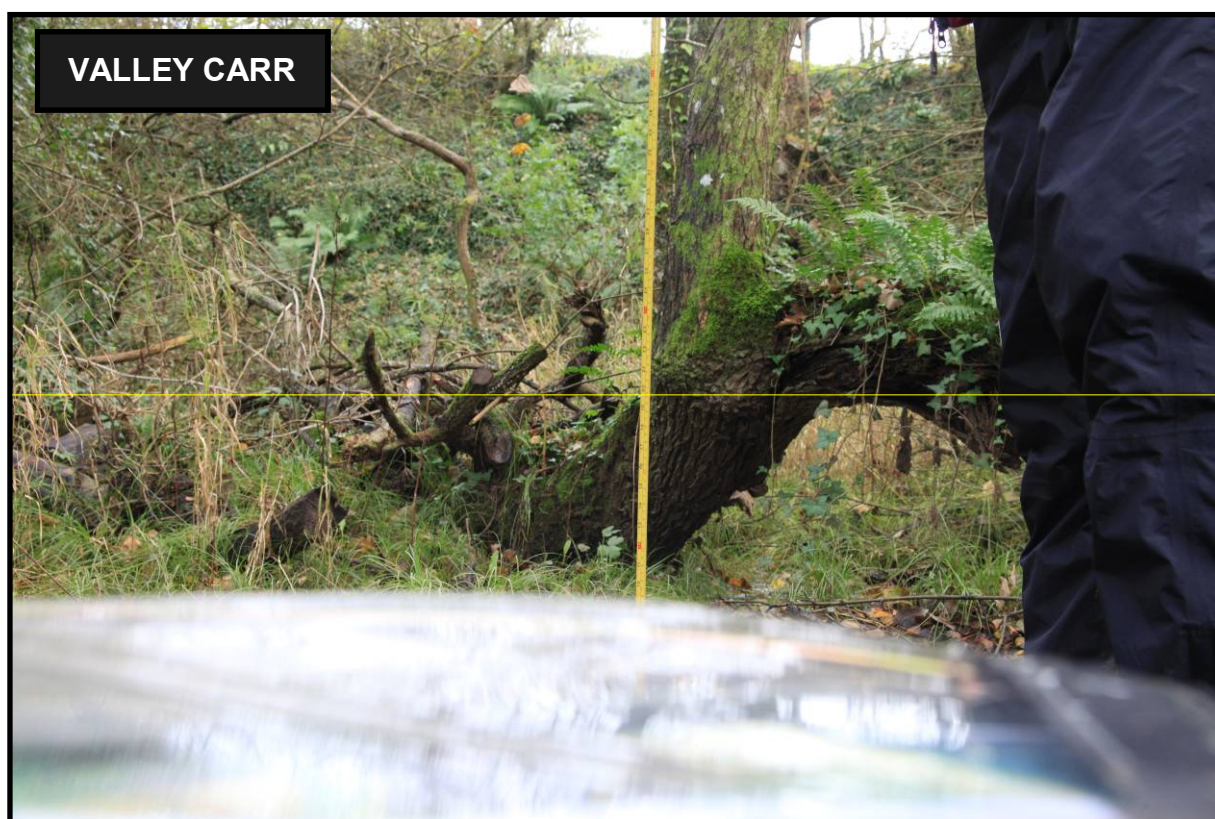
Section No.	1	Date	20/11/2013
Surveyor	GH & GJH	Time	10.40
Grid Reference	SW 65297,26223	Water Level	1.5m (approx)
Notes	Left bank looking downstream, just DS of NT gate and pathway. Photos 51 (river) and 52 (carr).

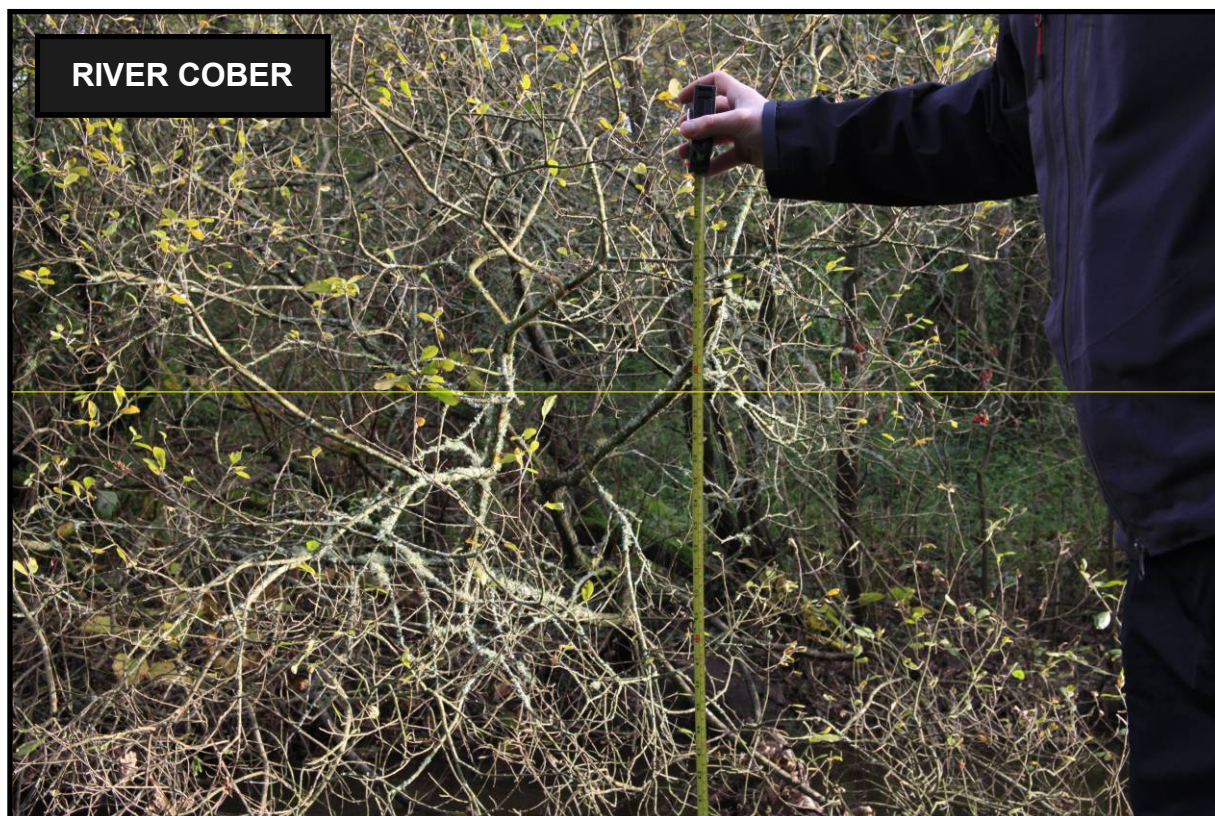
Section No.	2	Date	20/11/2013
Surveyor	GH & GJH	Time	11.00
Grid Reference	SW 65305, 26147	Water Level	1.5m (approx)
Notes	Right bank looking DS. South of NT gate. Photos 53,54 and 55

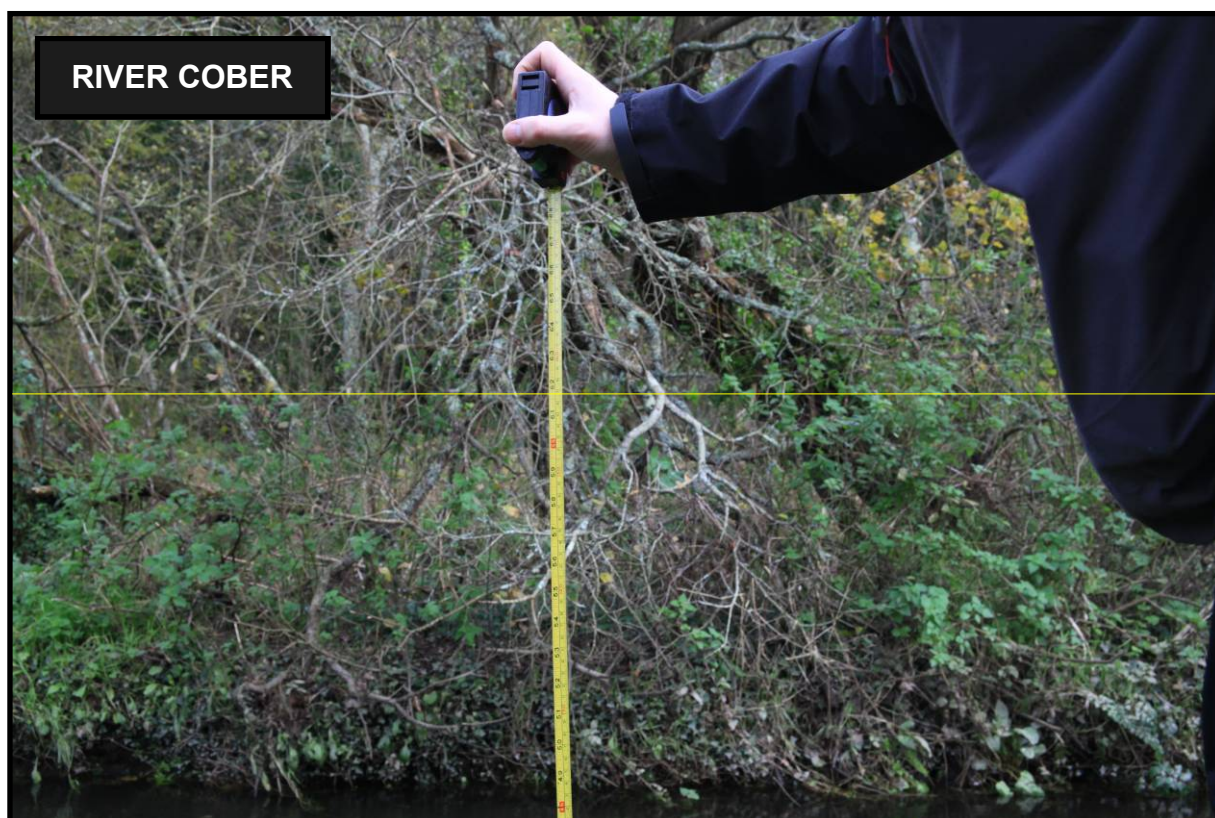
Section No.	3	Date	20/11/2013
Surveyor	GH & GJH	Time	11.25
Grid Reference	SW 65251, 26318	Water Level	1.25-1.5m (approx)
Notes	Right bank, looking downstream. North of NT gate by public ROW. Photos 56 (river) and 57/58 (carr).

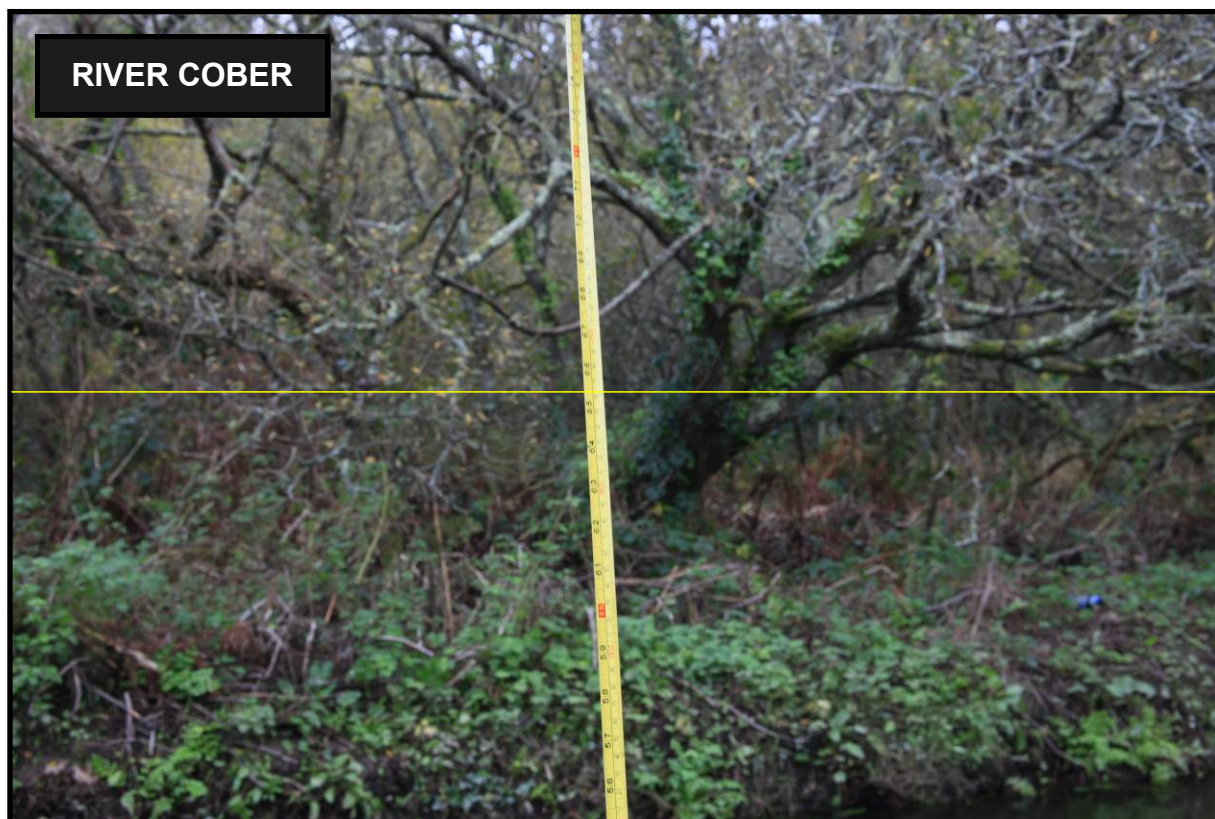
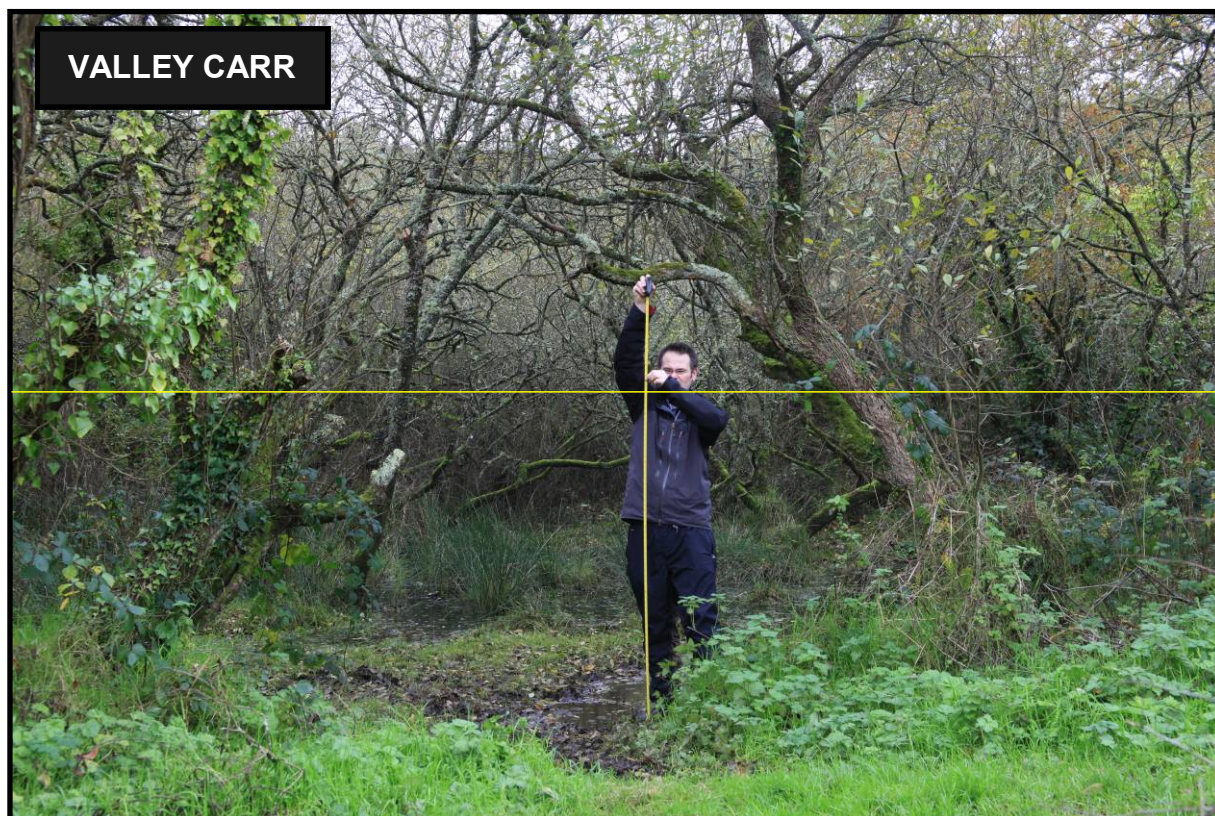
Section No.	4	Date	20/11/2013
Surveyor	GH & GJH	Time	12.00
Grid Reference	SW 65239, 26431	Water Level	1.5m (approx)
Notes	Right bank looking DS, North of NT gate by public ROW. Photos 59 (river) and 60 (carr).

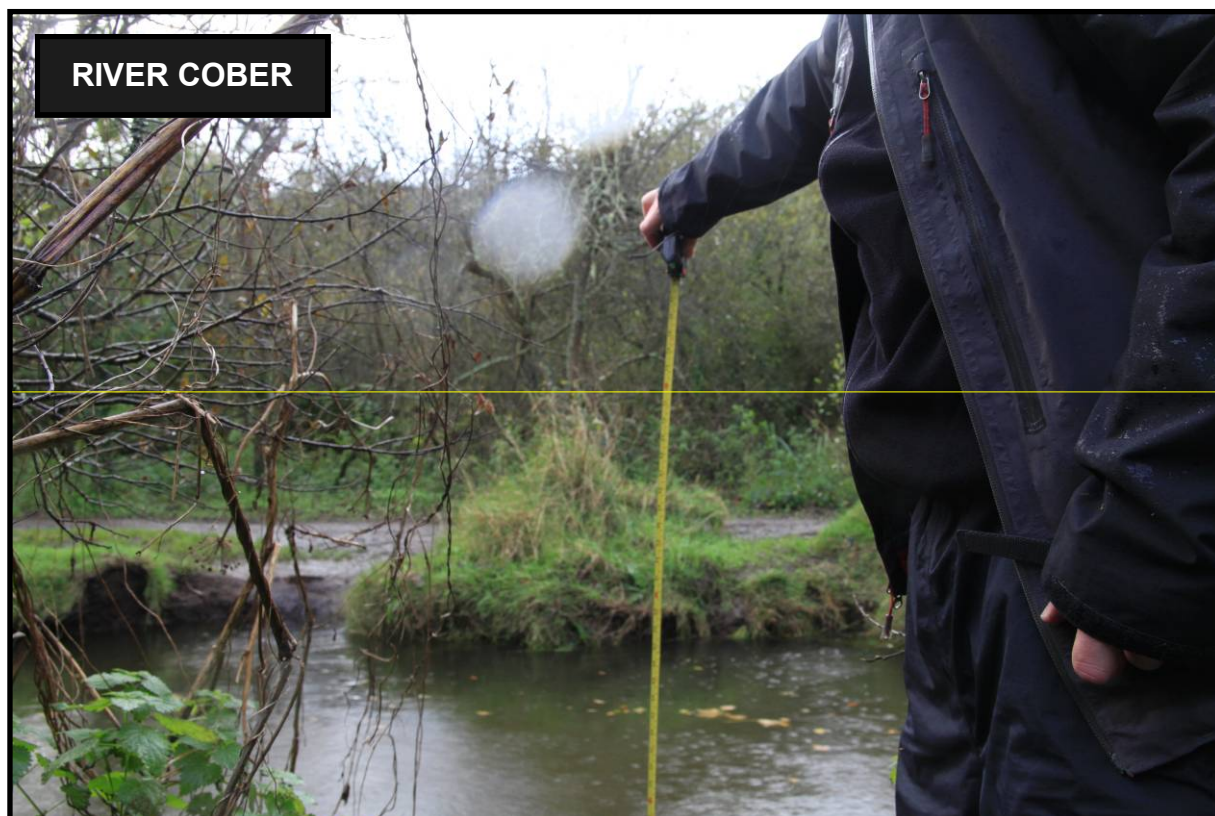
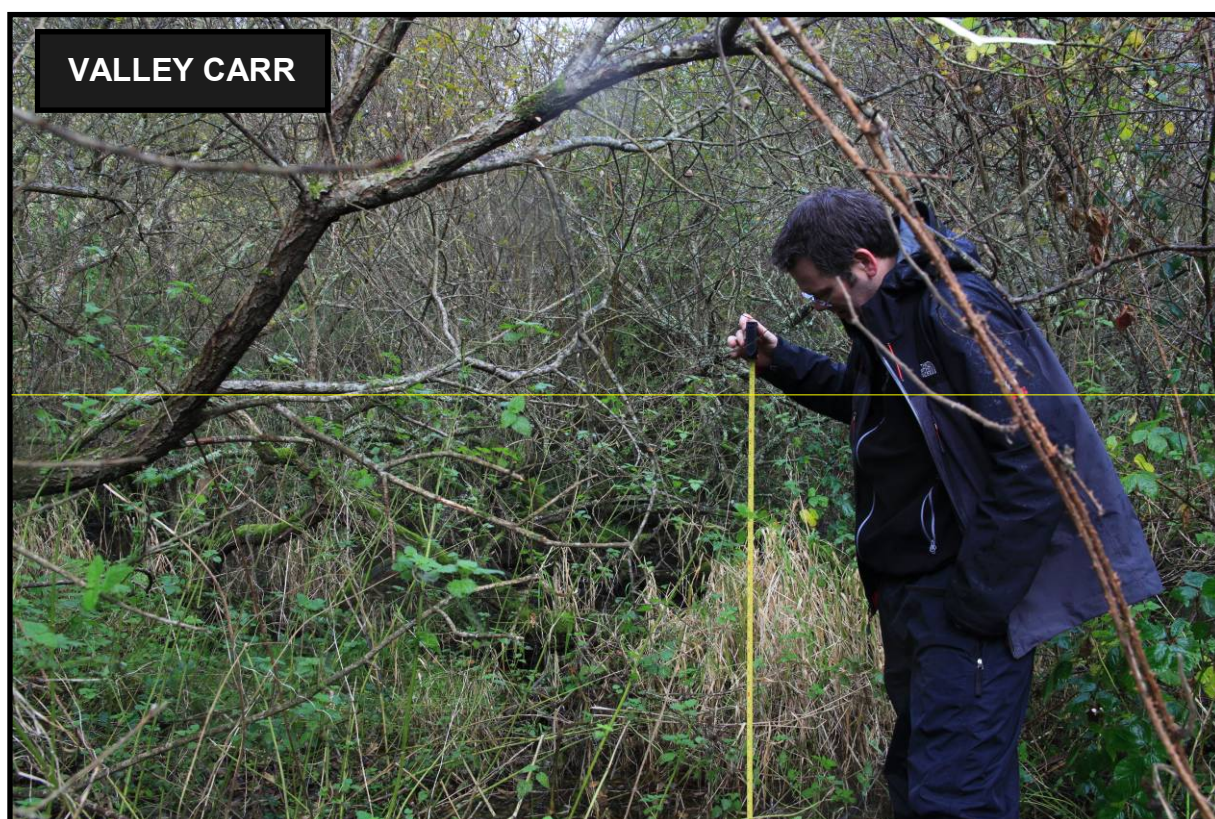
Section No.	5	Date	20/11/2013
Surveyor	GH & GJH	Time	12.50
Grid Reference	SW 65268, 26288	Water Level	1.5m (approx)
Notes	Left bank looking DS, North of NT gate by public ROW. Photos 59 (river) and 60 (carr). Access into Carr extremely difficult due to dense vegetation and surface water-logging.

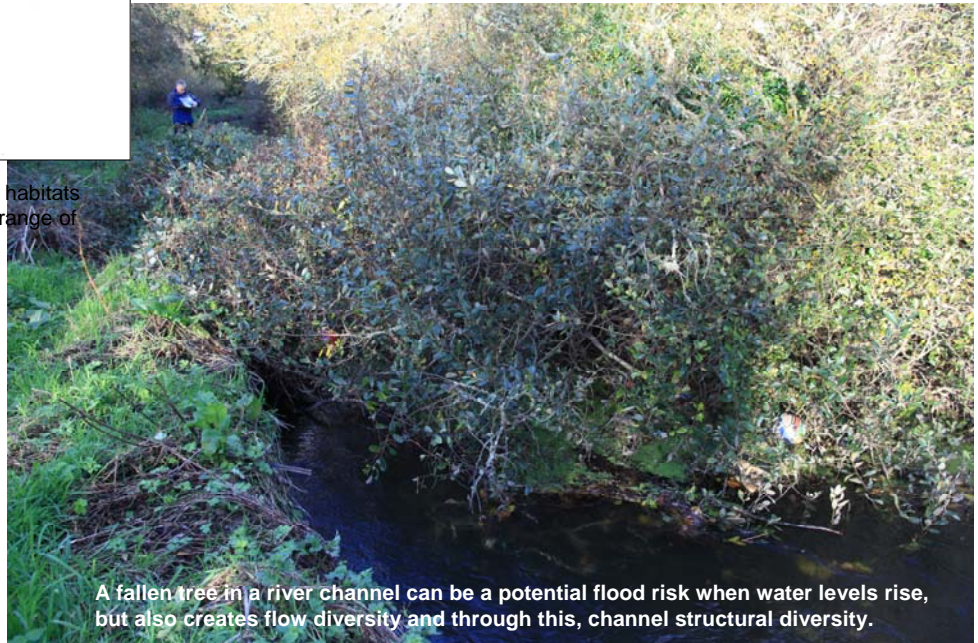
Revetment made from reclaimed logs wired together – a potential use for fallen timber removed from the channel.

Fallen trees and timber in rivers can cause flood risk, so may need removal. In other situations, they may have no effect. Standing and fallen dead wood in and by rivers provides vital wildlife habitats. In rivers, habitat and channel structural diversity can be greatly enhanced by dead wood.

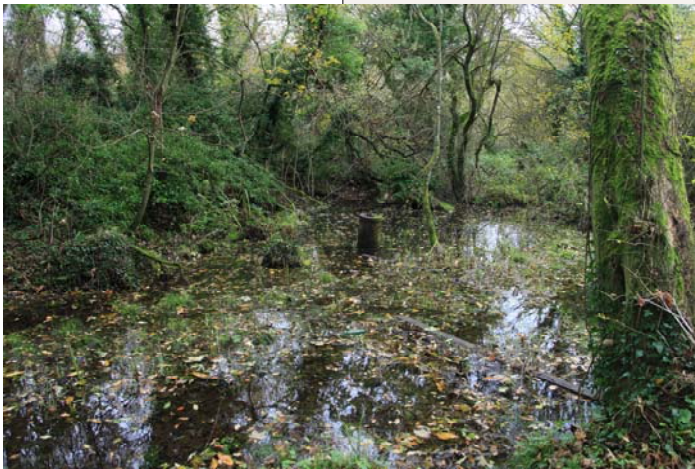
Technique:**River Cober - Backwater Creation Using Old Channel**

To create flow diversity to benefit wildlife without impeding channel. Old channel through the carr can be partially re-used to provide refuges for fish and other organisms during high flow conditions.

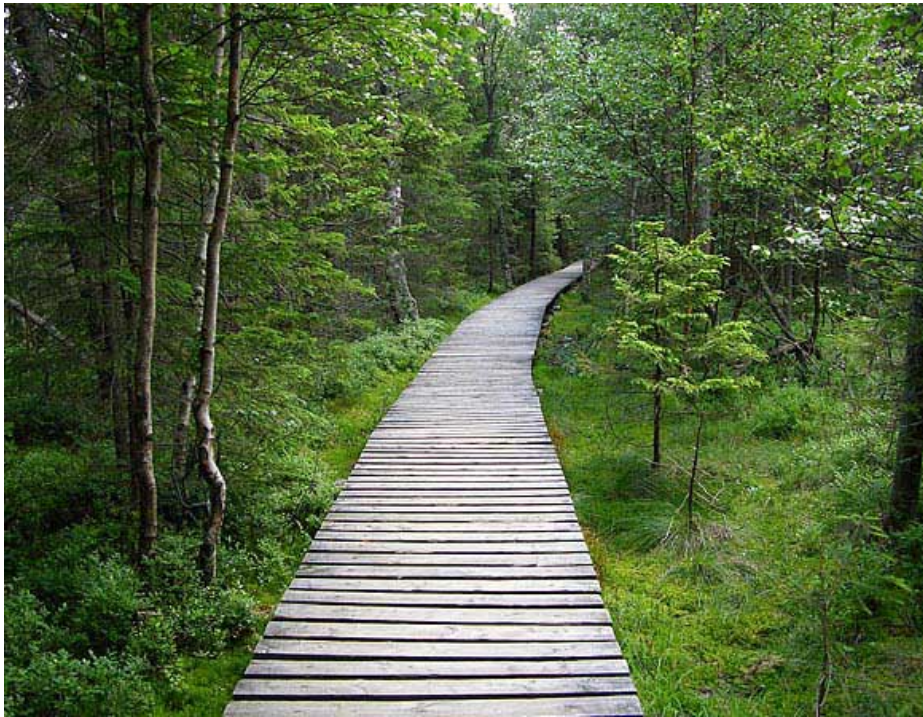
Technique:**Valley Carr - Raised Boardwalks to Allow Floodplain Flow**

Fallen trees and timber in rivers can cause flood risk, so may need removal. In other situations, they may have no effect. Standing and fallen dead wood in and by rivers provides vital wildlife habitats. In rivers, habitat diversity can be greatly enhanced by dead wood.

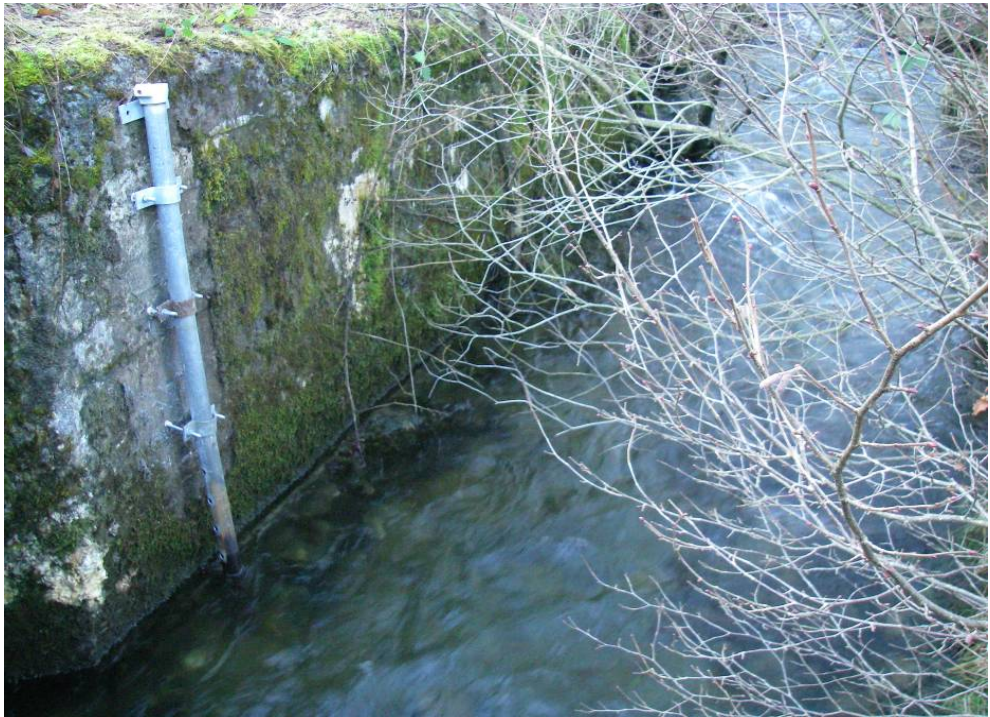
Technique:**Water Level Monitoring – River Cober**

Monitor river water level (stage) in the River Cober as it passes through Loe Valley Carr SSSI. Characterise levels, variation and response of flow to rainfall and inundation by fluvial overbank flow and / or upstream inundation. Acquire reliable, long-term quantitative data on flow levels: a critical requirement of the future management plan.
