FLOOD CAPACITY MODELLING AND FLOOD INUNDATION ON THE RIVER COBER, HELSTON, CORNWALL

***Submitted by Catherine Judith Nichol to the University of Exeter as a
dissertation towards the degree of Master of Science by advanced study in
Surveying/Land and Environmental Management, September 2016***

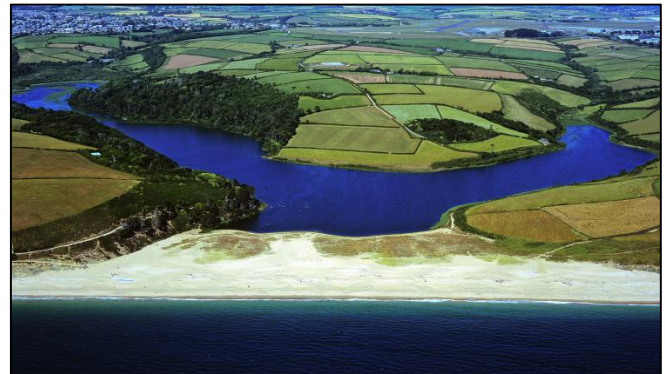
Figure 4:5 - Loe Pool and Loe Bar from an aerial image, allowing the unique geographical feature to be seen in its entirety. Helston can be seen in the top left of the picture. (Source: Visit Cornwall, 2016.)

south south west of Porthleven at the end of the River Cober (Figure 4:5). The bar is a rare example of a bay-bar formation (May, 2007). It is composed and formed mainly (over 90%) of chalk flints, despite the adjacent cliffs being mainly killas and quartz based and there being no other sources of flint locally (Toy, 1934). The sediment that makes up the bar can be categorised into two class sizes: medium to very coarse sand and small pebbles (May, 2007). Due to the orientation of the beach and reduced amount of sediment on the beach, incoming

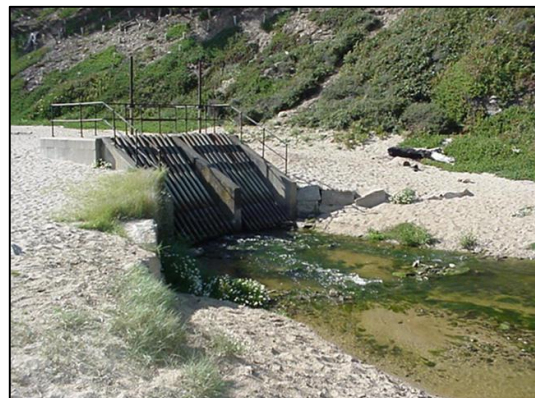
Figure 4:6 - The mine adit that now prevents water levels being too high in the Loe Pool and in turn helps reducing flooding along the River Cober. (Source: Helston History, 1999.)

4:6). After the improvements and more recently it became the case that the velocity and pressure of the water was great enough that a stoppage would be rare if not impossible. The implication the bar has on flooding in Helston is further reinforced by the historic requirement and tradition to break the bar. There was a traditional ritual for The Mayor to present a stout leather purse to the Lord of the Penrose estate with 3 halfpence in to ask permission to break the Loe Bar (Toy, 1934). The breaking of the bar stopped the bar acting like a dam for the River Cober and hence alleviates flooding. Loe Bar was cut in the Winter of 1867 and 1868 (Toy, 1934). More recently the bar had to be cut though because the mine adit got blocked by storm water in 1979 (Figure 4:7) (Helston History, 1999).

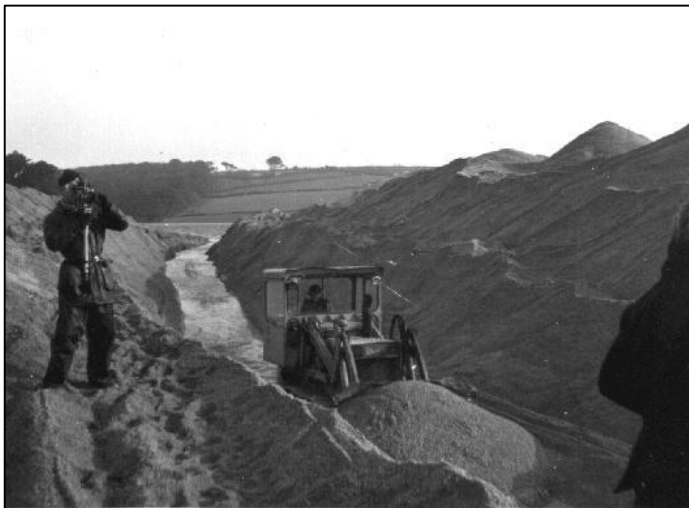
Figure 4:7 - Photograph demonstrating the cutting of Loe Bar by South West Water machinery; 15th February 1979. (Source: Historic Helston, 1999.)

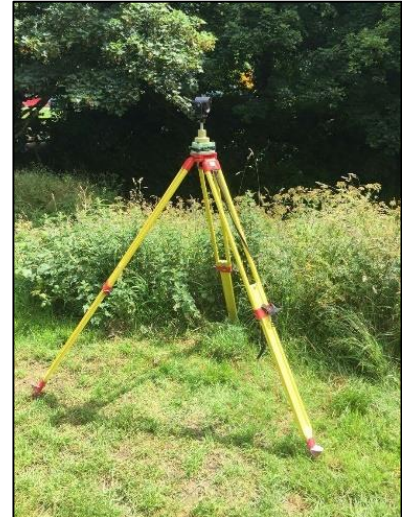
Figure 5:2- Tripod and Leica Circular Prism set up (centred and levelled) over the control station Bridge, for use in resection. (Source: Authors Own.)

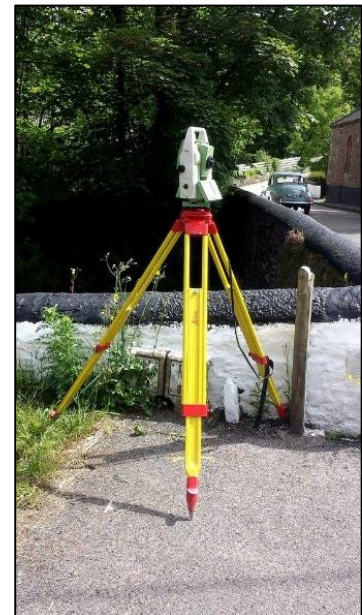
Figure 5:3- Leica 1200 Total Station setup and levelled over control station- Pavement, in order to setup using the known back sight function. (Source: Authors own.)

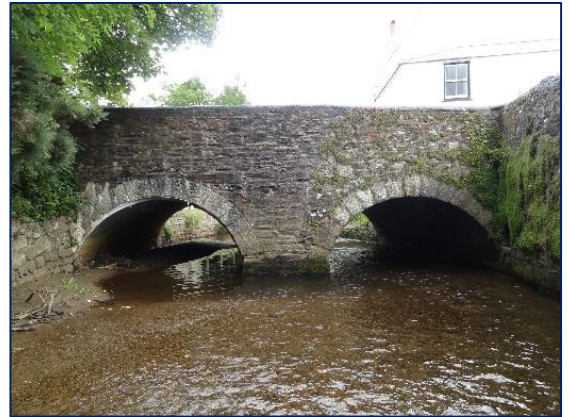
Figure 6:15- Picture demonstrating the distinctive arches of the St Johns bridge Helston. (Source: Authors Own.)

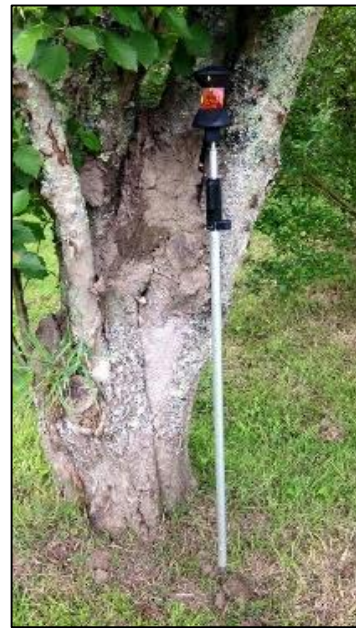
Figure 7:7- Evidence on flood inundation on a tree in the South West corner of Area 1 (Appendix 1a).
