# Historic Landfill Investigation, Helston Cornwall.

An Environmental Survey of the Penrose and Fairground historic  
landfill sites.

Submitted by Rebecca James to the University of Exeter as a dissertation towards the  
degree of Master of Science by advanced study in Surveying and Land Environmental  
Management, September, 2016.

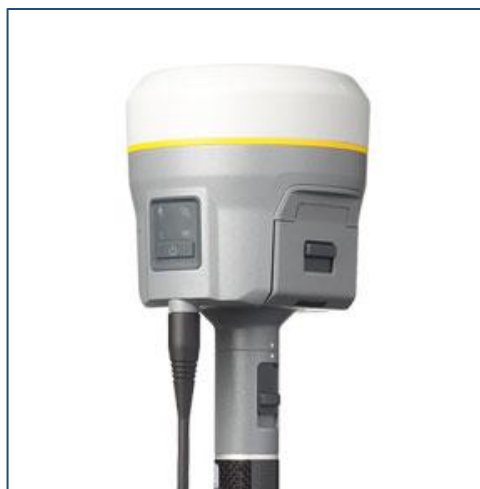
*Figure 8 Photo of a Trimble R10 GNSS receiver.  
Source: Trimble Navigations Limited (2016).*

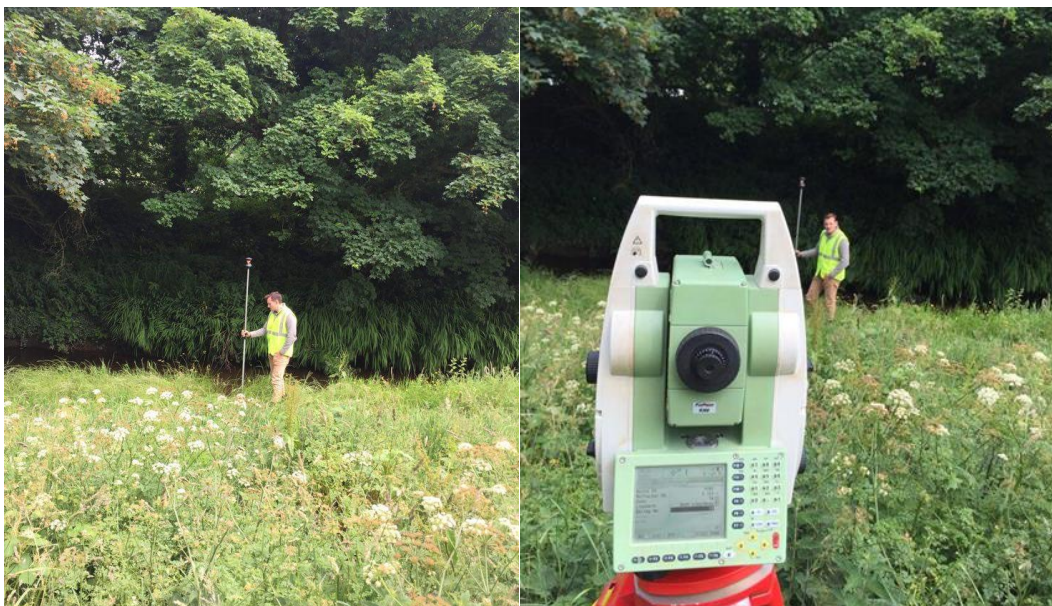
*Figure 10 Photographs of detailing the top of the river bank at Penrose, Helston. Using a detailing pole and 360 Prism. Source: Author, 2016.*

This process was repeated for Area 3, where the total station and prism were interchanged, so the TPS was sat over “Island” and the prism was on “Bridge”. Once again the method of “Known Backsight” was used and surveying of the area was carried out. When detailing all the areas, the Leica 360° prism was used with the detailing pole (Figure 9). Using this type of prism allowed for Automatic Target Recognition (ATR) tracking to be utilised effectively. This application on the total station allowed it to track the position of the prism and increased the efficiency of recording observations.

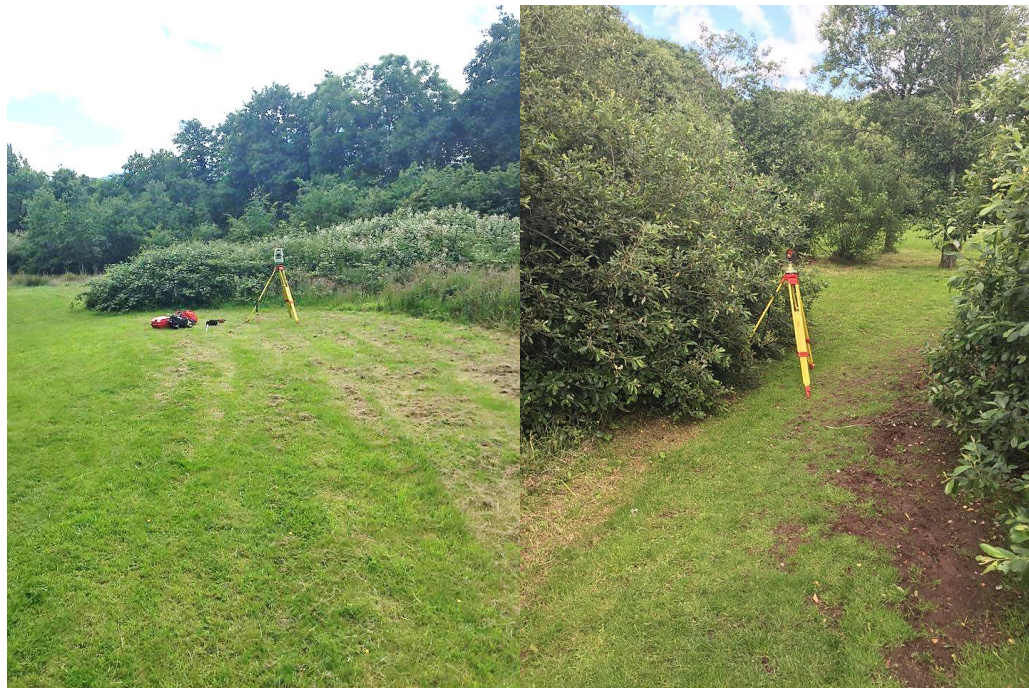
*Figure 11 photographs of the temporary station traverse around Area 4 on the Penrose amenity site. Source: Author, 2016.*

For the surveying of Area 4 there were no control points established due to it being a wooded area that would not allow the GNSS system to work to a desired accuracy. The limited coverage in the area therefore required a series of temporary stations to be setup to traverse around the site. In total, six temporary stations were setup to survey area 4 (Figure 10).

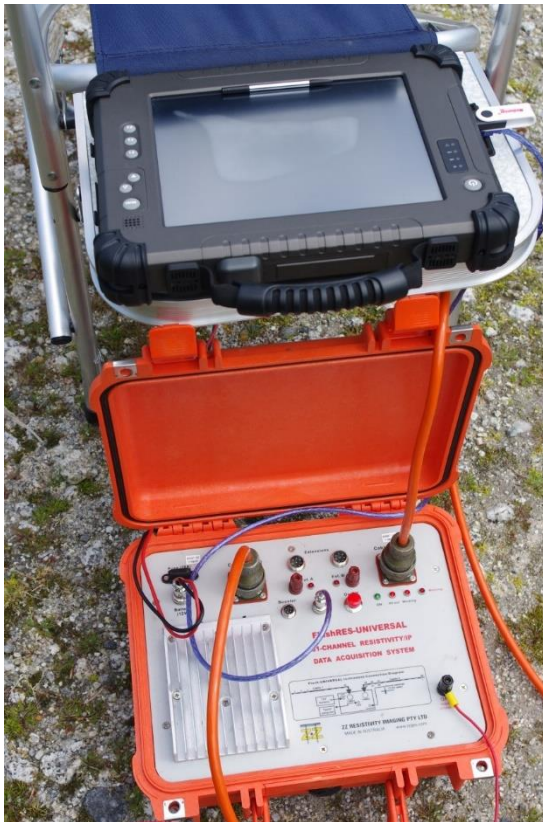
*Figure 12 Photograph of the FlashRES-Universal 96 system used for the resistivity data collection, it also shows the laptop used to run the data acquisition. Source: (N. Wood, 2016).*

The FlashRES-Universal 96 Resistivity and IP meter was the system used at acquire data for this investigation (Figure 11). Using this system, the resistivity

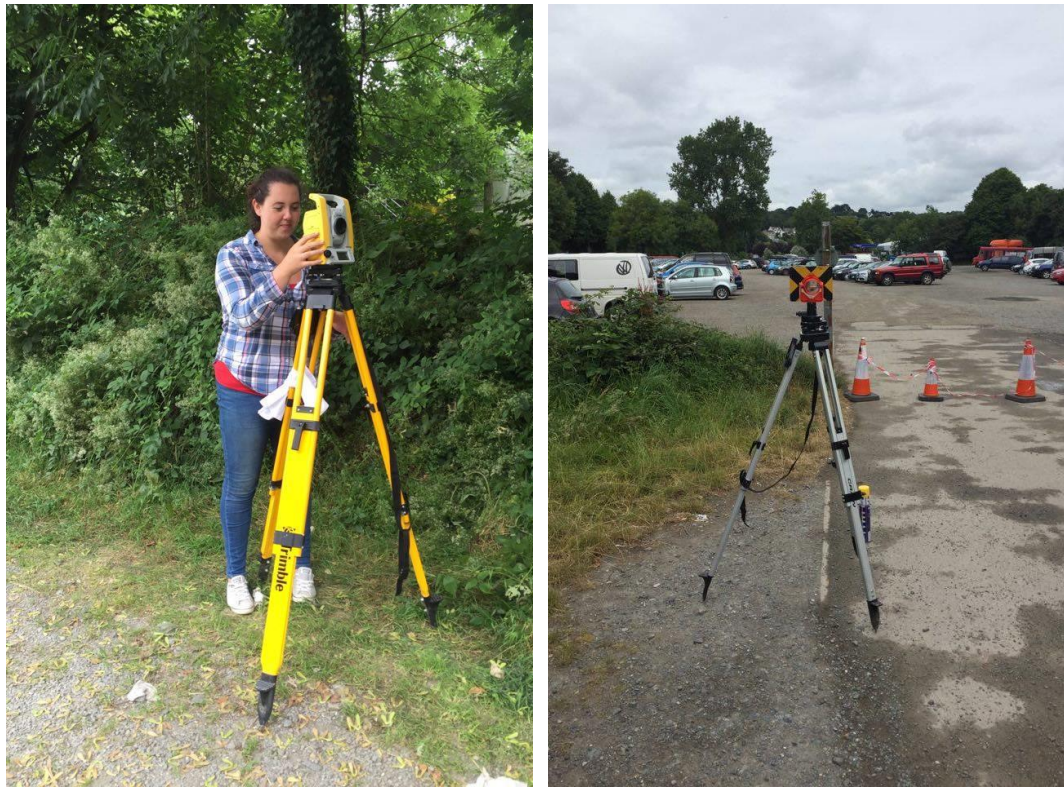
*Figure 13 Photographs of the resection setup to survey the positions of each electrode used for Electrical Resistivity.*

The process ran for approximately 45 minutes and at any given time two electrodes along the array were charged with an electrical current. Therefore, being vigilant of passers-by and also dogs off leads was important. The programme was also set to run in a stacking mode of 4. Meaning that for every point at which a reading is taken, 4 measurements is actually recorded and an average taken. As explained inversion for each measurement was required post-process to produce true resistivity values. In order to give the data set some context, the electrode array was surveyed using a Trimble M3 Total Station. This was carried out using the established control points, "Blue Van" and "Far CP". Because of the position of the array, a resection was carried out. Meaning that the total station was roughly 45° between both control points, providing a good line of sight to survey in each electrode position (Figure 12).

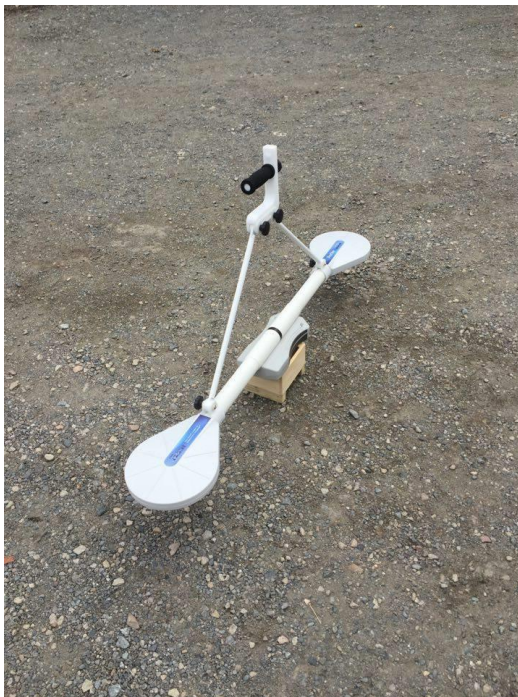
*Figure 14 Photograph of the EMP-400 Profiler in the field (Source: Author, 2016)*

For this investigation the GSSI EMP-400 Electromagnetic Profiler (figure 13). This is a dual-coil system that consists of two coils of wire separated by a

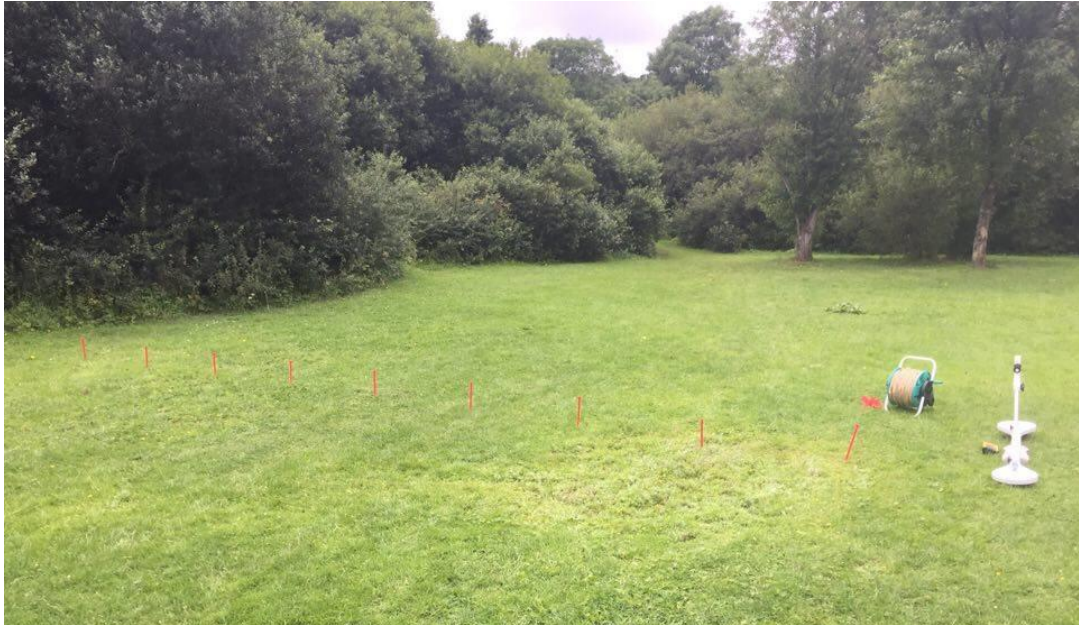
*Figure 16 Photograph illustrating the grid system used to collect the EM data. The red stakes mark the start and end of each transect line. Source: Author, 2016*

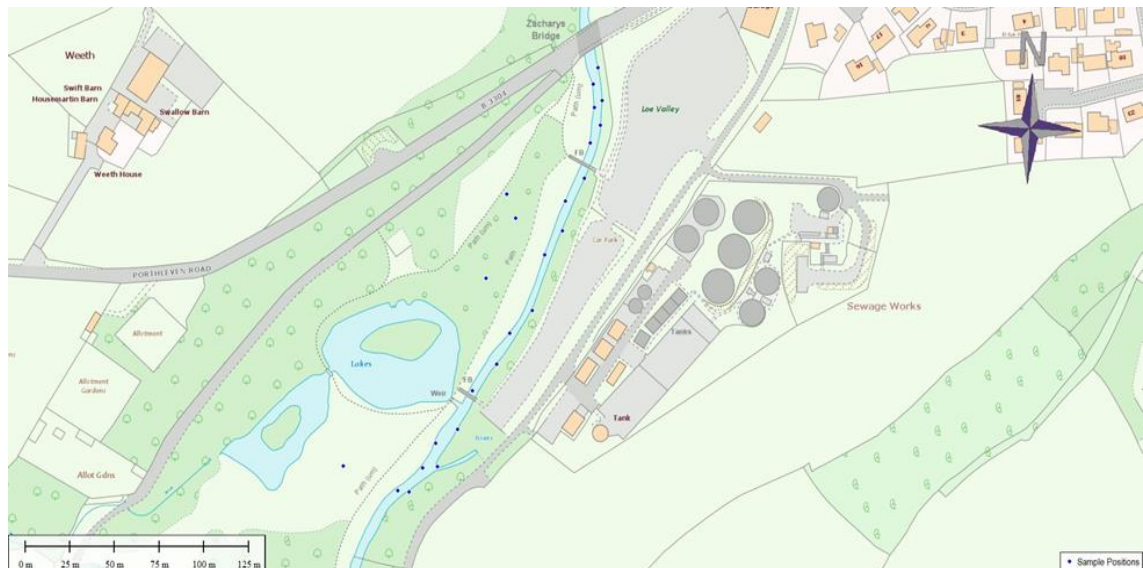
Figure 17 Map illustrating the soil sample positions taken from the river banks at of a section of the River Cober at the Penrose Amenity Site.

Soil samples were taken from a section of the River Cober that runs through the Amenity site. The samples were taken using a steel auger and were taken in a systematic approach ensuring that each sample was roughly equidistant apart, to ensure that whole river was evenly represented. However, any features of specific interest were also included in the samples. Samples were taken on both sides of the river channel and for each site the corresponding GPS readings were taken. In total 23 samples were taken along the river and 4 in the field area of areas 2 and 3. Attempts to take samples further down the river were tried, however the depth of the river on the meanders did not allow it. The sample sites can be seen on the map below (Figure 16).

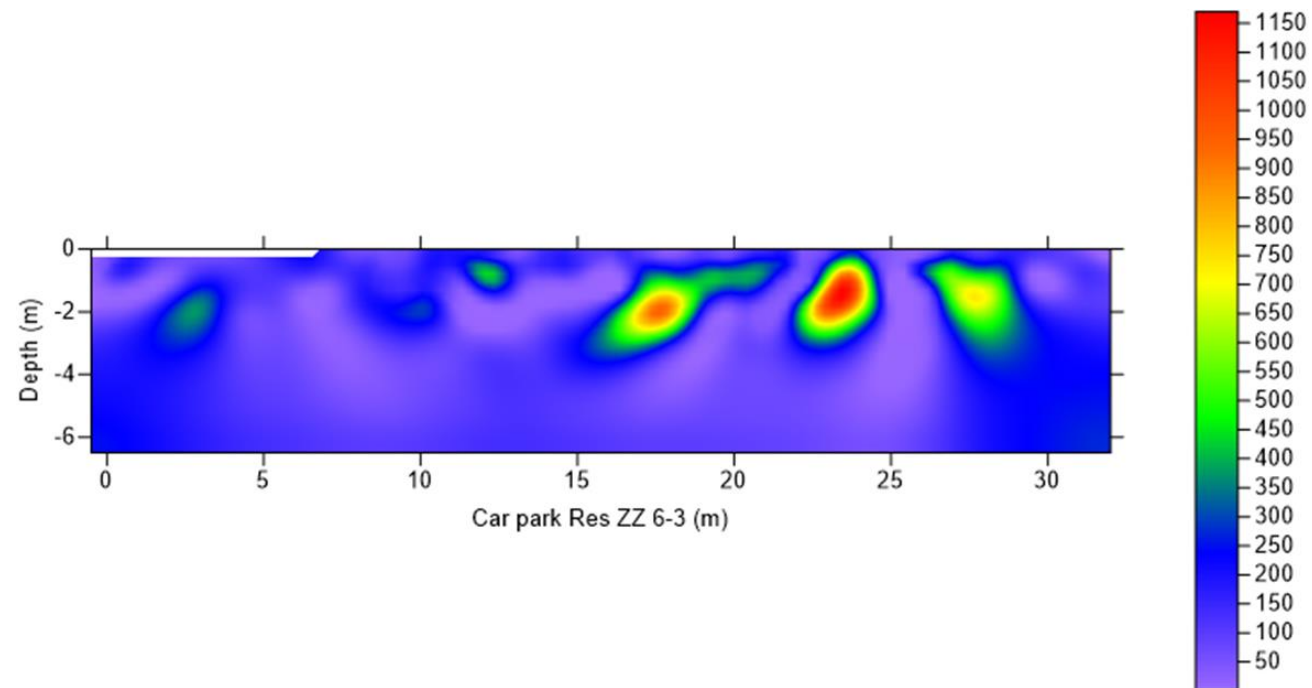
Figure 19 Heat map illustrating the resistivity results for the car park (ohms/m)

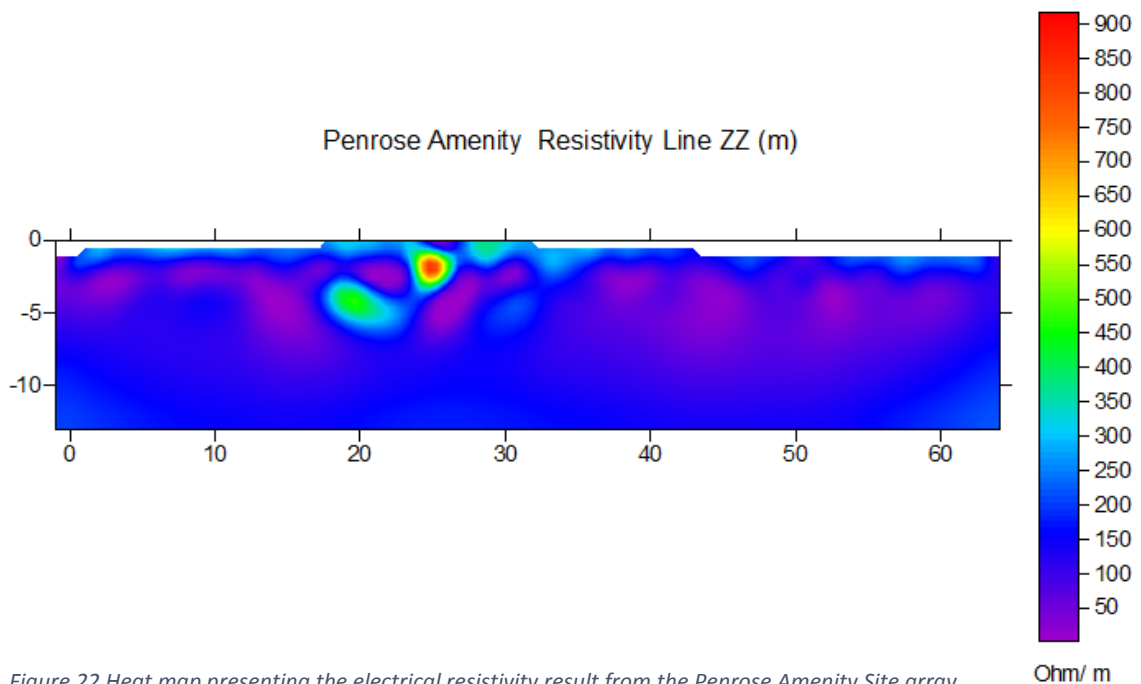
Figure 22 Heat map presenting the electrical resistivity result from the Penrose Amenity Site array.

Succeeding the Car Park results, is the electrical resistivity results for the setup at in A3 of the Penrose Amenity site. Figure 21 illustrates the Amenity site's resistivity results. From the map it is again clear to see that there are areas of high resistivity, which lie between 20 and 30m of the electrode array. These highs reached 900 Ohm/ m which is lower than that observed at the Car Park but is still significantly high in terms of electrical resistivity. Again the background resistivity of the site lies between 50- 200 Ohm/m which highlights this area of considerably higher resistivity.

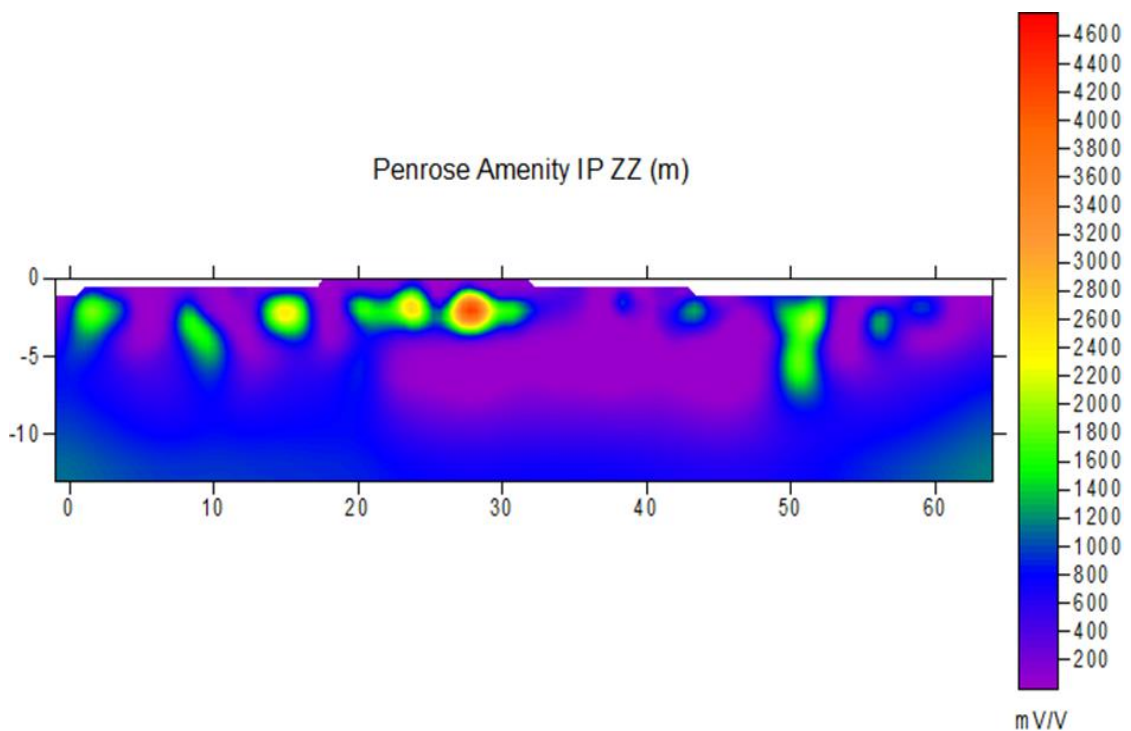
Figure 23 Map illustrating the IP results from the Penrose array (mV/V).

Figure 22 illustrates the induced polarisation results of the Amenity site survey and shows that again the area of high IP are similar to that of the resistivity results. The highest values of IP were again observed between 20 -30 m along the electrode array at values of 4200 m V/V. What is noteworthy for these results is that unlike the resistivity data there are also areas of moderately high IP readings along the array. There are 7 areas highlighted as the green areas on the heat map which indicate observations of 1400-2000 mV/V. These areas indicate areas of interest for the survey. The high anomalies found in both the IP and resistivity data could indicate either a plume of contamination from landfill leachate or a void in the ground.

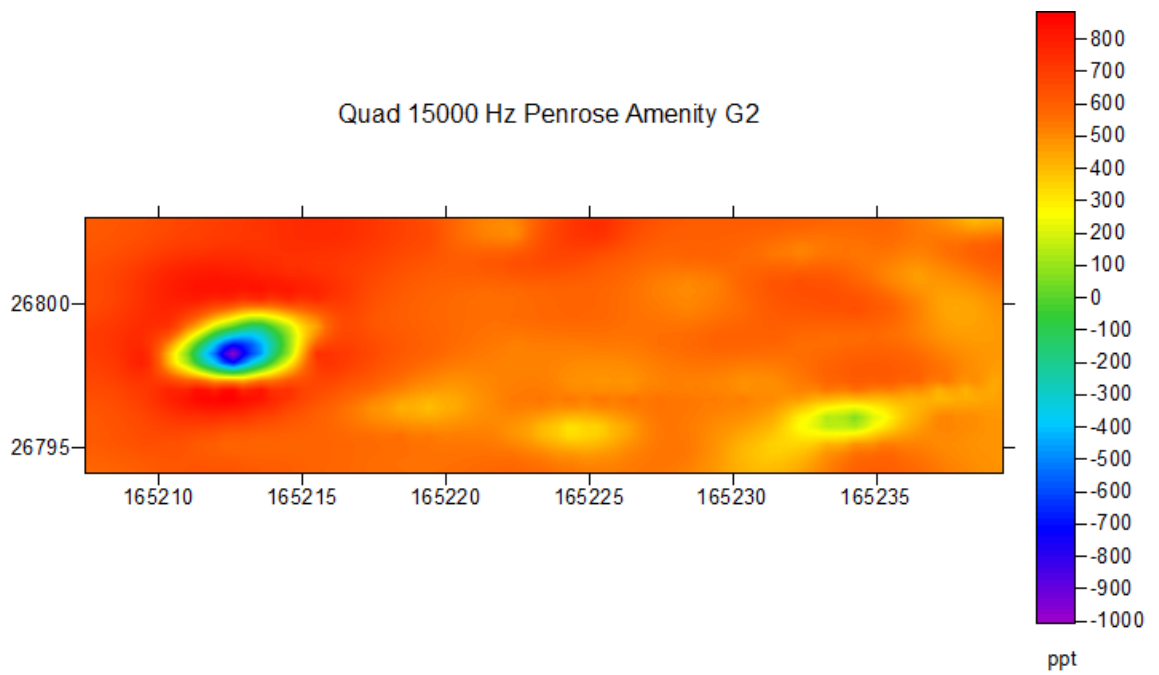
Figure 30 Heat map illustrating the final EM setup at Grid 2 at the Penrose Amenity site in the Quadrature mode at 15000 Hz.

Finally the results from the second grid setup on the Penrose Amenity site was analysed and exposed an area of localised anomalies located at the start of the grid. The results for this grid have indicated an area of extreme lows that are greater than any of the other setups. The measurements observed an area of low conductivity that reached levels of up to -1000 ppt in the quadrature phase. This level of low conductivity is standalone regardless, however, it is made to stand out more so as it is surrounded by an area of relativity constant conductivity of around 800ppt. An anomaly of this extremity very much so sparks interest as to what is causing it and it could be a range of reasons. The in-phase results also have emphasised that this is an area of great interest as it again exhibits low conductivity in the in-phase results also. In fact the in-phase observations exceed the quadrature with readings reaching up to -2000 ppt. Given these observations, it was no surprise when the apparent conductivity results also revealed that the area demonstrated characteristics of low apparent conductivity of -22 Millisiemens/m. The feature that has been picked up could be one of many things. For instance an area of high resistivity in both the quadrature and in-phase results could mean that it could be an area again of contamination. Or equally it could be a large boulder or void. The notion of it being a boulder is ruled out in terms of probability as this boulder would have to display characteristics of little to no mineralisation in the rock at all. It is suggested that this is not the case in this instance as a large boulder with no

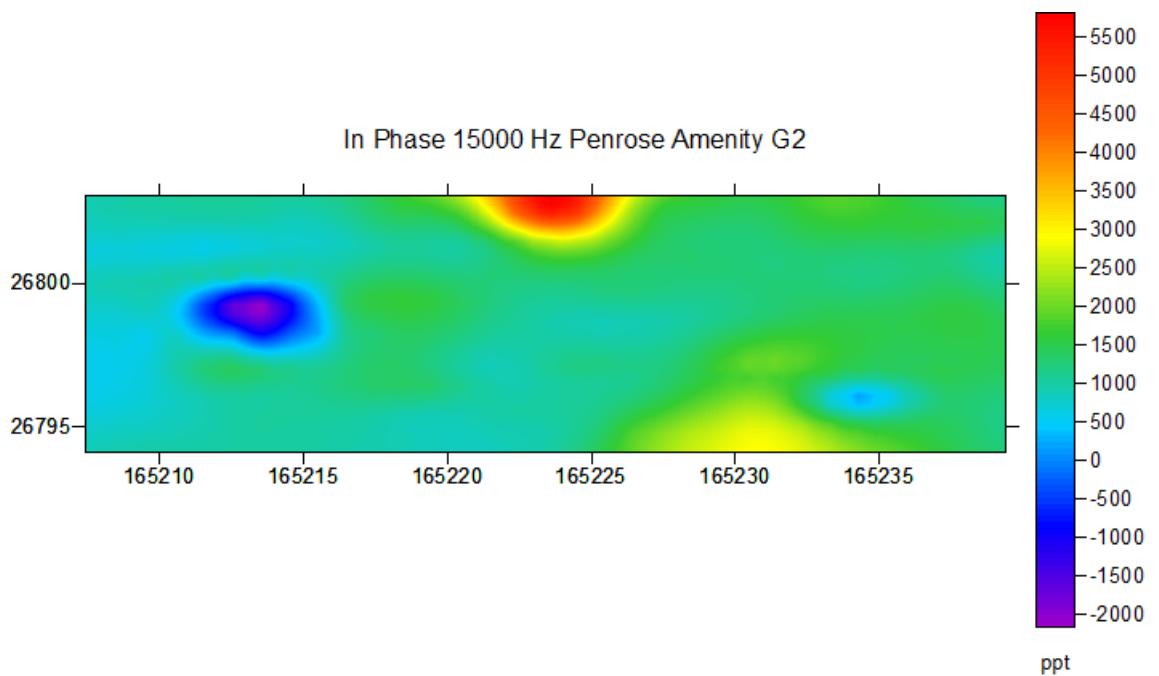
Figure 31 Heat map of the in-phase EM results at Penrose Amenity Site Grid 2

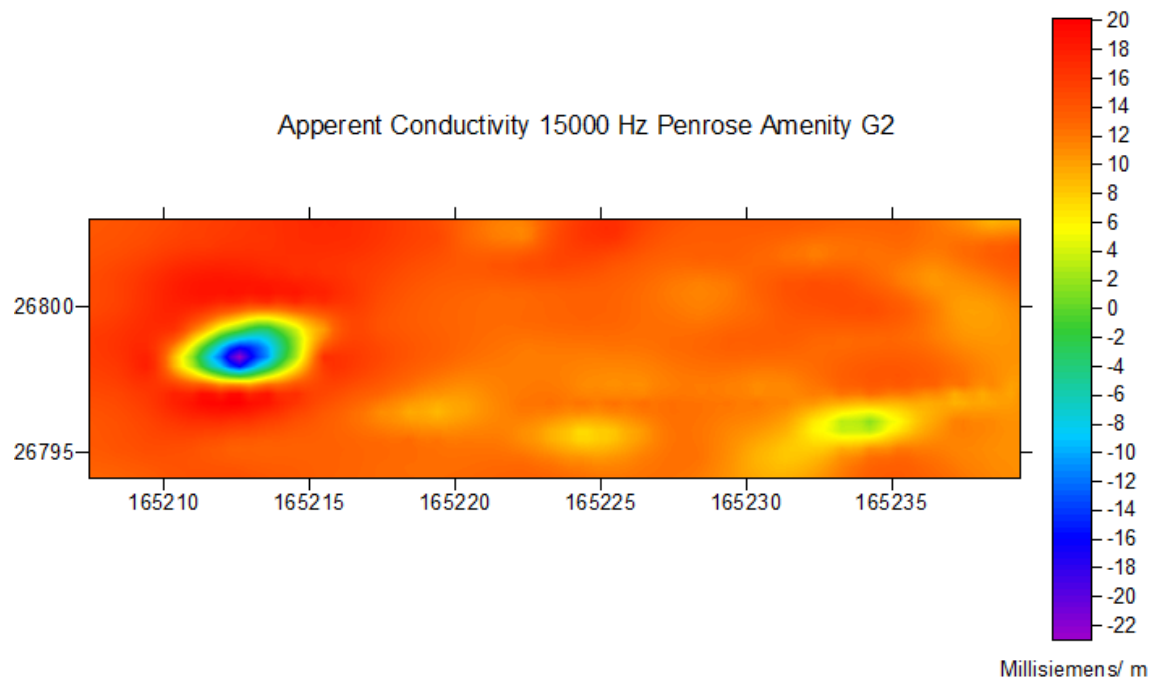
Figure 32 Heat map illustrating the final apparent conductivity results at 15000 Hz for the Grid 2

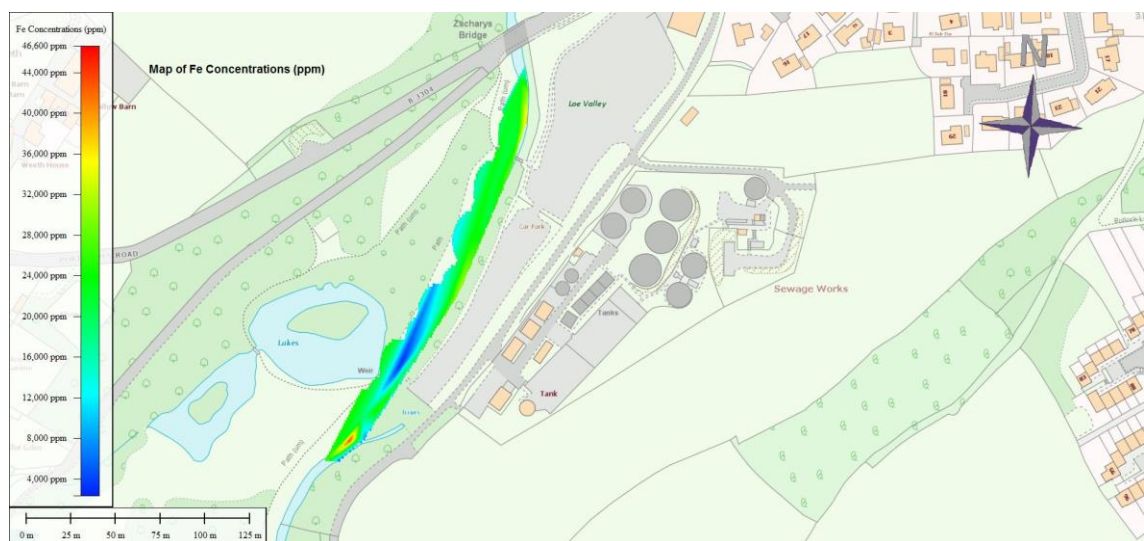
It can be seen that the levels of iron for the most part is observed to be in the range of 20,000 and 32,000 ppm (fig. 32). However, there is a stretch of the river downstream that shows highs of up to 46,600ppm. In order to understand these areas of interest within the data, additional maps were then created that looked to locate the position of the quartile ranges of the data and their position along the river. Figure 33 illustrates these quartile ranges and separate the lowest values from the highest. Thus, focusing the investigation to specific areas along the site to understand the spread of data in greater depth. It emphasises that the high values of iron can be found to the North of the river, near a water outlet that is stained orange and also to the South of the river. From anecdotal evidence from users of the site, it has been suggested on a number of occasions that building rubbish was dumped at the site. Suggesting the possibility that scrap steel could have been tipped.

Figure 33 Heat map of Fe concentrations (ppm)

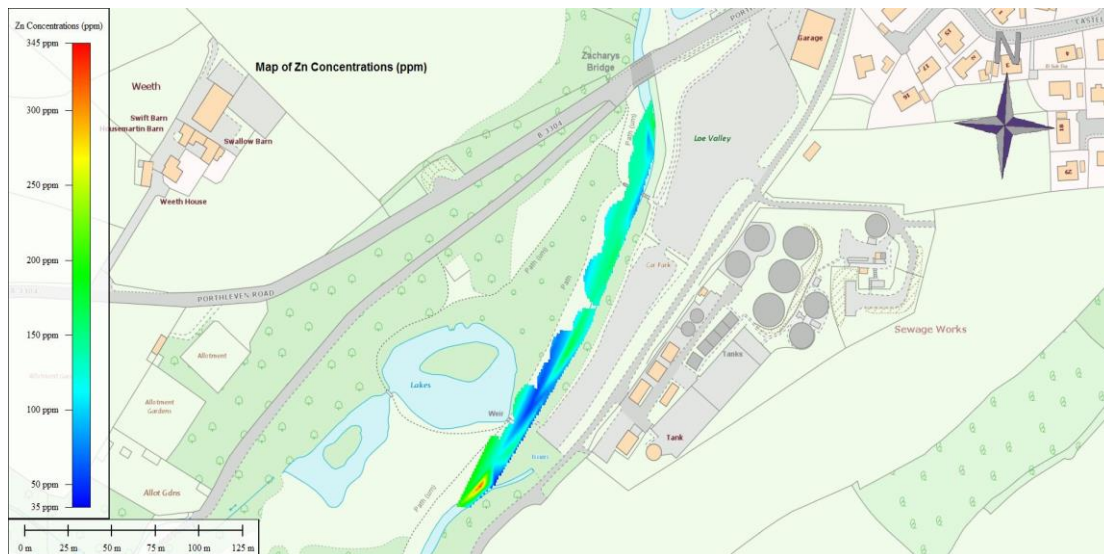
Secondly, the observed Zn levels were mapped as a heat map to demonstrate the overall spread of the data (fig. 34). The map below indicates that the levels of zinc are relatively low values with the majority of readings ranging from 35-250 ppm. However, there is high reading of 350 ppm at the South of the area.

Figure 35 Heat map of the Zn concentrations across the sample area (ppm)

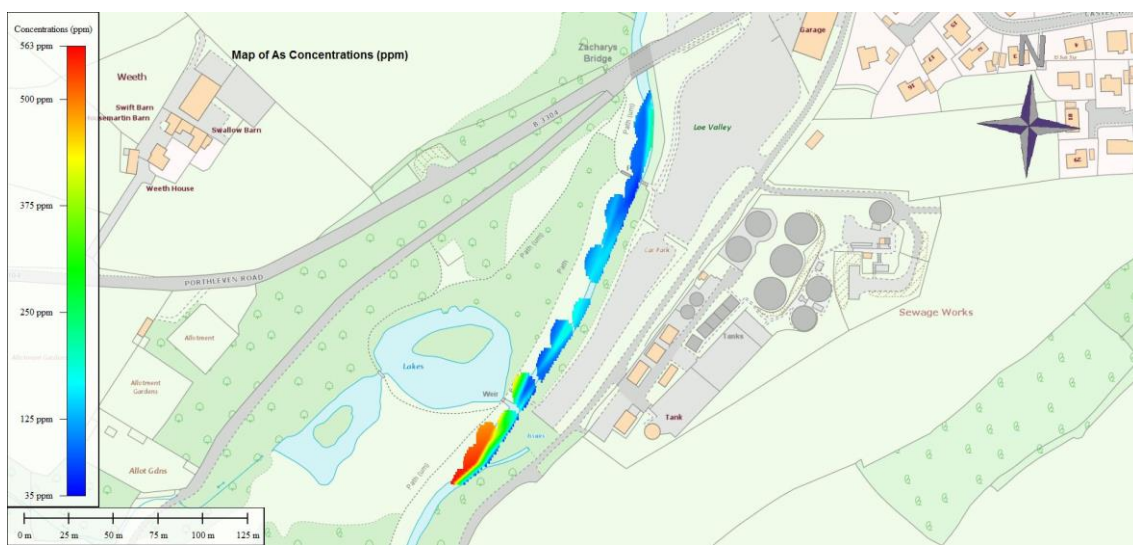
Arsenic being a well-known contaminant and its presence in any environmental survey is of interest for monitoring. Figure 36 again, highlights the spread of the data across the river running through the site at Penrose. It illustrates that there is some traces of arsenic at the site. Especially downstream, where there is an area of high As concentrations reaching 563 ppm.

Figure 37 Heat map illustrating the spread of data across the river for As concentrations (ppm)
