Loe Pool SSSI Macrophyte Monitoring Boat and Grapnel Survey 2015

Report Date: December 2015

Survey Date: 11 September 2015

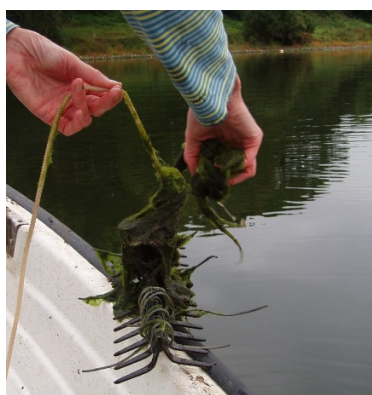
At each survey point along the 14 transects, two grapnel trawls are thrown approximately 4 metres from the boat. The grapnel is constructed of two rake heads, wired together back-to-back. The total catch for each trawl is weighed *in situ* to the nearest 5 grams. Weights are wet weights with excess water gently shaken off higher plants, or squeezed from algae. The proportion of the catch occupied by each species is assessed visually. These must be considered very approximate, particularly since density varies between species.

Grapnel: Two rake heads wired together and attached to a line
