A Hydrographic Survey of Loe Pool

By Tomas Joseph

September 2015

Submitted by Tomas Joseph to the University of Exeter as a dissertation towards
the degree of Master of Science by advanced study in Surveying,
Land/Environmental Management

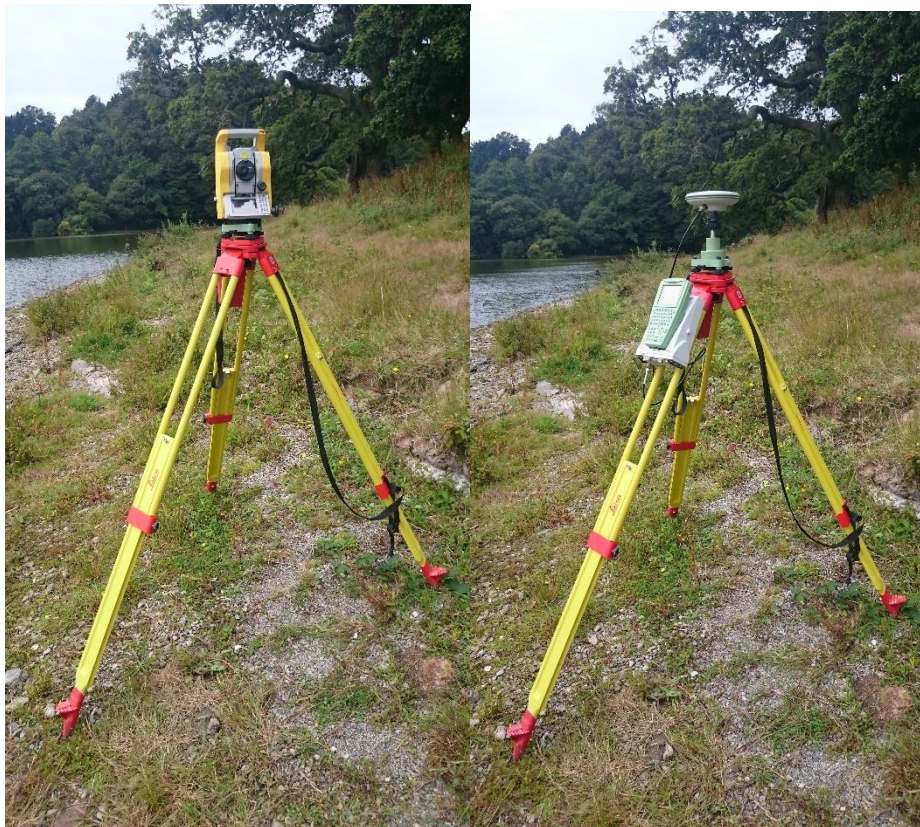
Figure 3-2 Trimble TPS and LEICA 1200 GPS unit.

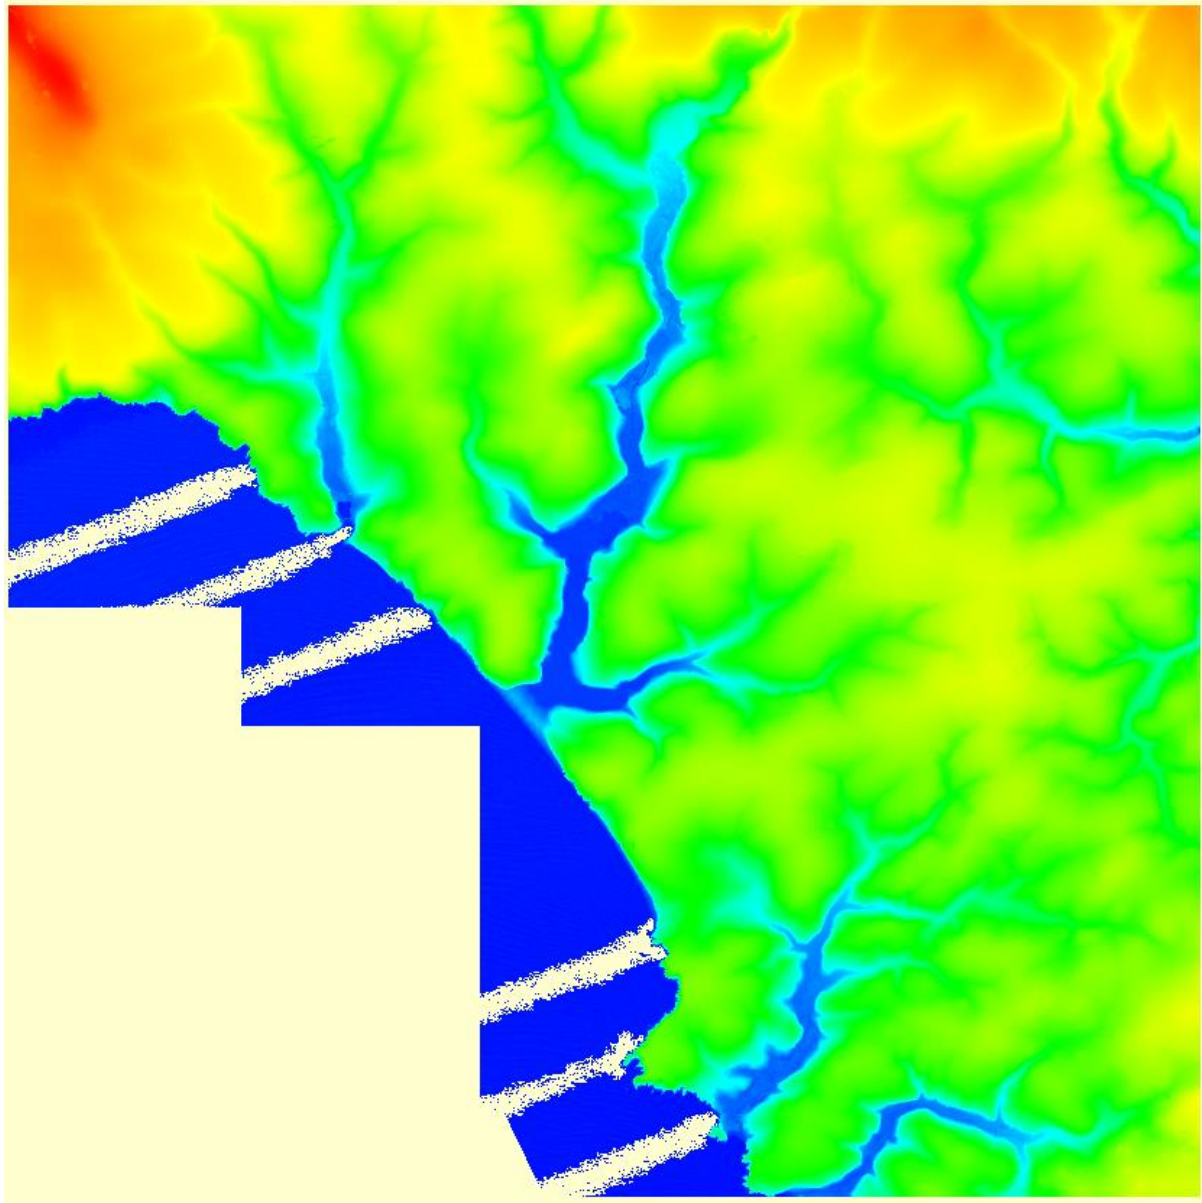
Table 4-1 The complete TELLUS Lidar data for the grids contain Loe Pool.

Essentially the process takes the large Lidar data (figure 3-1) and turns it into a smaller grid file (figure 3-2).

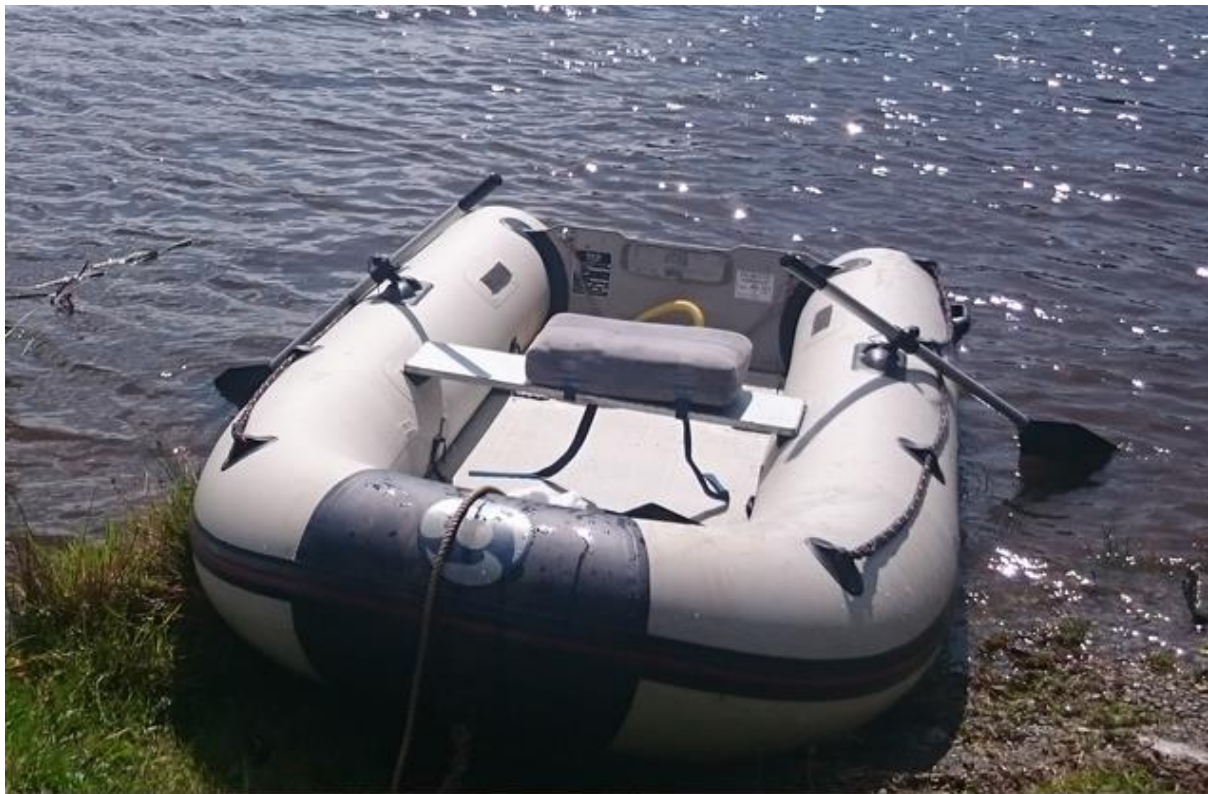
Figure 5-1 (Author 2015).

The boat used as a survey platform was a fully inflatable Yamaha 350sti as picture in the following figure, this boat was used for the sidescan sonar and the magnetic surveys (the boat contained no ferrous material so could be used for the magnetic survey without affecting the sensitive GSM-GEM19 magnetometer).

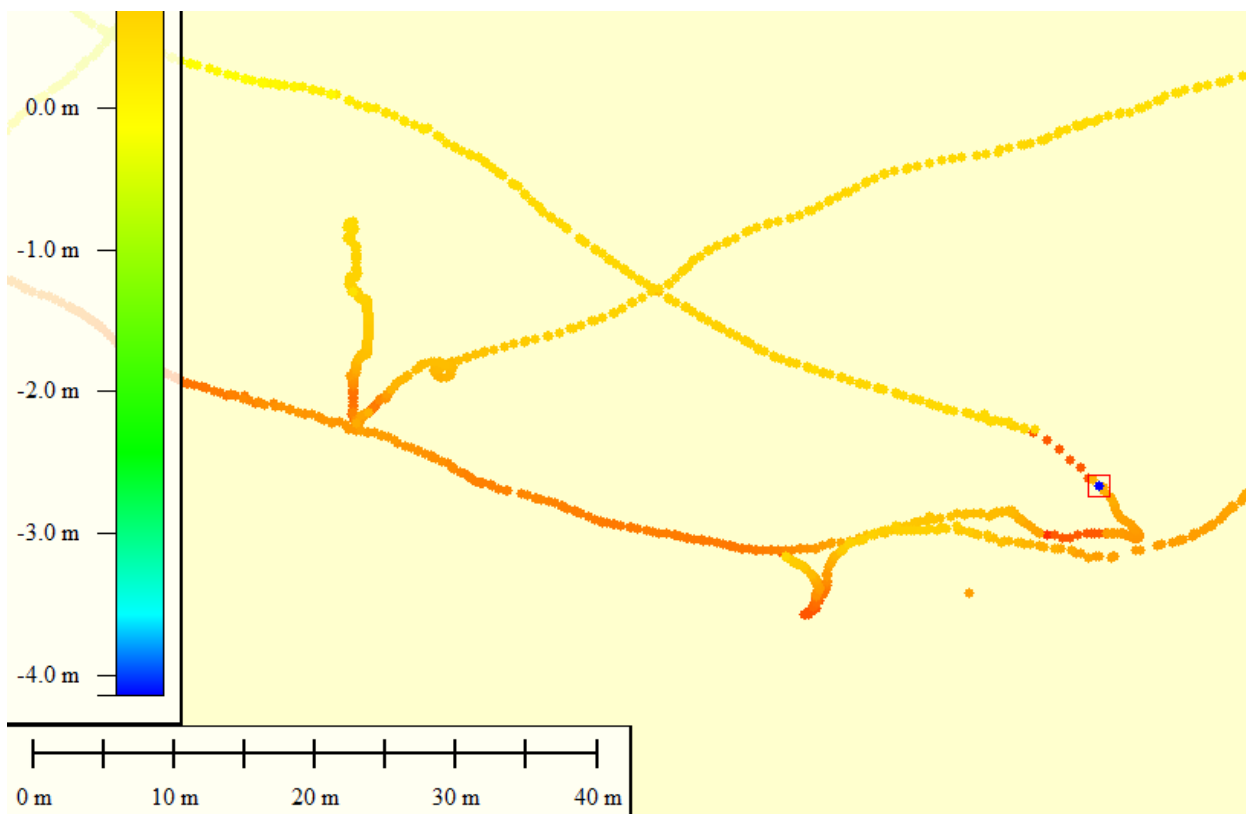
Figure 5-6

1. The CSV files were opened in Global Mapper as Lidar Points so that each point could be selected individually, figure 3.3 shows one of the questionable points being selected to

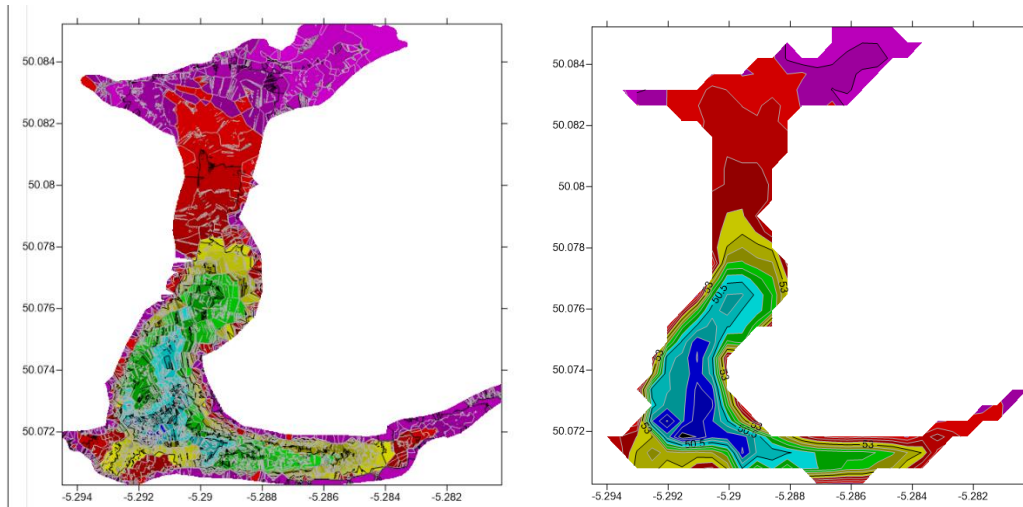
2. Depending on the desired output different spacing and gridding methods could be chosen, in this case all of the grids produced using the Kriging method. This is a method of interpolation which uses a geostistical algorithm to express trends in the data (Golden Software 2015), it was chosen as it is a very flexible method and after comparing it with other methods such as nearest neighbour and natural neighbour it did not produce false contours while the other methods did (figure 3.8). The node number can also be chosen and affects the spacing of the grid lines when the grid is produced, the higher the number the more nodes/grid lines are produced giving a higher resolution in the final contour map or 3d surface (Golden Software 2014). As shown in figure 3.7 node number and spacing can have a dramatic impact, the aforementioned figure shows one map with only 30 nodes and the other with 1000, the fewer nodes the simpler the map becomes

Figure 5-10 A map using 1000 nodes on the left, and one with only 30 on the left.

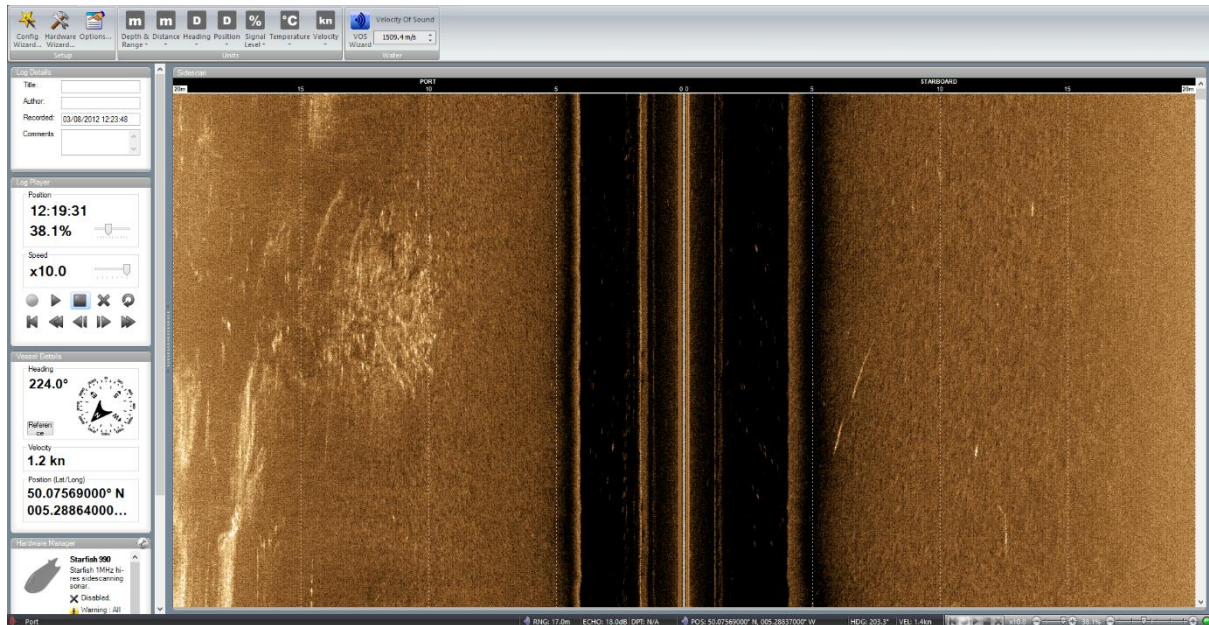
1. The files were exported from the starfish 990f via USB cable to the author's computer.
2. The files were reviewed using starfish scanline v2.1 (figure 3-18), when objects of interest were seen the coordinates of the object were noted down (Figure 3-19) and stored in an excel spreadsheet and a snapshot was exported of each object (Appendix B).

Figure 5-18 A tree is visible on the left of the image, this figure shows how data was seen when review log files.

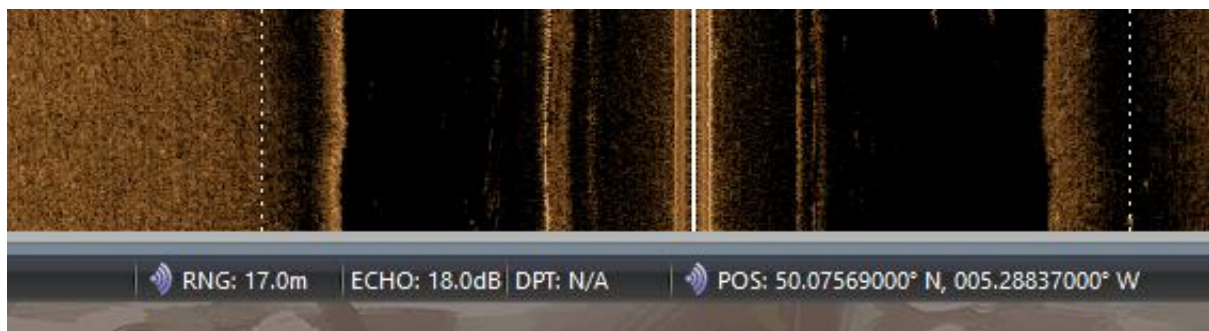
Figure 5-19 Coordinate data is visible on the right of the image.

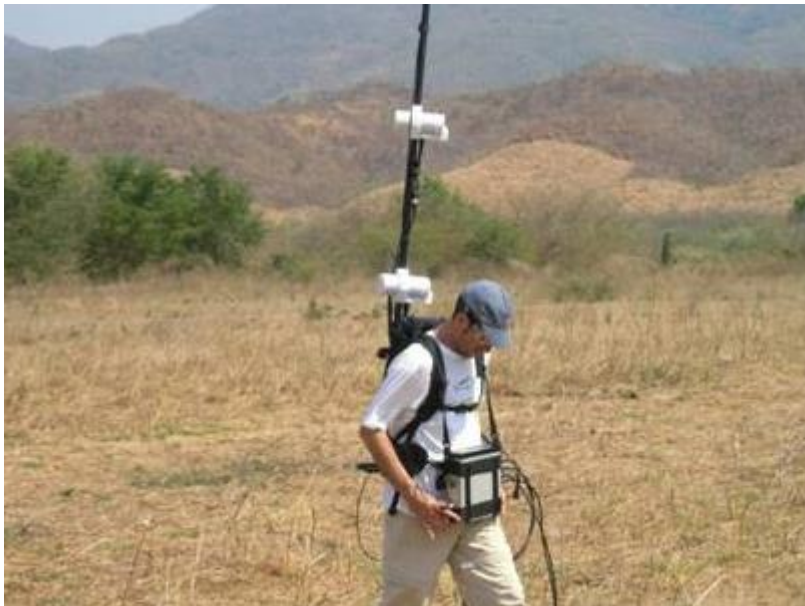
Figure 5-21

The GSM-19 was designed to be attached to a harness worn as a backpack would be, with the antenna on the back while the data logger attaches to the front of the harness (this setup can be seen in figure 3-21). However for this survey the harness was not used, instead the antenna was held in the front of the boat, the bottom of the antenna was placed using the dimple where the air intake for the bow floor is to keep the antenna and sensors in the same position throughout the survey. The data logger was placed at the bow of the boat and was covered with a towel to protect it from splashes of water.

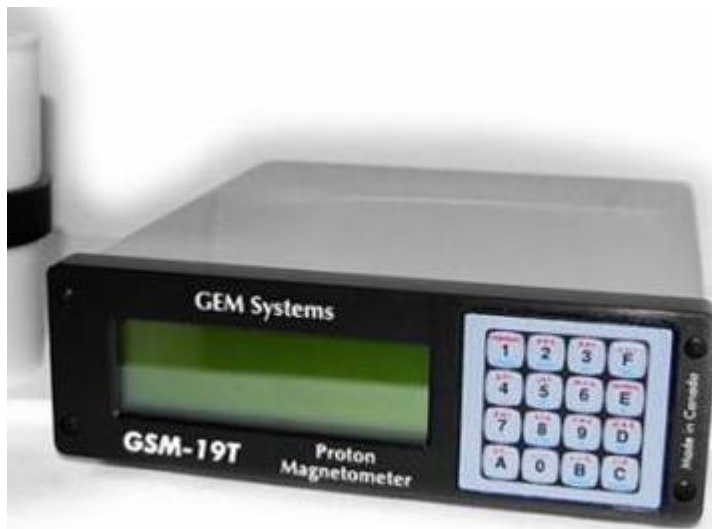
Figure 5-22 The data logger part of the GSM-19 system (GEM 2008).

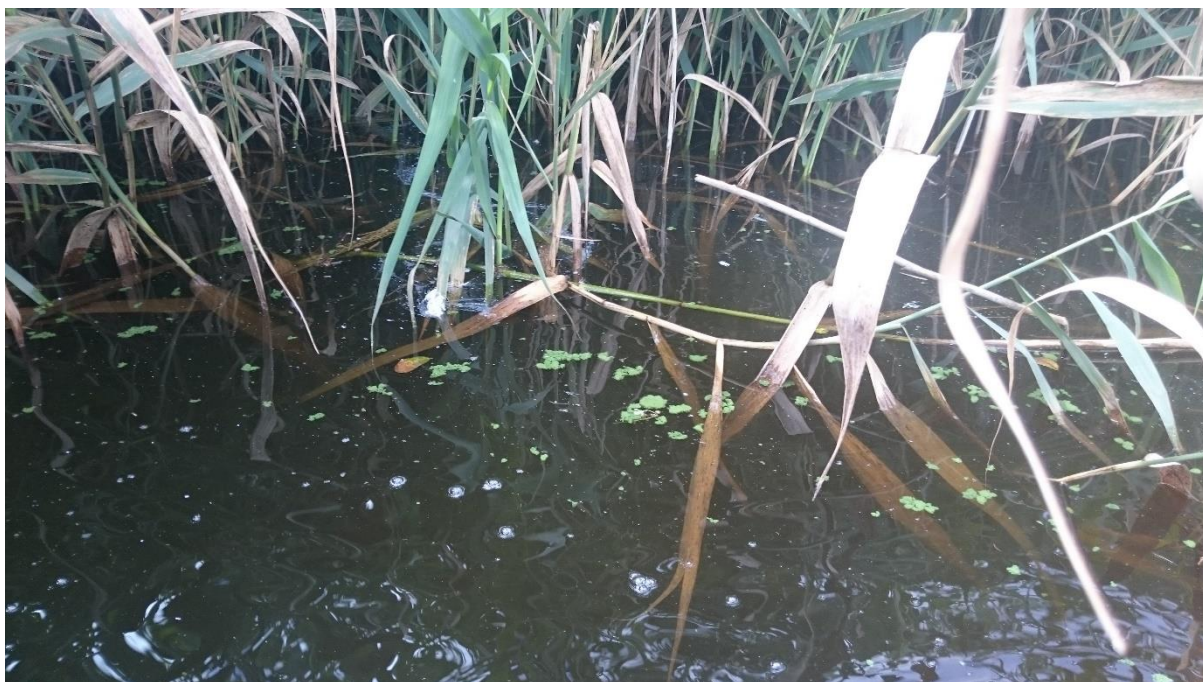
Figure 9-2 Cyanobacteria spotted in Loe Pool (Author 2015)

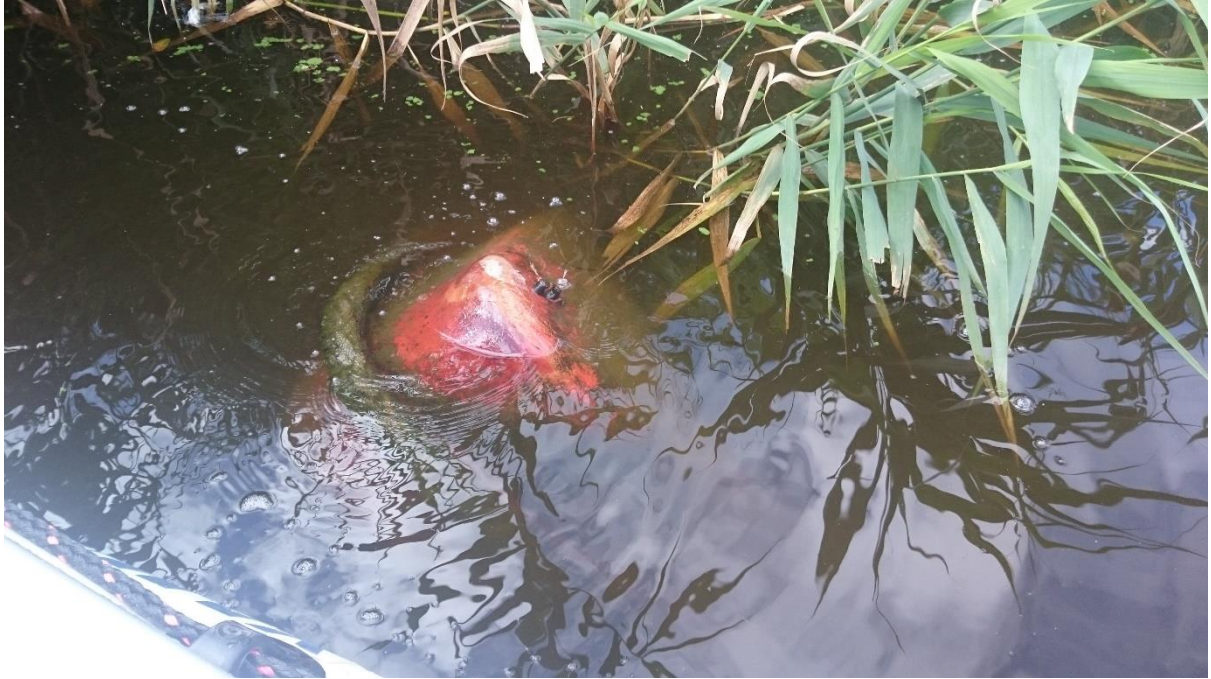
Figure 9-4 Sunken Boat.
